MADAGASCAR:
TRAINING FOR SAFER CONSTRUCTION
AFTER CYCLONE KAMISY

Draft for Review

July 1993

Case study prepared as part of a project, *Evaluation of Post-Disaster Housing Education as a Local Mitigation Approach*, for BHM, Inc., under contract with the AID Office of U.S. Foreign Disaster Assistance, Washington, D.C. 20523

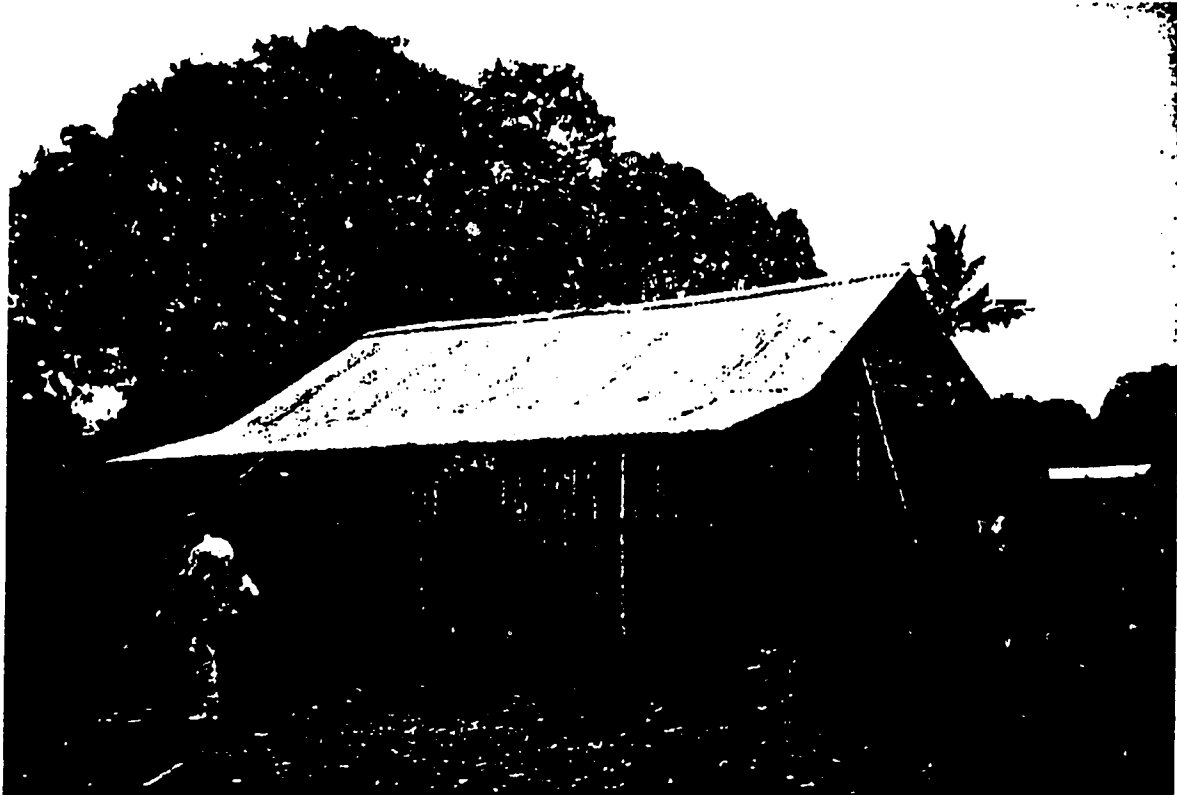
Figure 4: House built by one of the Kamisy teams in Anivorano. The frame was erected by the trained crew and the walls infilled with raffia by the owner. Here the verandah has been partially enclosed as well, extending the living space for the family.

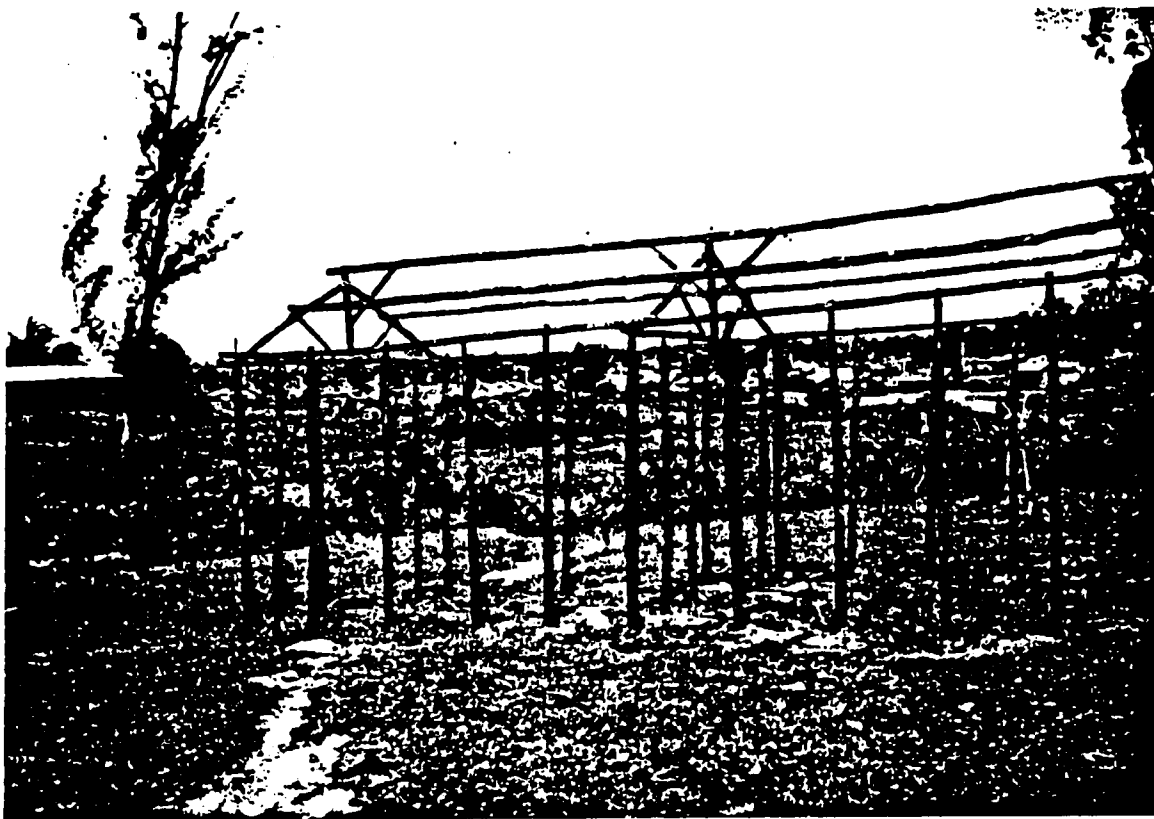
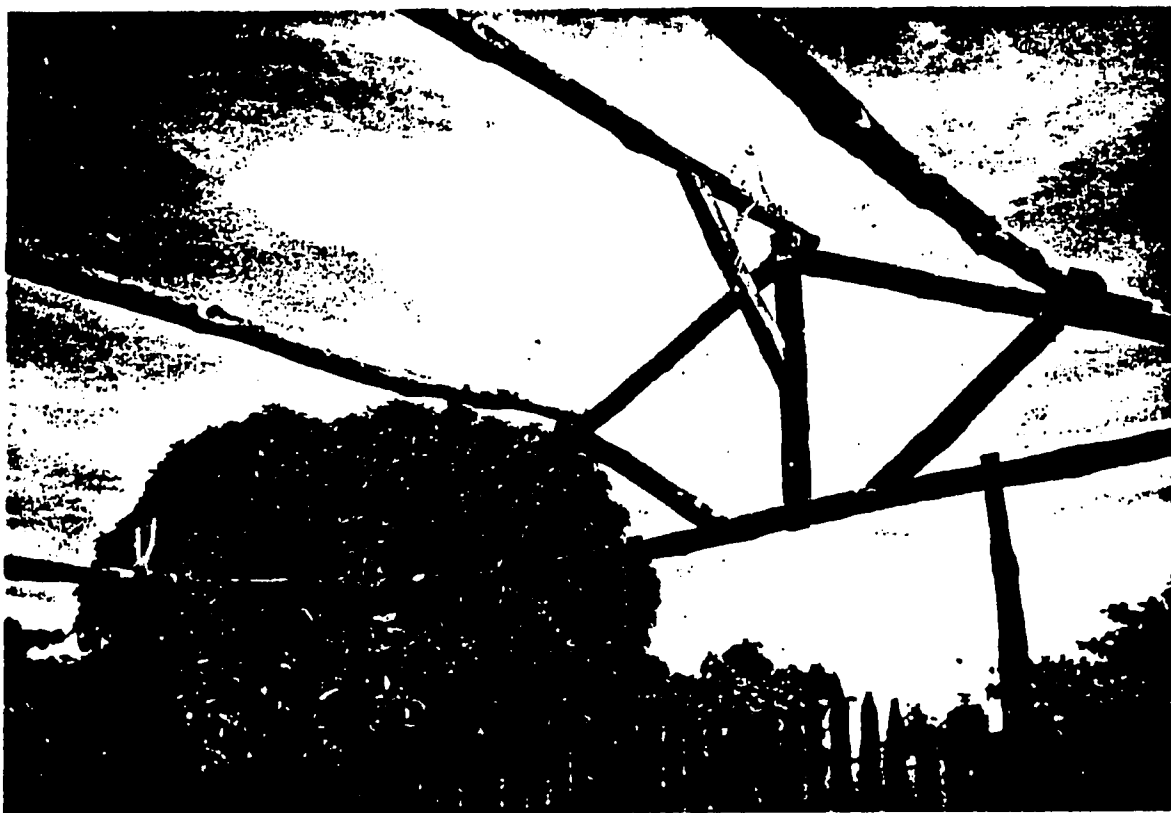
Figure 5: New house frame in Mahajanga. The poles are thin unsawn saplings. Most of these members are so small that they cannot be nailed without splitting.

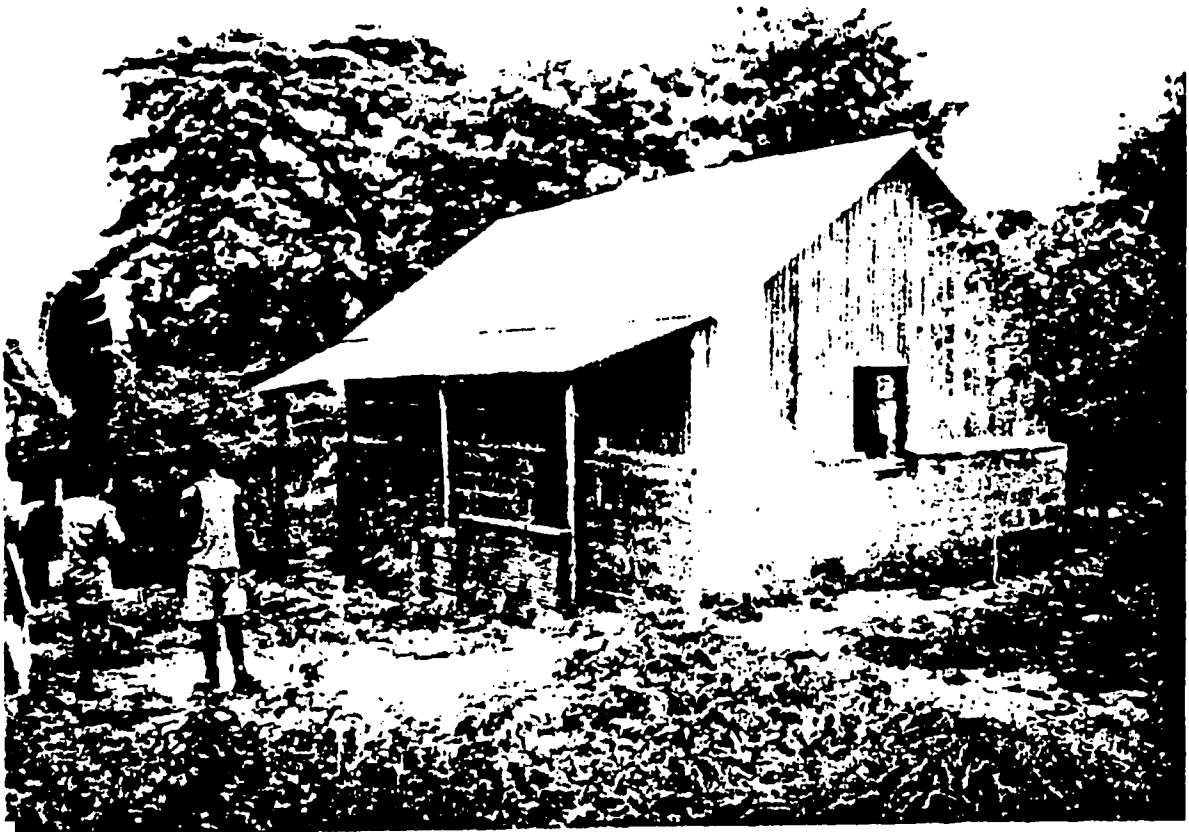
Figure 10: Typical project house in Mahajanga. This one has concrete block half-walls. Its occupant built the house with 4 others on a construction team supervised by the private contractor on whose land the house is sited. He now acts as a guard for the contractor whose home is next door.

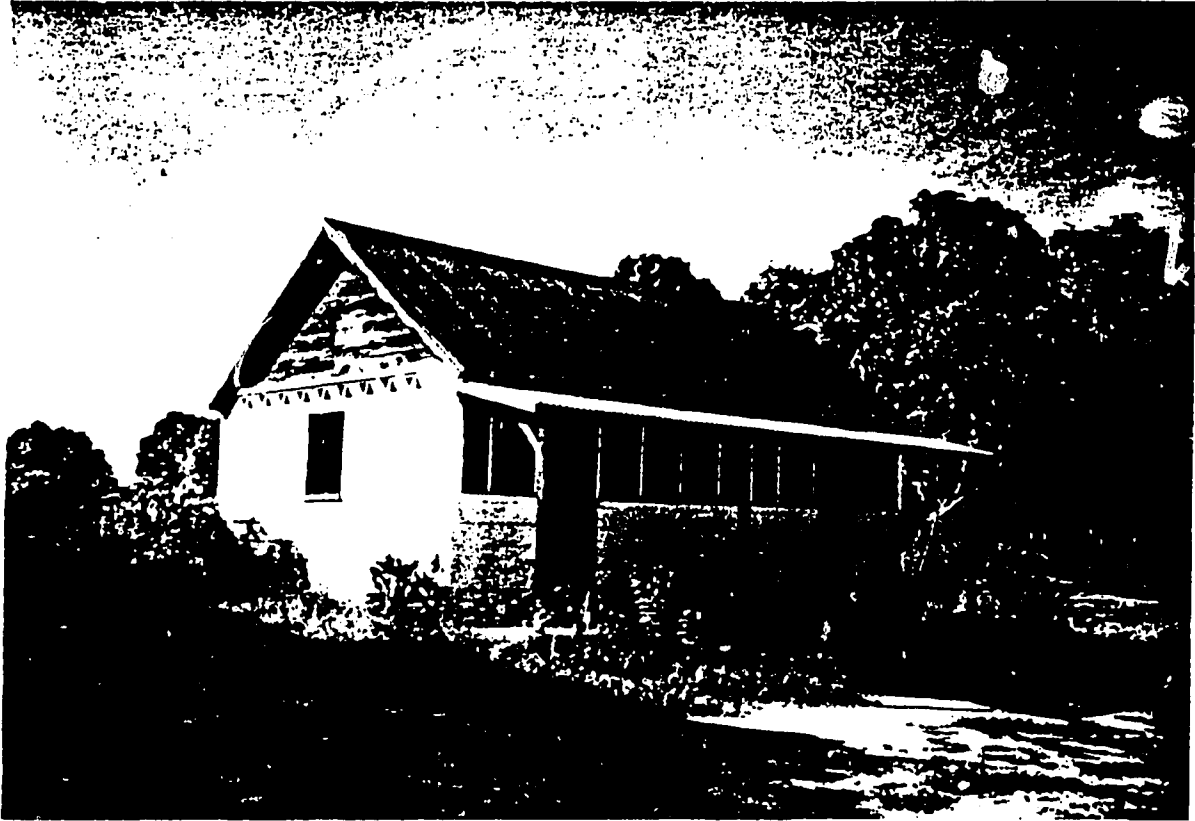
Figure 11: One of three model houses grouped in "Cité Américaine". This is a wood frame structure with concrete wall screen around. The gables are sheathed with wood siding. There is no running water or electricity to the site of the houses. Two of the 3 houses remain unoccupied.

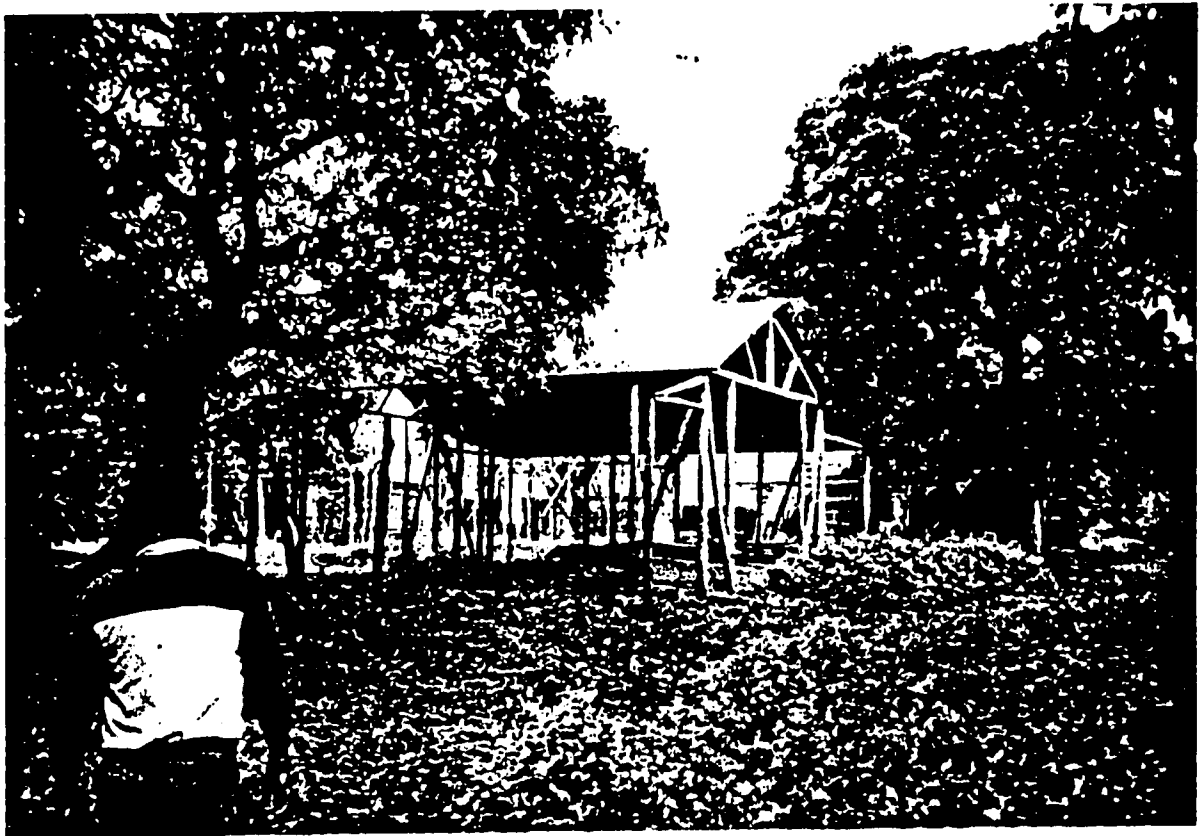
Figure 12: "Kamisy house" in Anivorano, still unoccupied and incomplete.

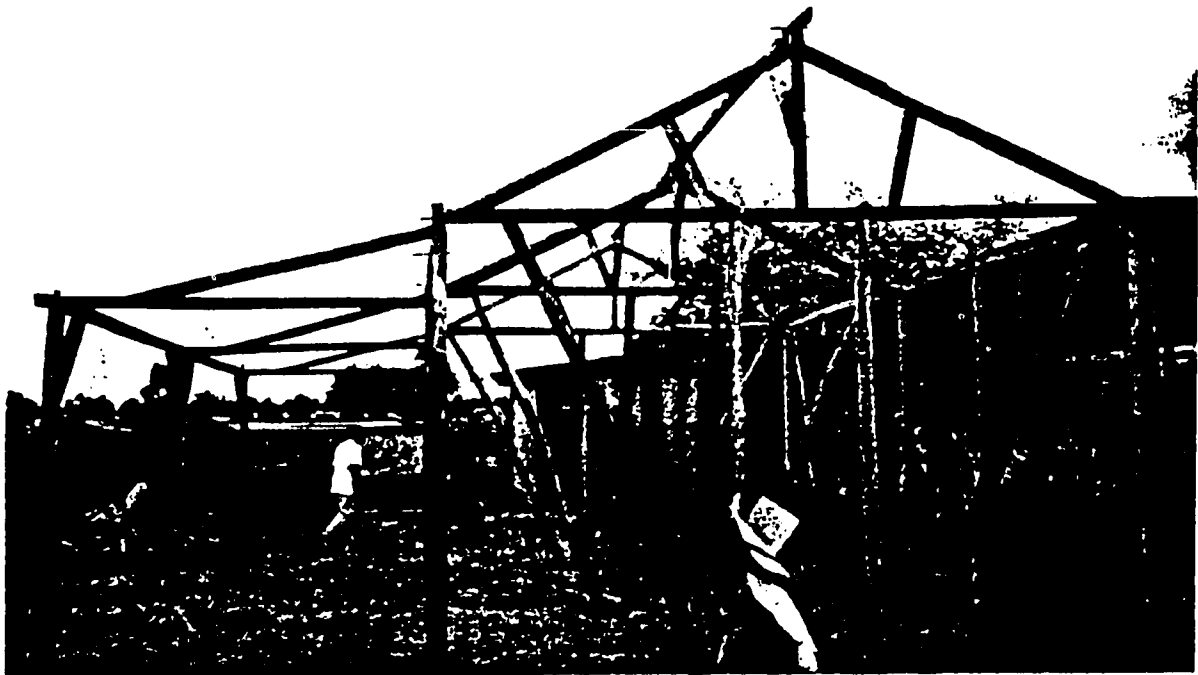
Some instances of continuing replication can be found. Outside of Antsiranana, we saw a new house under construction on the road to the university. The frame was well built: a typical building style on no foundation with the poles set right into the ground as is usual, with diagonal bracing and crude cyclone straps made out of odd pieces of steel angle and plate. Wooden pegs were used instead of nails at major joints and throughout the roof structure [see Figures 13 and 14]. The owner said that he had built the house himself to be cyclone-resistant. The roof pitch was good; the roof sheets were only partly installed and not well-fastened, but he said that this was only a temporary roof. We were not able to determine where he had learned these techniques – whether from seeing model structures or reading books or talking with builders. He did say, however, that he intended to build a wind-resistant house. He said the whole process could take about 45 days.

Figure 13: New house under construction in Antsiranana. Poles are set directly into the ground. Note diagonal bracing.

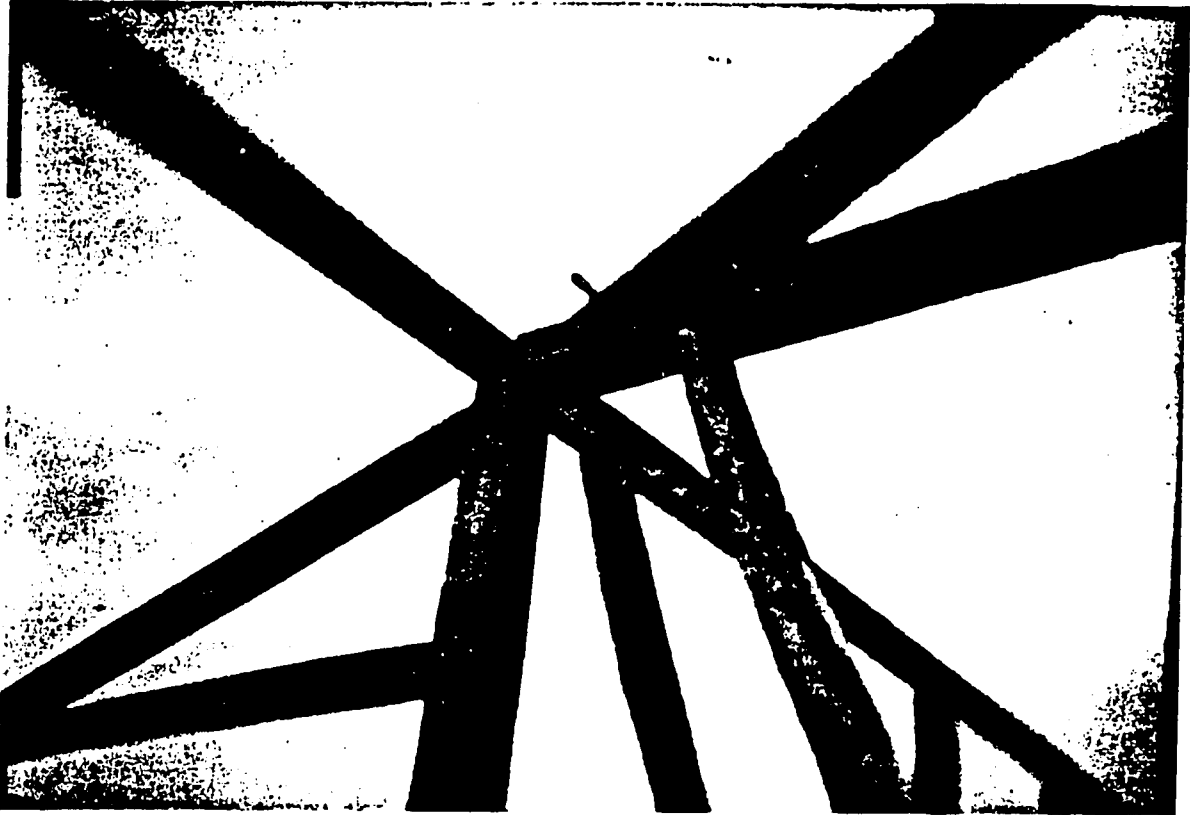
Figure 14: Detail of new house in Fig. 13. Note wooden pegs used in lieu of nails.

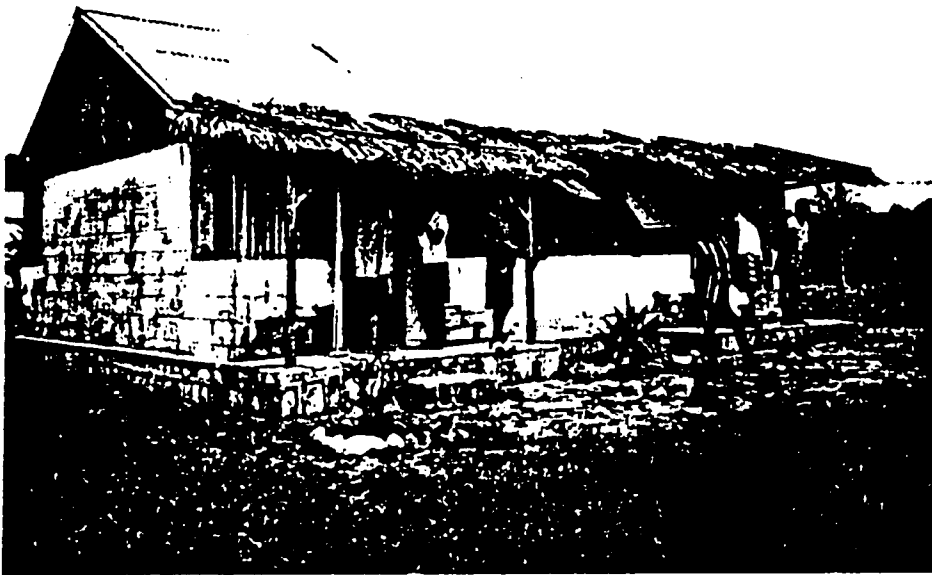
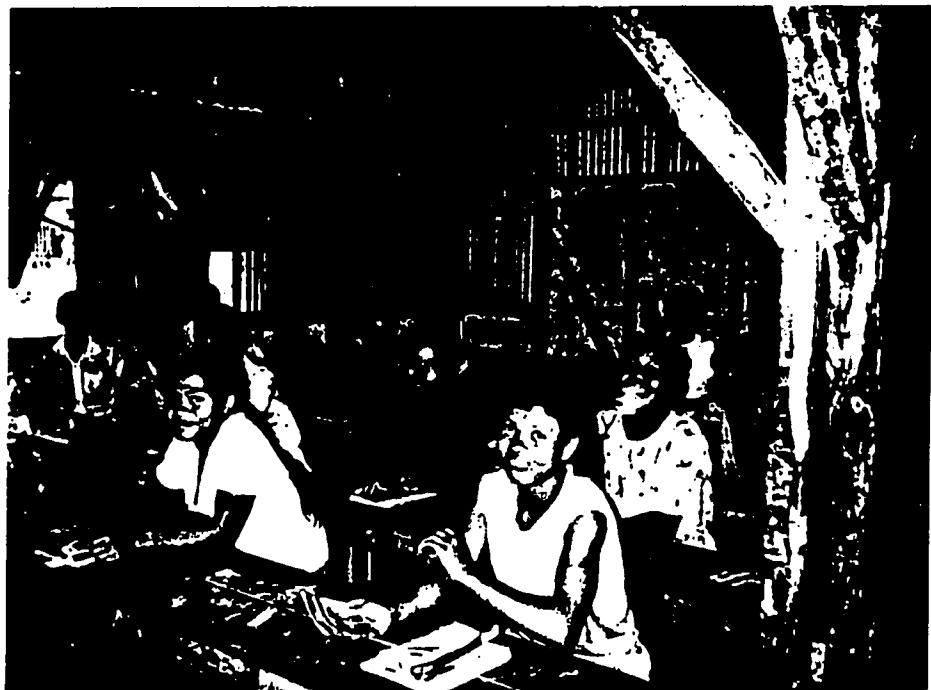
In Mahajanga, four small buildings similar to the model house design were erected after Cyclone Kamisy, probably by Caritas, on vacant land across from a Catholic Church. It is said that their construction followed a request for post-disaster assistance for the community from the parish priest, so the plans and materials may derive from the USAID/OFDA project. In any case, they have become the school at Antanimalandy, and the director says they have withstood numerous storms since their construction.

Figure 16: Two of the buildings which serve as a school at Antanimalandy. Note bracing, straps, and similarity of design to the USAID Kamisy houses.
