Preserving Haiti's Gingerbread Houses

2010 Earthquake Mission Report

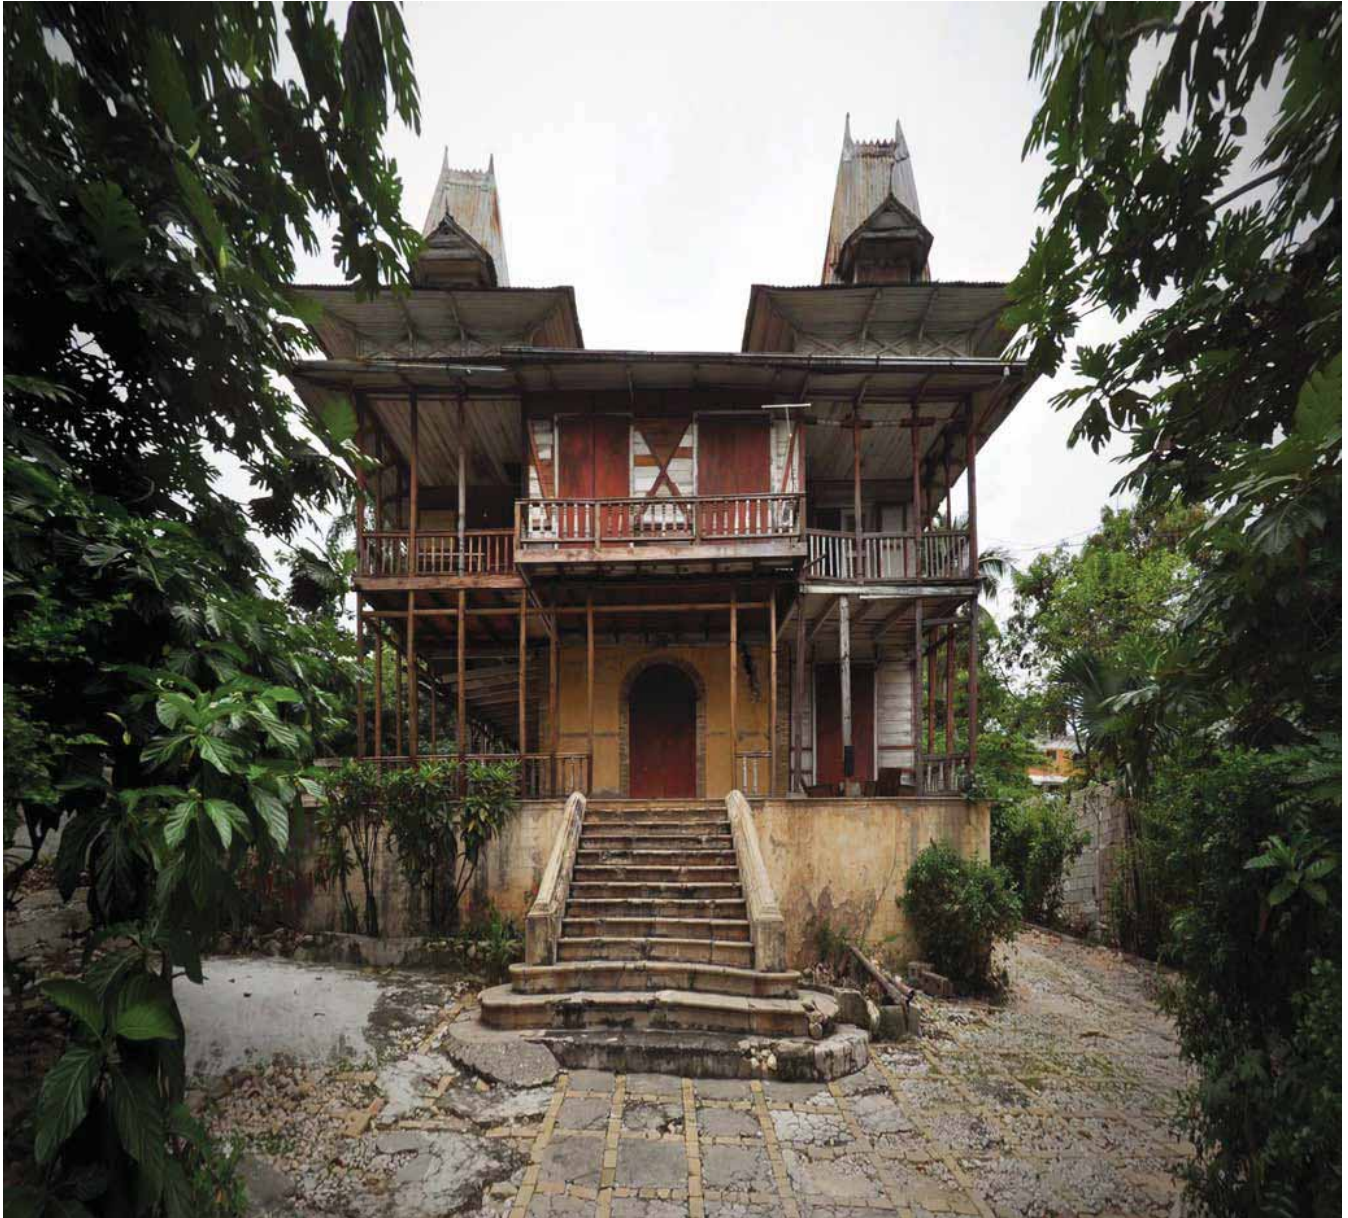
FIGURE 1 cover: The west front of the Villa Castel Fleuri on Avenue Christophe, a grand brick and rubble stone masonry house. This house was occupied by the President of Haiti for a short period in its history. It has suffered extensive damage in the earthquake mainly to the projecting stair tower on the east side, and porches on the west. The plates that hold the iron ties that penetrate the building are visible on the façade.

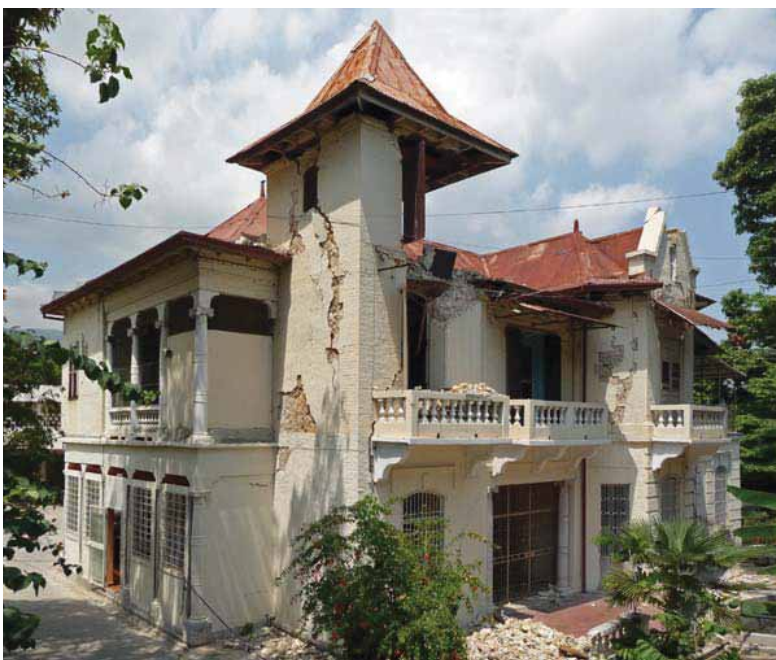
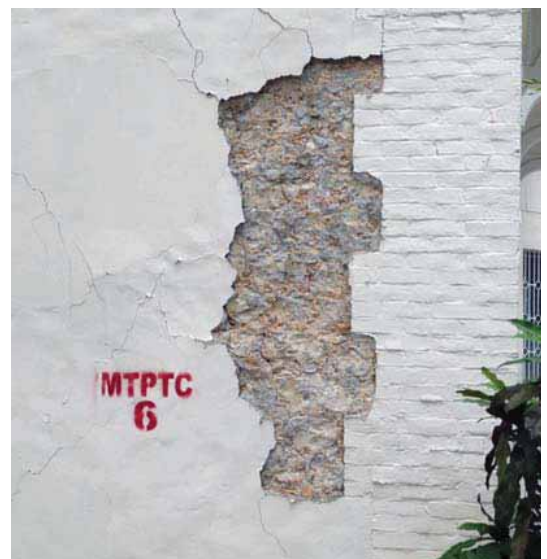
FIGURE 4 The red painted designation “MTPTC” indicates that inspection deemed the tower unsafe for occupancy by the Ministère du Travail Public et Télé Communications.

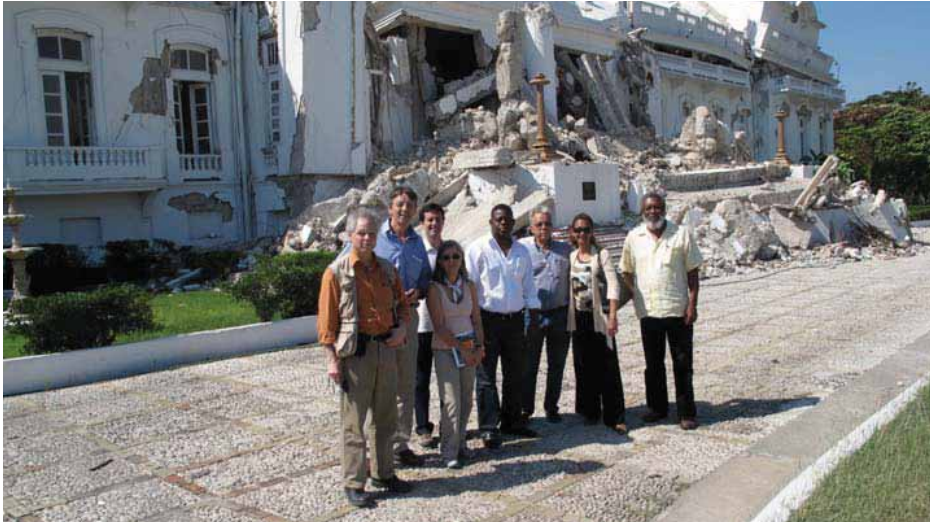
FIGURE 5 Dinu Bumbaru (ICOMOS), Herman van Hooff (UNESCO), Conor Bohan (HELP), Norma Barbacci (WMF), Olsen Jean Julien and Frederick Mangones (Assessment Team), Monique Rocourt and Daniel Elie (ISPAN) in front of the National Palace in February 2010.

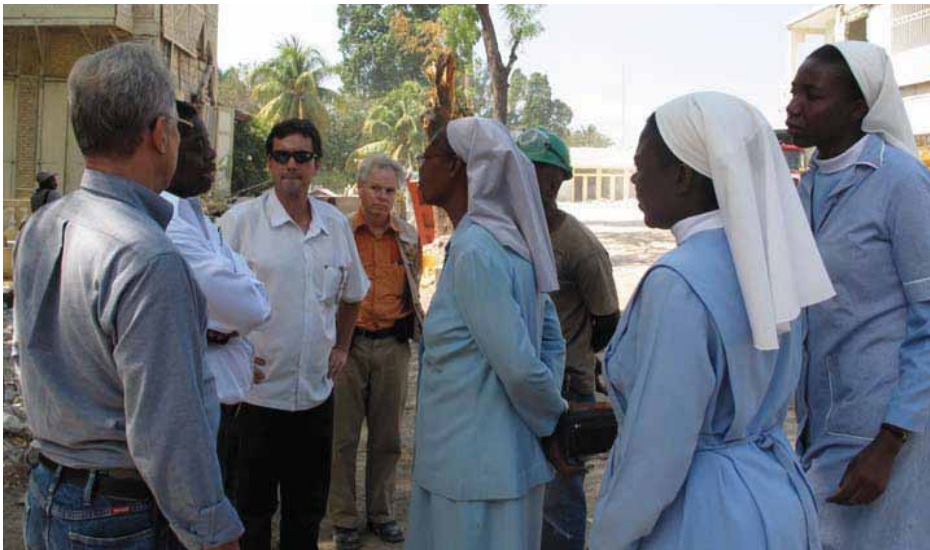
FIGURE 6 Frederick Mangones and Olsen Jean Julien (Assessment Team), Conor Bohan (HELP), Dinu Bumbaru (ICOMOS), and the nuns who own the Bazin House, in February 2010.

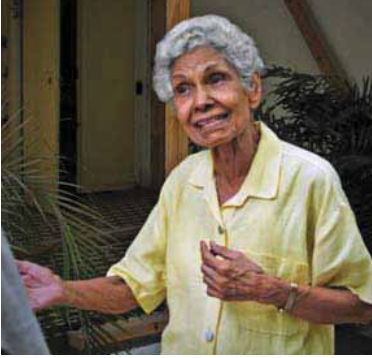
FIGURE 7 Madam Jacqueline Mathon, the owner of 9 Rue du Travail Première (shown in figure 137 on page 71). Her husband's father designed this house, and also another distinguished house, the Bazin House, nearby.

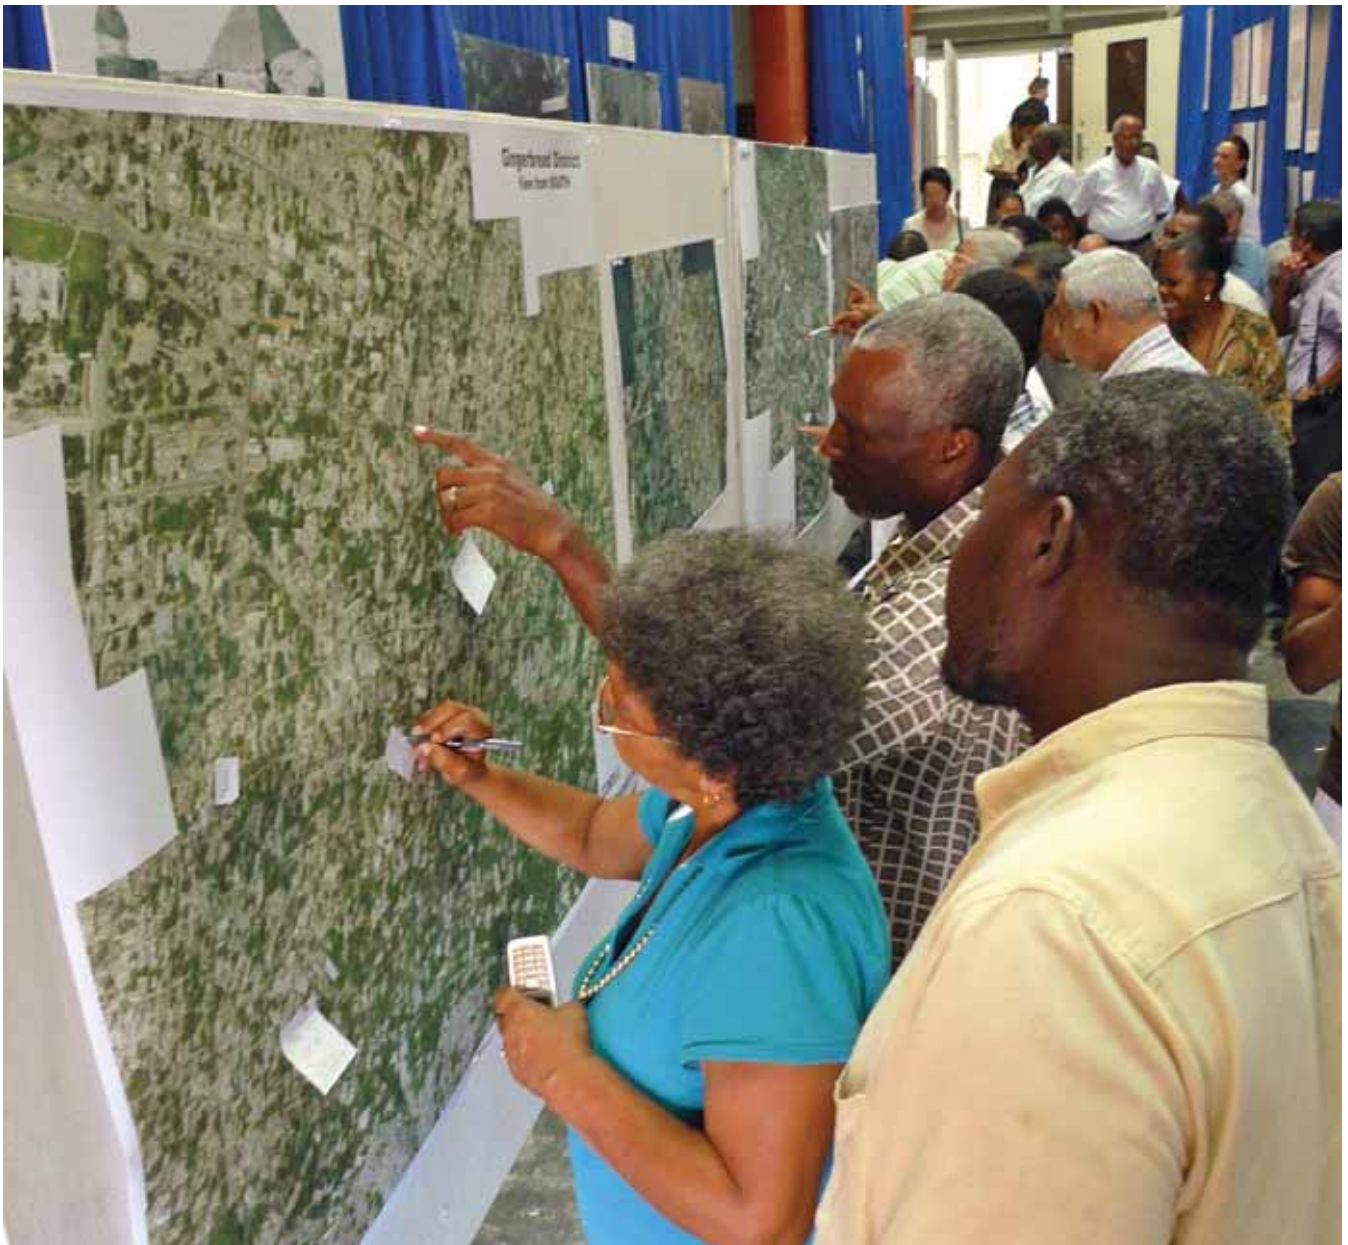
Assessment Methodology

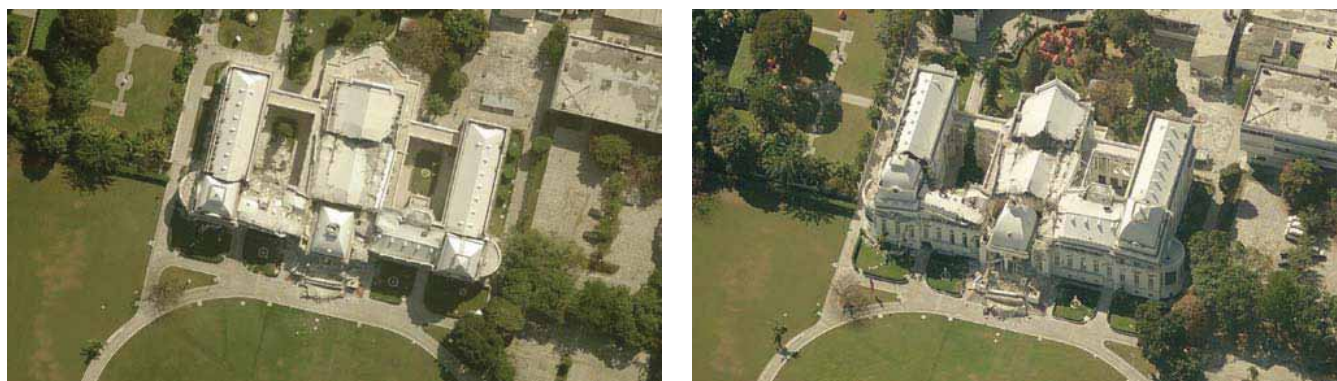
FIGURE 9 Straight-down aerial view of National Palace after the earthquake, and an oblique aerial view from the north.

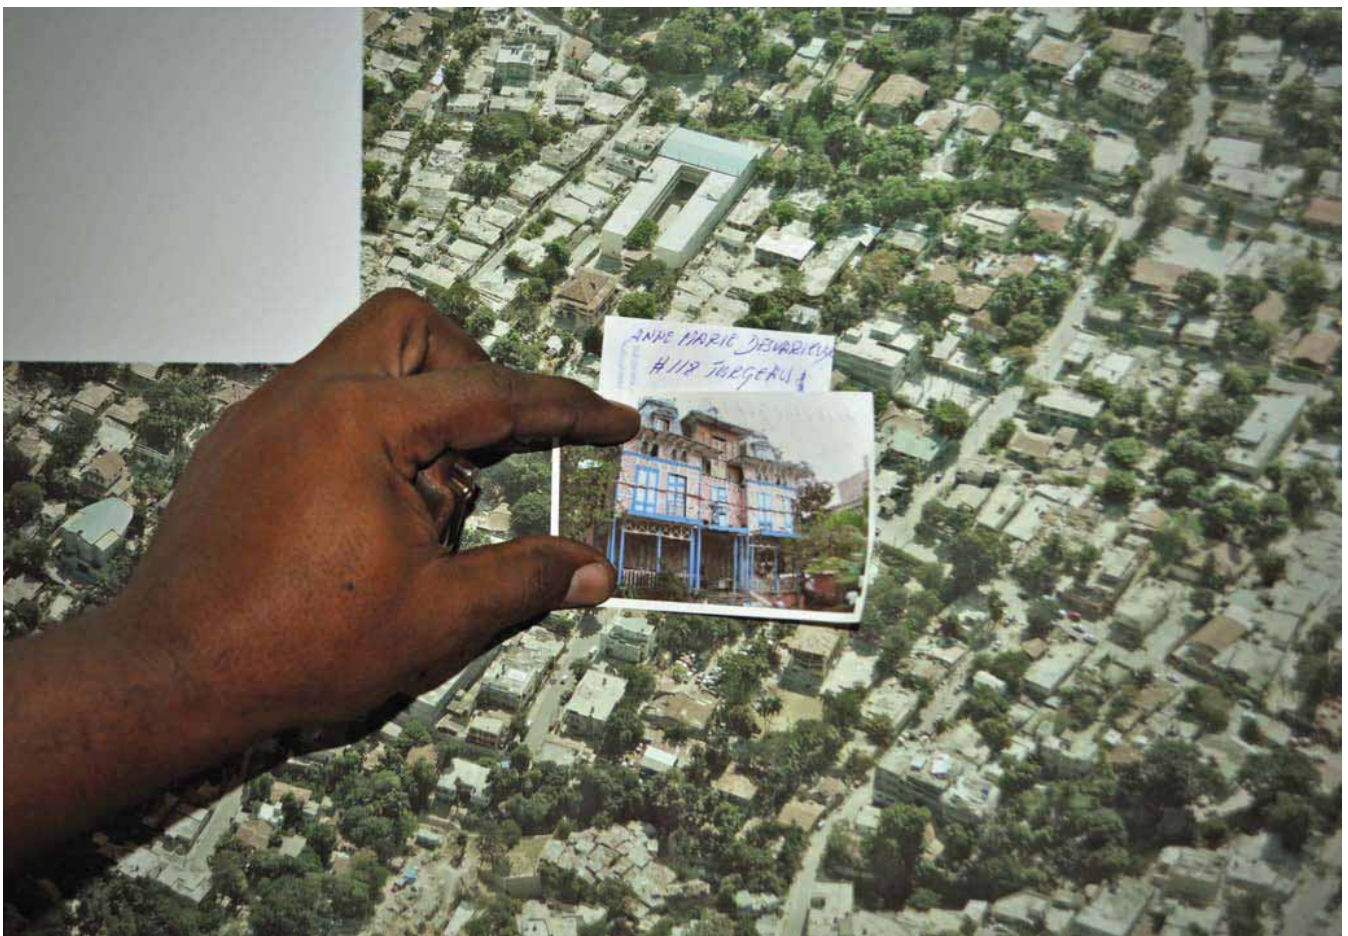
FIGURE 11 The first owner's meeting and the exhibition of the Pictometry mosaics of the aerial views of the Gingerbread district and downtown Port-au-Prince took place at FOKAL on April 20, 2010. Here, an owner marks his house on one of the views.

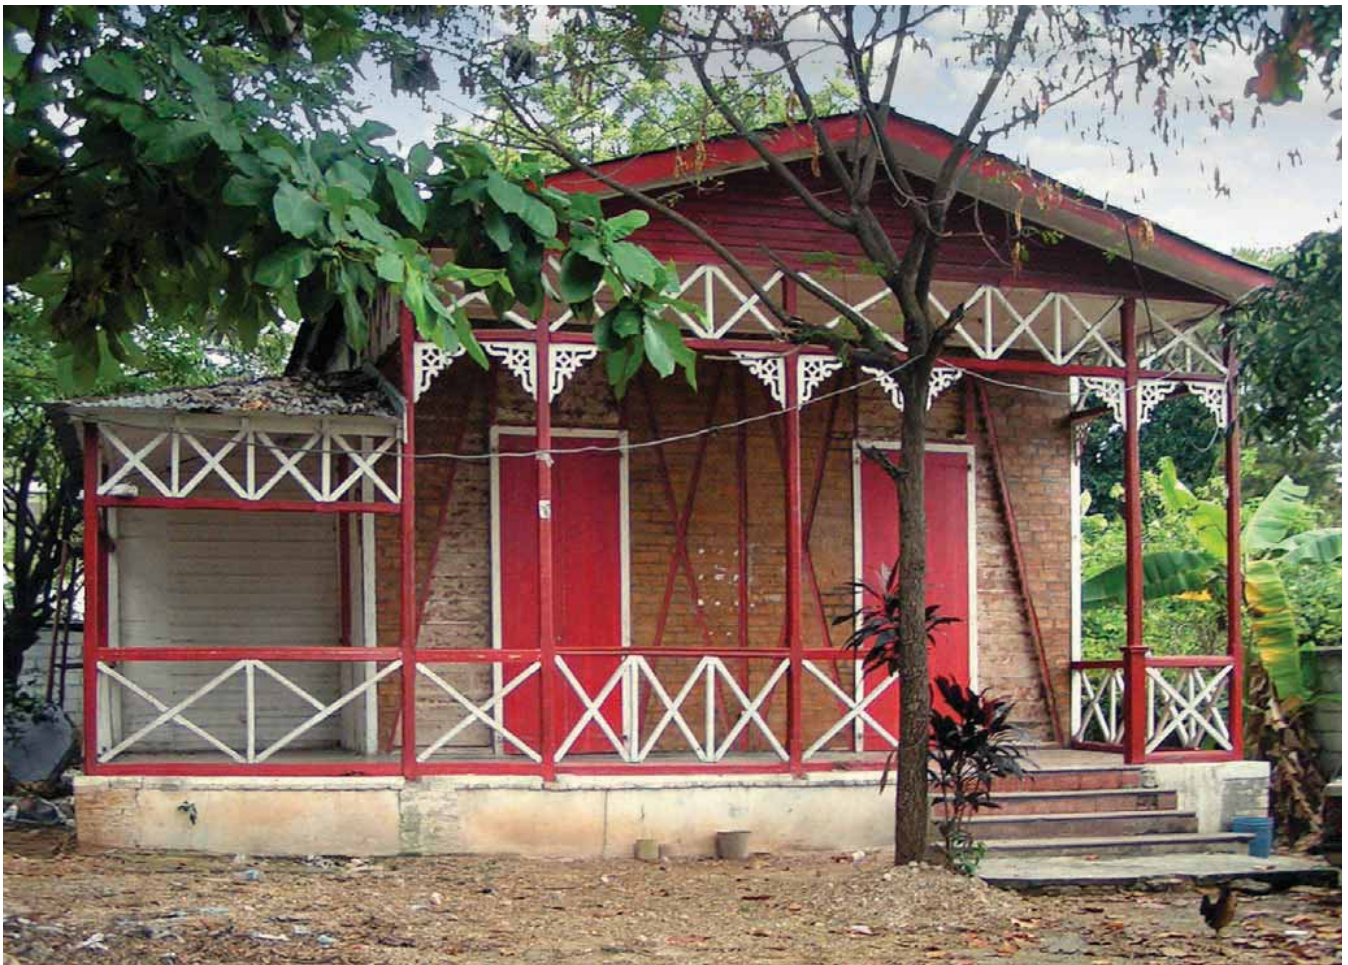
FIGURE 18 A smaller and simpler Gingerbread house at 26 Rue 7.

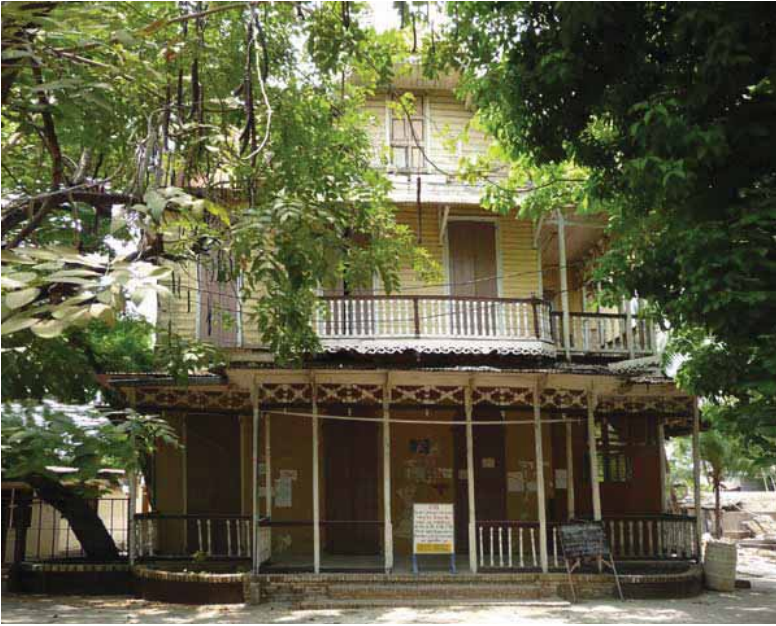
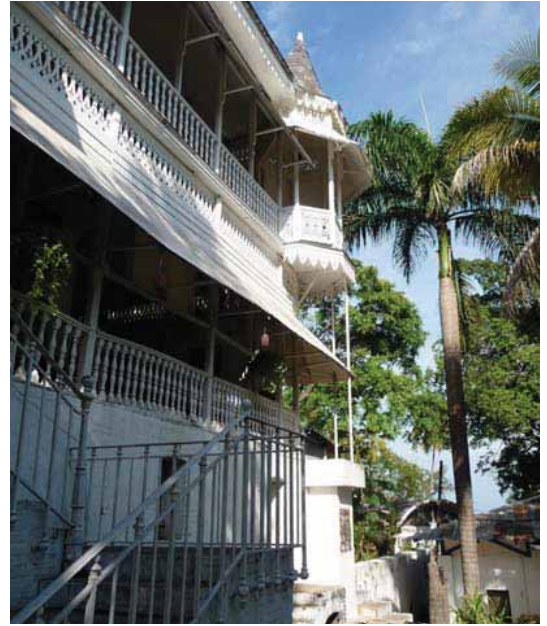
FIGURE 19 Non-residential uses of Gingerbread buildings: *above* College de Jeunes Filles, at 10 Lavaud 1; *top right* the Hotel Oloffson has been a hotel since 1936, and was a U.S. military hospital from 1915 to 1935; *right* 84 Lamartiniere is being repaired and renovated as a restaurant. *bottom* Two characteristic Haitian wooden buildings on Avenue John Brown with commercial space on the ground floor. All of these are iconic Haitian vernacular architectural forms derived from the “shotgun” house type that is long and narrow, with gable fronts, and rooms that extend across the whole width of the dwelling.

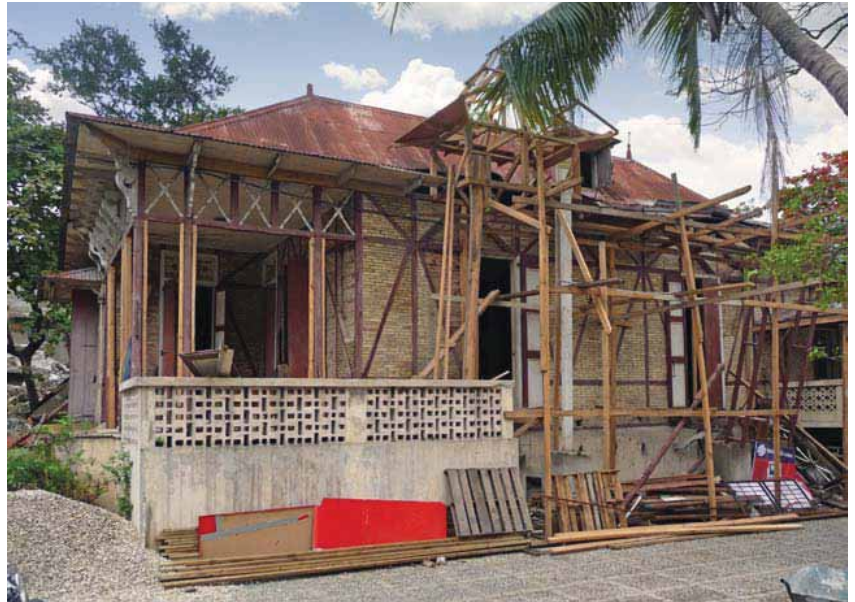
single-family residences (sometimes accommodating servants), mostly for affluent Haitians. However, there also were built—and still exist mainly in the northern and western portions of the district—many smaller and humbler buildings that exhibit simpler Gingerbread characteristics, and employ the same methods of construction (Figure 19 right).

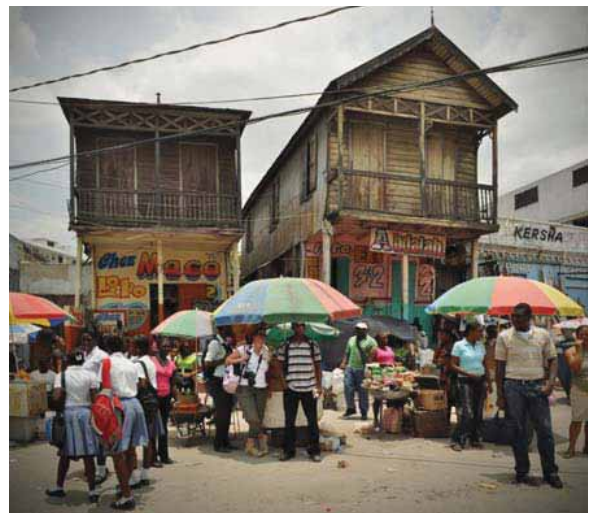
FIGURE 20 A large and elaborate Gingerbread house, still surrounded by its original spacious property, at 9 Rue Bellvue.

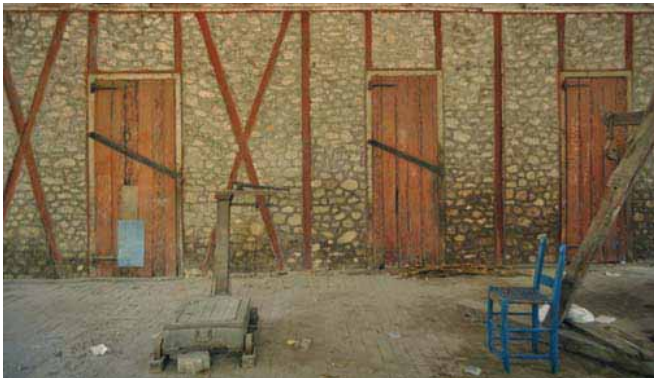
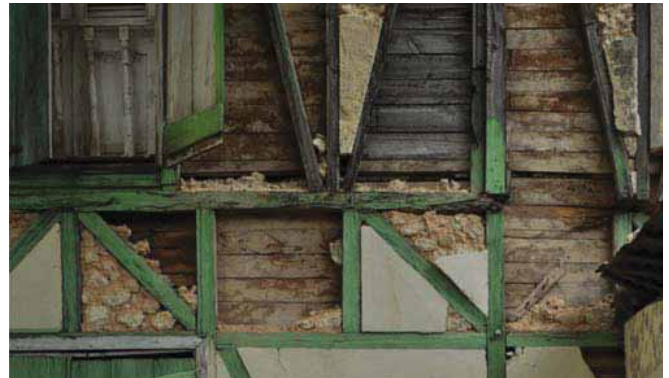
FIGURE 25 *left* A barn in Léogâne is an example of rubble stone *colombage* made with stronger igneous rocks than those used in Port-au-Prince, and not stuccoed. *right* A heavily damaged *colombage* wall showing the rubble stone infill characteristic of Port-au-Prince. See also figure 86.

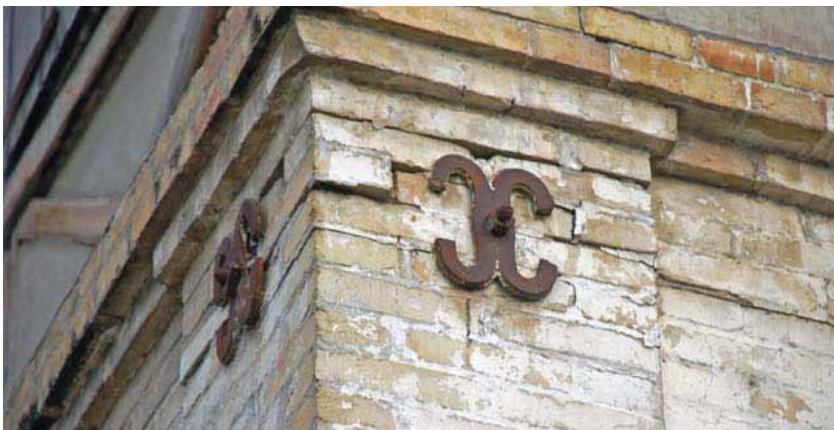
FIGURE 26 View of decorative end plates at the corner of this brick structure indicate horizontal ties along each wall of the intersect.

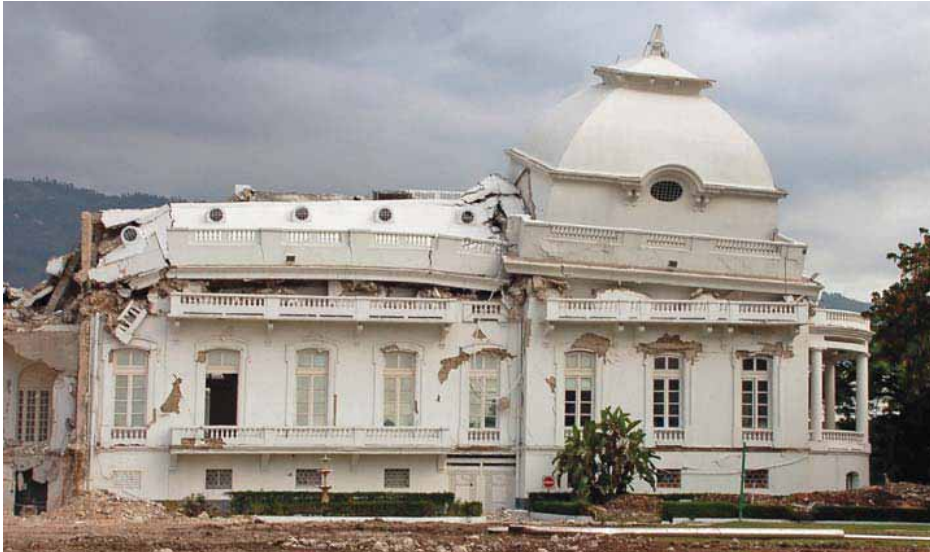
FIGURE 28 The *Palais Nationale*, constructed in 1918, is an example of early reinforced concrete use in Haiti. These buildings typically suffered full or partial collapse.

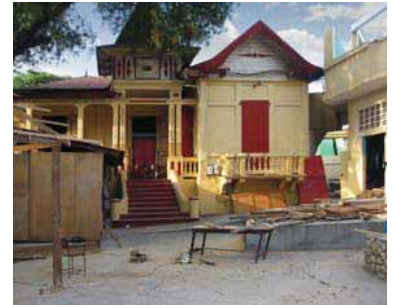
FIGURE 30 Concrete frame/confined masonry Gingerbread. This is the only variant of this type seen. It was undamaged.

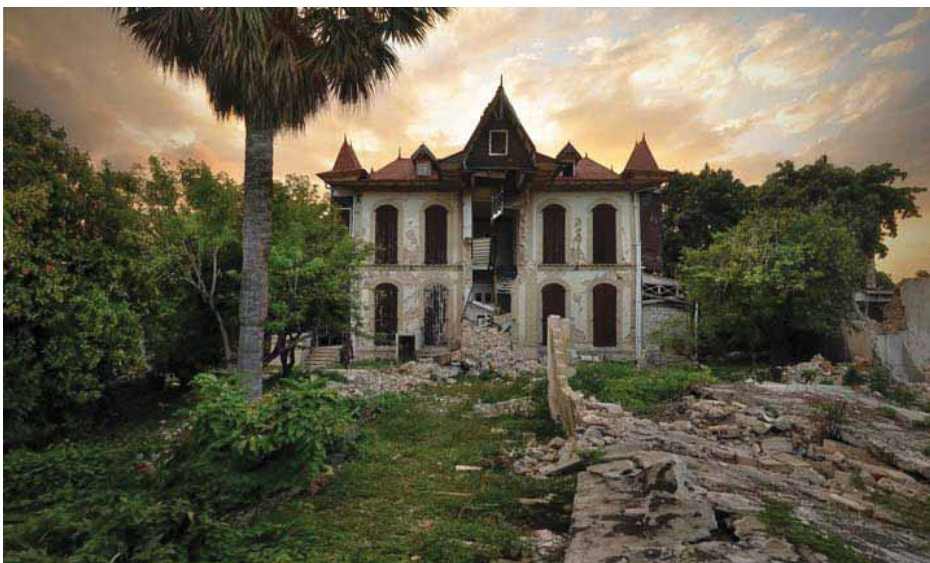
FIGURE 29 The east (back) elevation of the Villa Castel Fleuri on Avenue Christophe, a grand brick and rubble stone masonry house. This house was occupied by the President of Haiti for a short period in its history. It has suffered extensive damage in the earthquake mainly to the projecting stair tower on the east side, and porches on the west. The plates that hold the iron ties that penetrate the building are visible on the façade. See also Figure 47 on page 29.

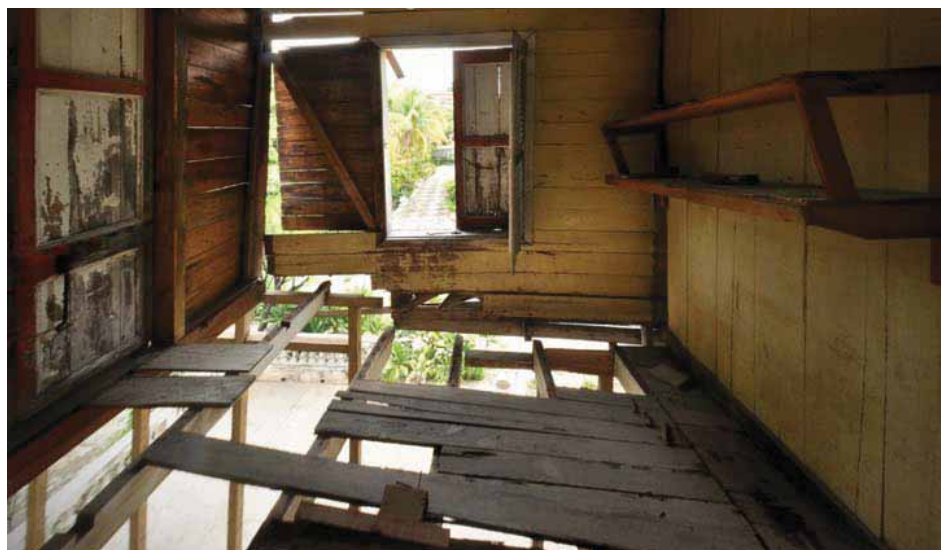
FIGURE 31 Drawing of a braced frame structure with sills, studs, and diagonals that are mortise and tenon and pegged together.

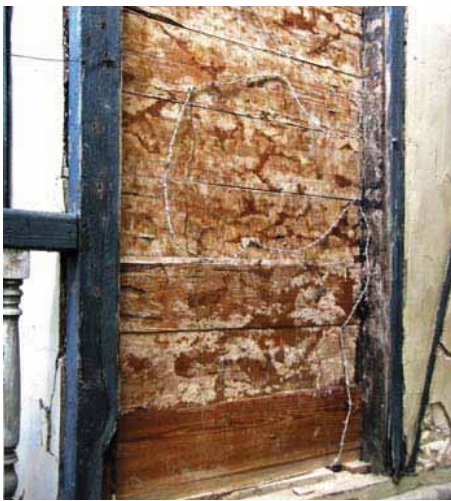
FIGURE 40 In this *colombage* construction the stone infill has collapsed due to the earthquake revealing the barbed wire reinforcement. This is an example of a non-construction material being adapted for construction due to its apparent availability. The barbed wire was galvanized and is still in good condition.

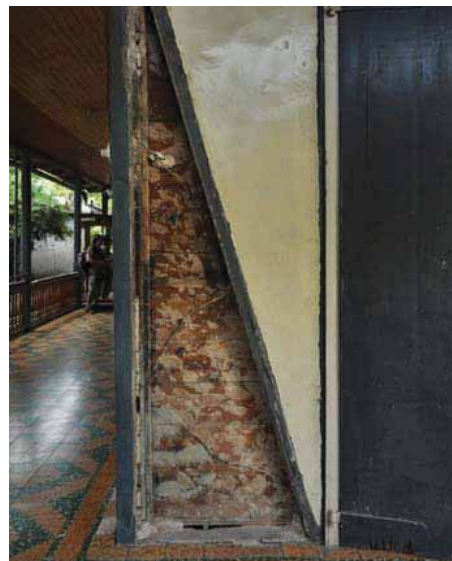
FIGURE 41 House at 15 Rue M showing plastered rubble stone infill. On the left, one panel fell out in the earthquake, revealing that it was reinforced with barbed wire inserted into the bay in a zigzag layout.

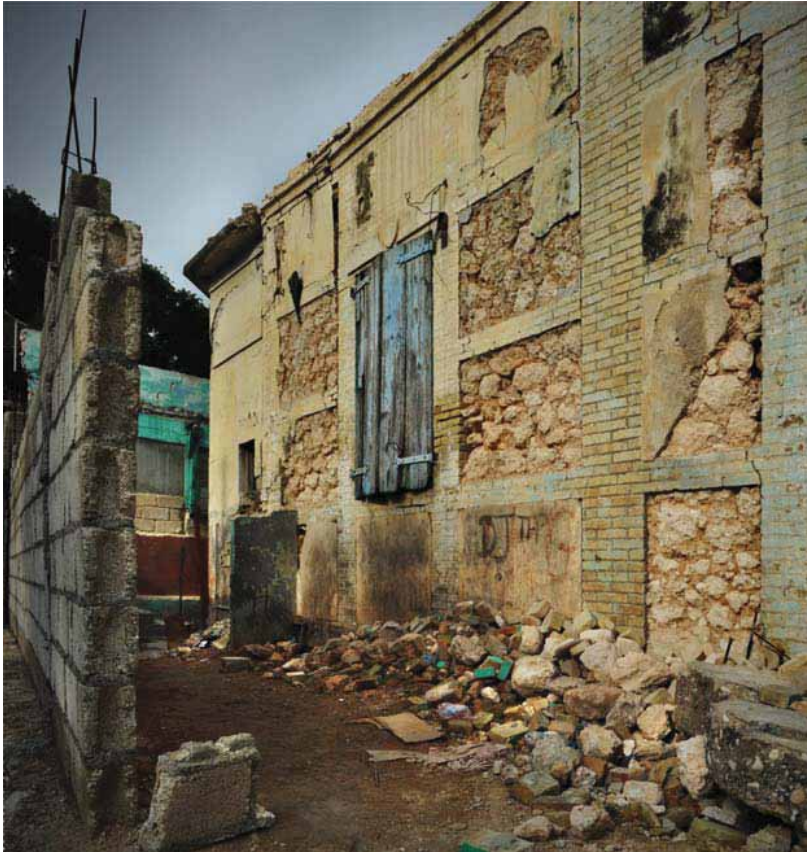
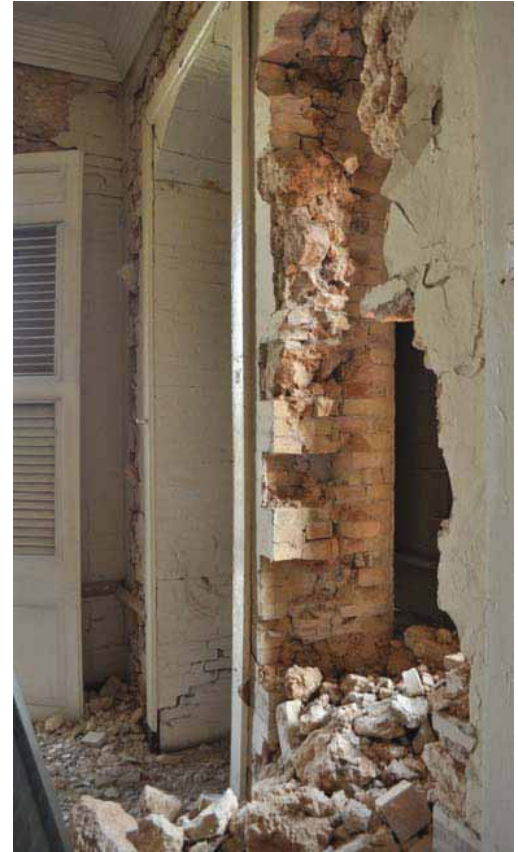
FIGURE 45 *left* Wall of a commercial building on Avenue Lamartiniere showing the characteristic layout of the mixed brick with rubble stone masonry found in many Gingerbread houses in Port-au-Prince. The brick piers and horizontal brick courses are crucial in restraining the walls from complete collapse. *right* Interior view of wall of the Villa Castel Fleuri (see Figure 1) showing a rubble stone panel which has completely collapsed out from between the brick masonry piers. Notice the brick keys that had extended into the rubble stone panel.

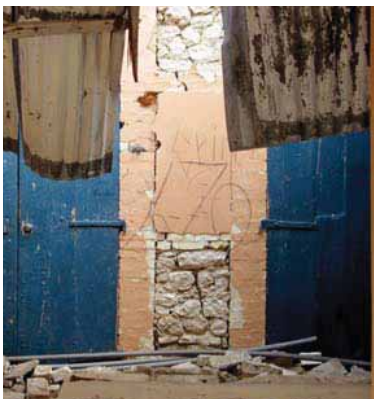
FIGURE 46 Characteristic 'brick frame' with rubble infill construction

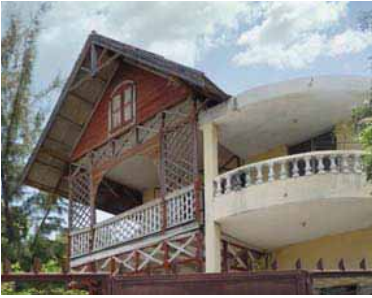
FIGURE 48 Concrete additions are often awkward or compromise the Gingerbread buildings architecturally, like this one at 51 Avenue Christophe.

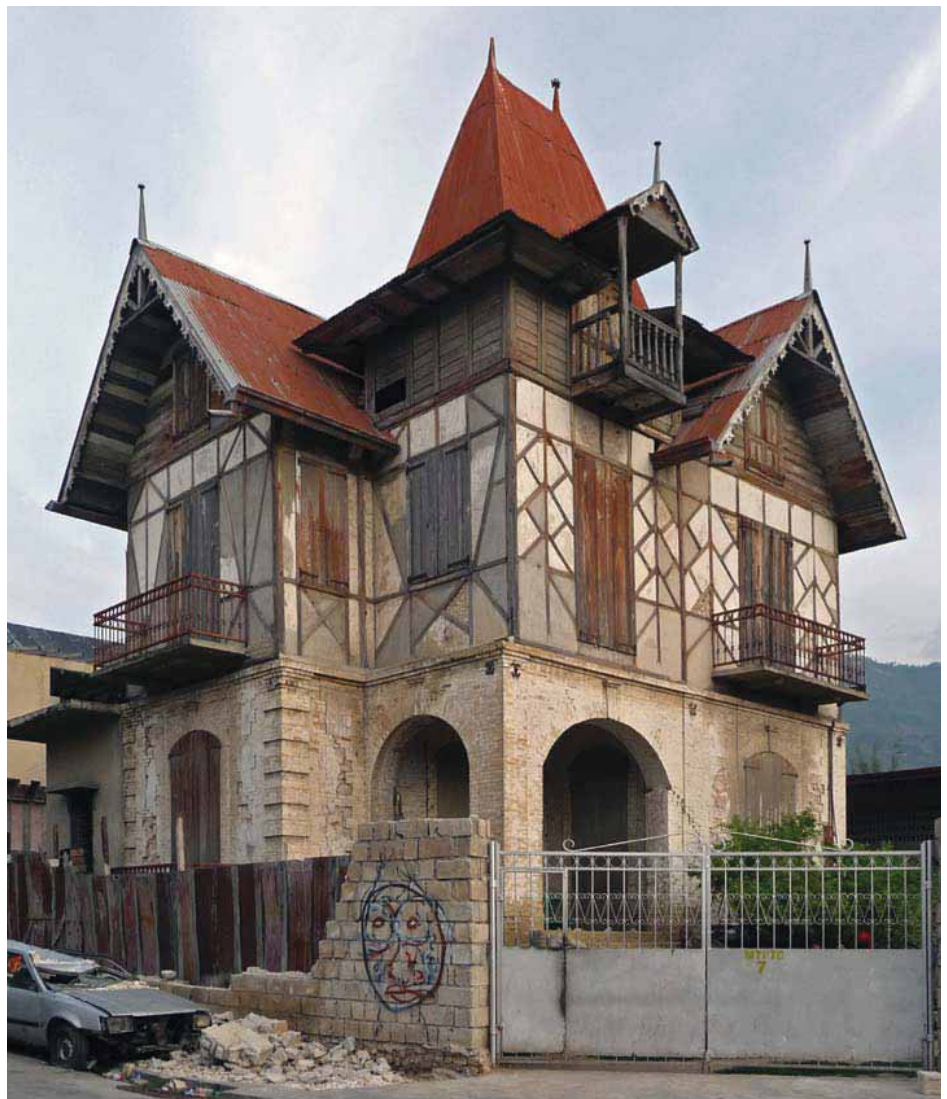
FIGURE 49 Hybrids are very common. This Gingerbread house at 59 Lavaud 3 utilizes all three wall-construction systems:
Attic walls—wood frame
Second story—colombage
First story—masonry bearing wall
 Note also the one-story concrete addition at the back left corner.

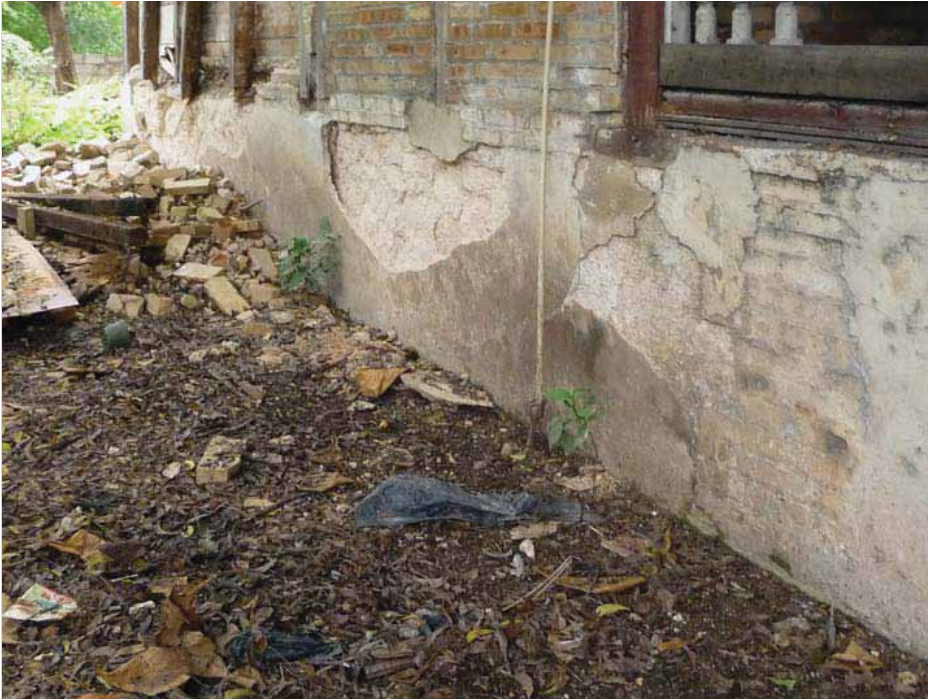
FIGURE 50 Spalling of the exterior finish plaster of the house at 84 Lamartiniere reveals two contiguous sections of foundation stem wall. One of irregular limestone *left*, and one of brick *right*.

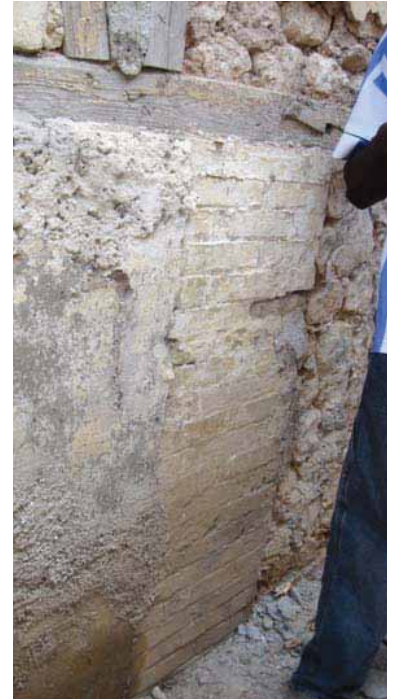
FIGURE 51 The original brick masonry foundation pier can be seen and is infilled on either side with stuccoed stonework. Rising damp from the ground has caused extensive deterioration to the exposed stone masonry. This results from the migration of soluble salts to the surface where they expand on drying, causing the surface of the masonry to spall.

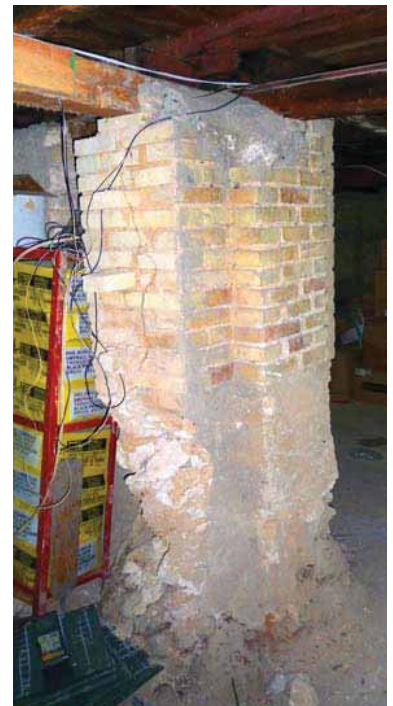
Gingerbread Houses almost never have basements, and the first level is typically raised as much as one meter above grade. It is apparent that many of the smaller Gingerbread Houses composed of wood were originally raised on masonry piers rather than erected on continuous foundation walls. The practice of erecting structures on masonry piers was once prevalent in the Caribbean to aid in control of insect problems and address chronic dampness. Though these piers can sometimes still be seen (Figure 50), the spaces between these piers typically have been infilled with masonry (Figure 51).

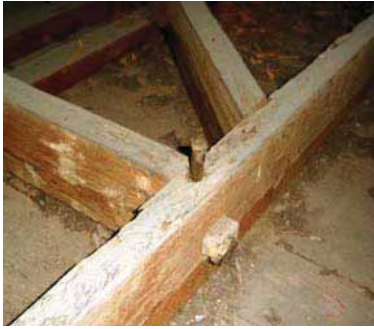
FIGURE 53 Attic framing with mortise-and-tenon joinery with wooden peg.

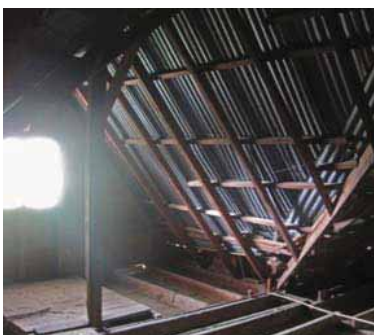
FIGURE 58 The wood structure and purlin spacing of this attic would only accommodate corrugated metal roof, indicating that these roof materials were original.

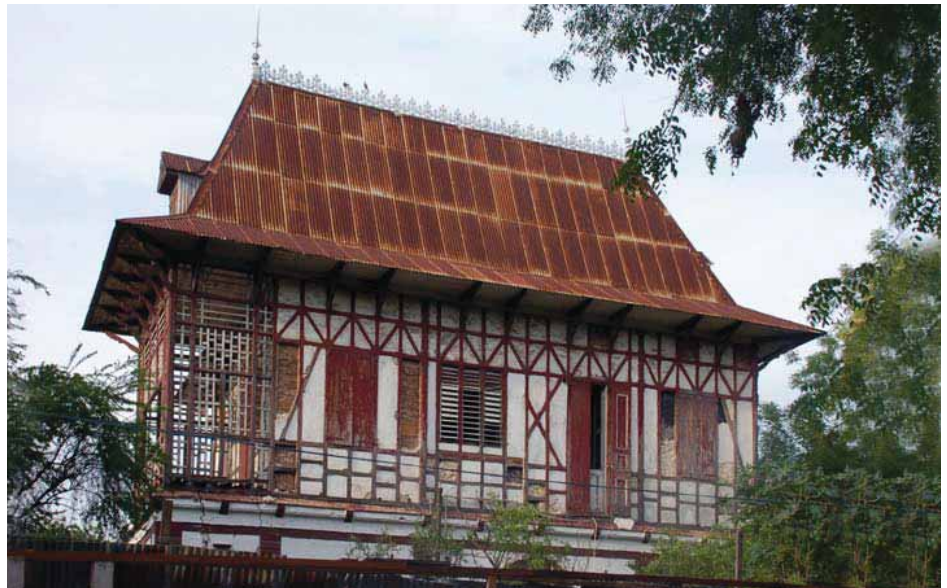
FIGURE 55 Corrugated ferrous metal roofs are quite common on the Gingerbread houses. This house has a metal crest at the ridge as well.

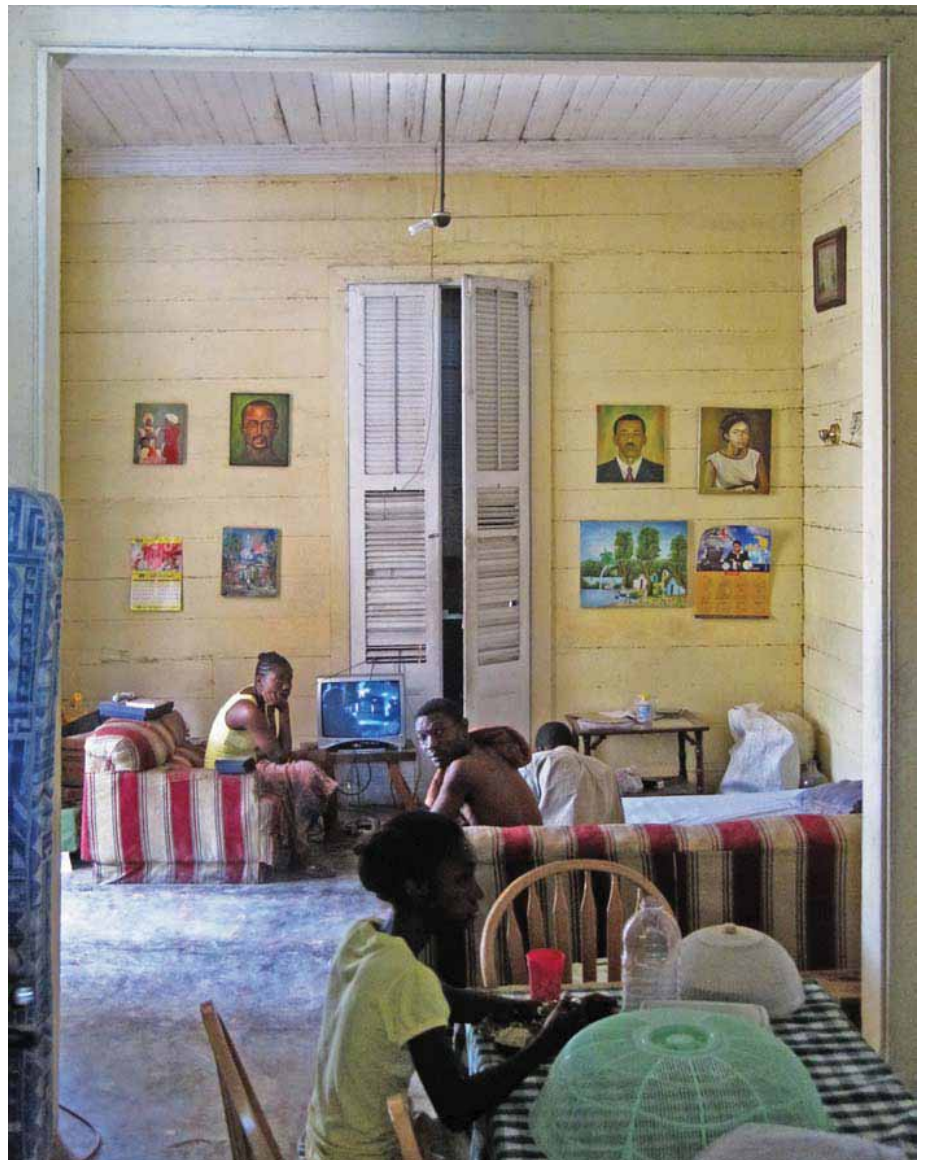
Floor Systems: The floors of the Gingerbread Houses tend to be wood framed with perpendicular wood plank flooring (often tongue and groove). This is usually the system for the first floor, over a shallow crawl space, and for any second or third floors (Figure 59). In some instances the first floor is of mortar (or concrete) on grade, usually with a tile finish (Figure 60). In one instance, Le Manoir, the second floor has an original concrete slab.

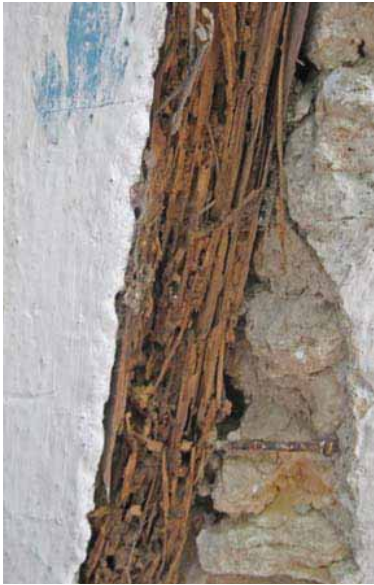
FIGURE 62 Termites thrive in Port-au-Prince, and many of the wooden structures are severely damaged due to termite attack.

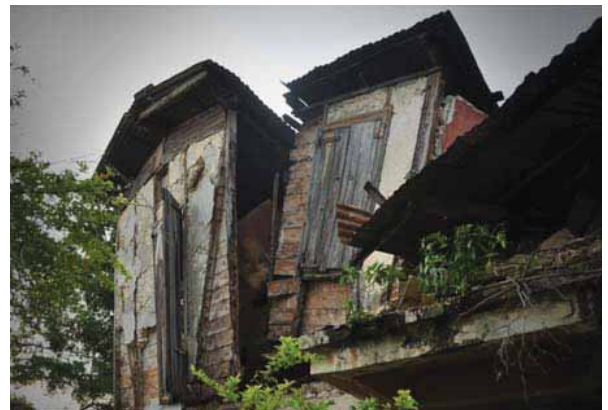
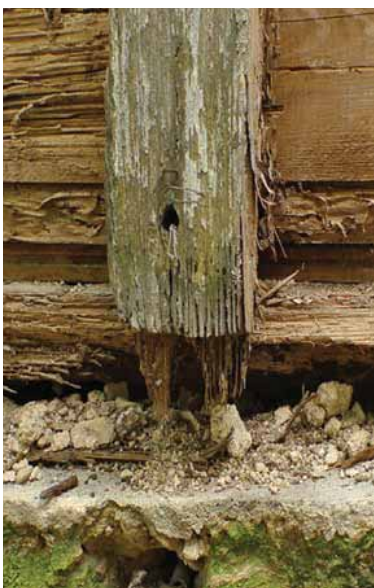
FIGURE 64 The post tenon is still present; the sill has rotted away.

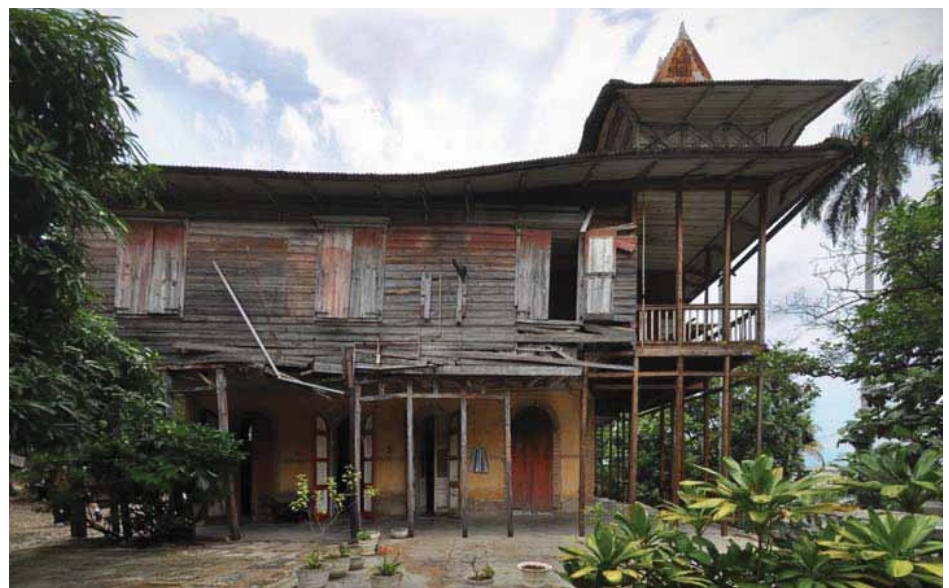
FIGURE 65: The Patrice Pamphile House (shown also in Figures 2 and 32) showing the heavily deteriorated wooden part of the structure, which at one time probably had been an open porch.

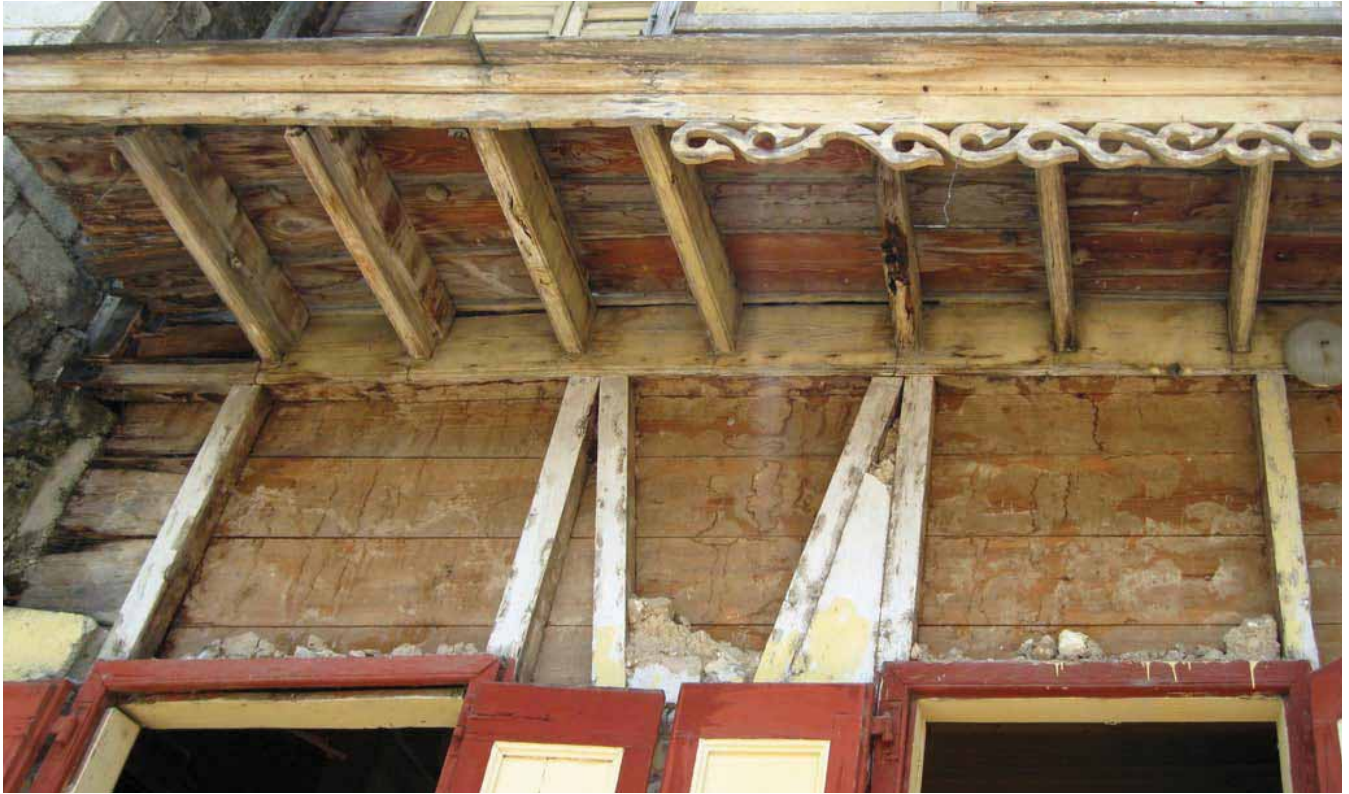
FIGURE 66 Poor construction and detailing have made many balconies vulnerable to decay and structurally unsafe. For those balconies supported on the cantilever extension of the floor joists, decay can extend into the house, putting both the balcony and interior floor at risk.
