Preserving Haiti's Gingerbread Houses

2010 Earthquake Mission Report

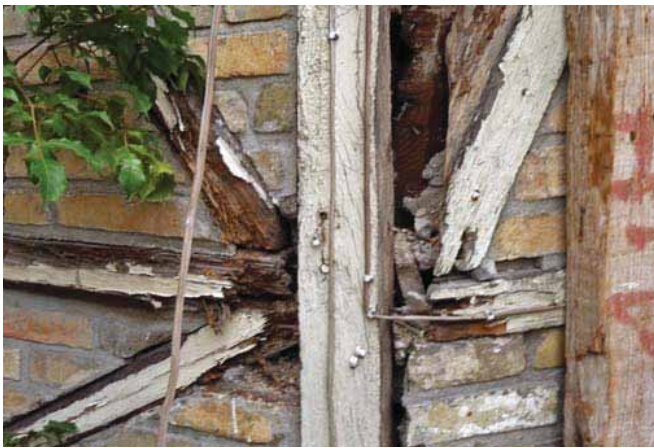
FIGURE 67 Rot of timber frame members at corner of *colombage* house at 32 Lamartiniere.

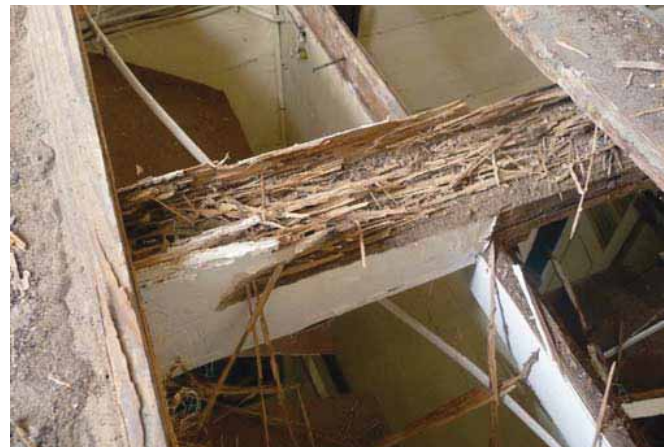
FIGURE 68 Termite damage in second story floor joists.

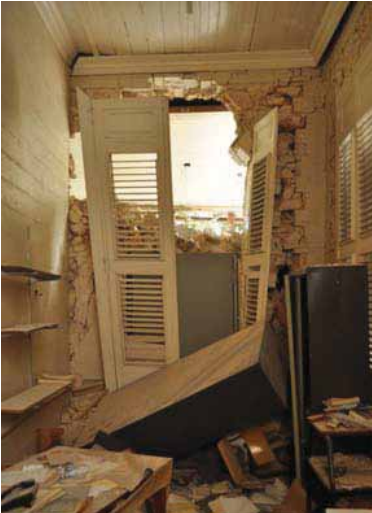
FIGURE 69 Hole in the masonry wall of Castel Fleuri caused by a concrete vault constructed in the exterior side and adjacent to this wall.

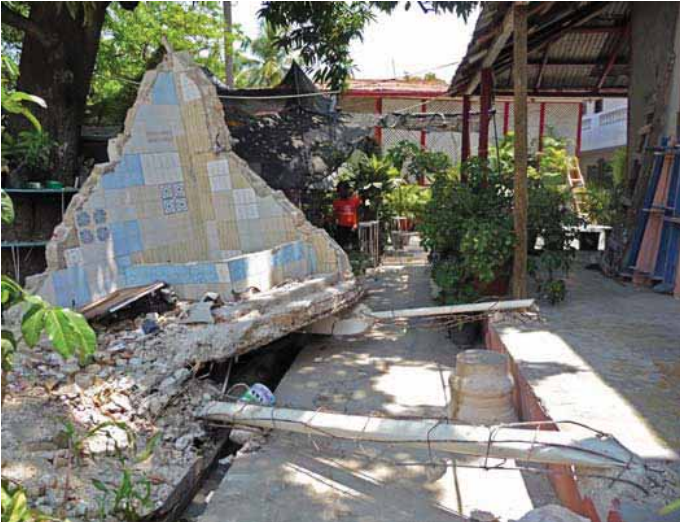
FIGURE 70 This second floor concrete bathroom addition at 5 Lamartiniere landed on the ground after its concrete columns buckled as it pulled away from its parent Gingerbread house. Note sewer pipes in the center of the rebar of the buckled columns.

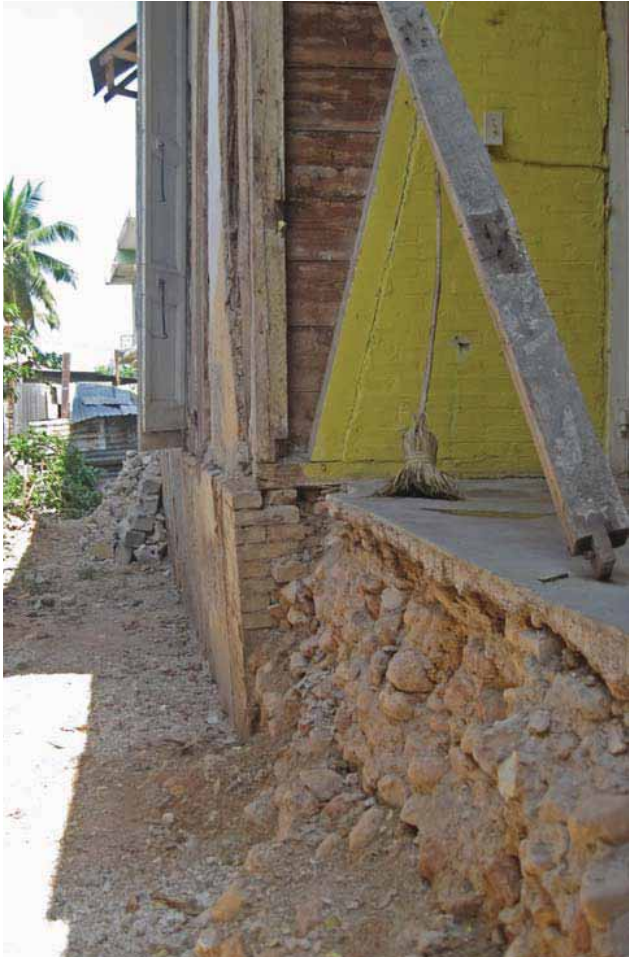
FIGURE 71 A portion of the foundation wall has collapsed at the house at 2 Avenue N, revealing that the crawl space below the first floor had been filled with rubble and the wood floor had been replaced with a slab on grade. Lateral loads on the wall from the fill caused it to collapse. The foundation wall remaining has rotated outward.

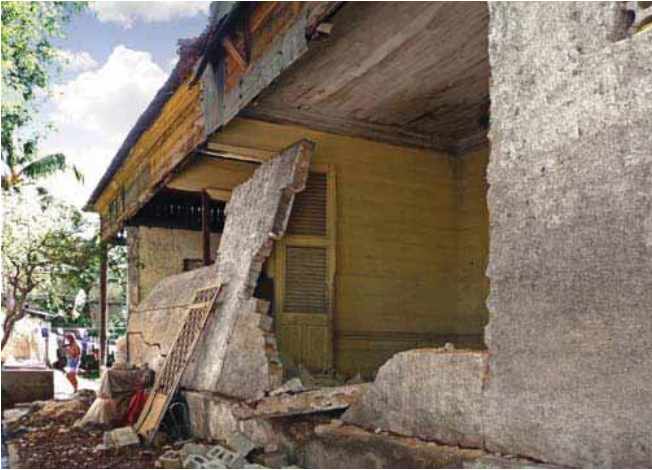
FIGURE 72 A replacement side wall of concrete block at 19 Lamariniere suffered partial collapse.

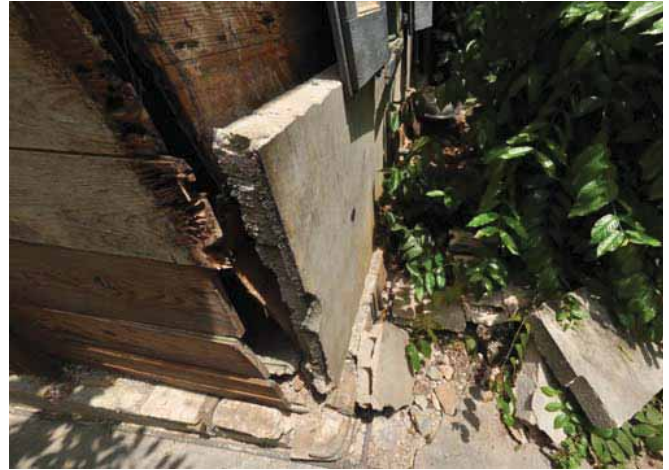
FIGURE 73 These are examples of *colomage* where the rubble infill has been replaced with concrete. This has accelerated the rotting of the timber framing, which then broke during the earthquake causing the collapse of the heavy concrete infill.

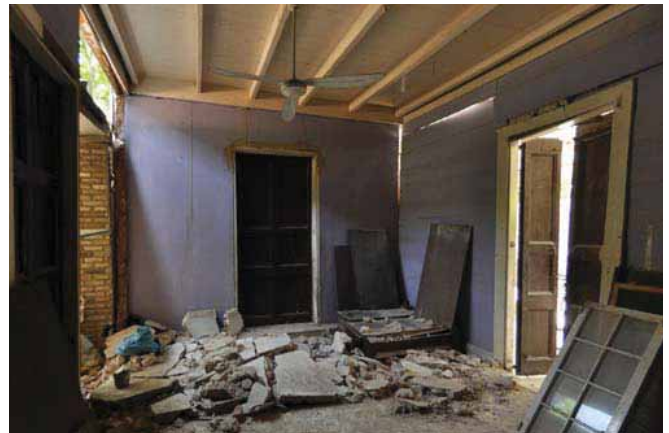
FIGURE 74 Improper repair of stone infill of *colomage* using concrete. These repairs constitute a fill that is much stiffer and more cohesive than the fill it replaced.

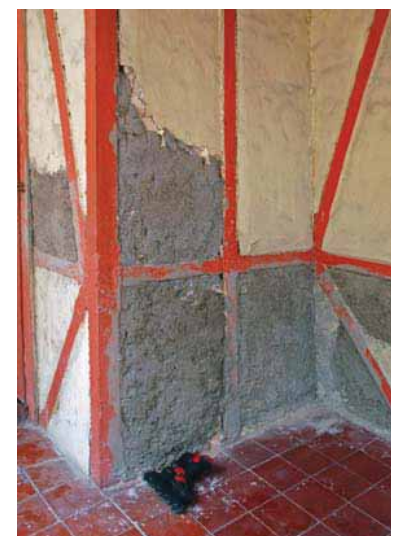
Building height (number of stories) and tall or slender above-ground foundation walls were also apparent indicators of earthquake vulnerability.

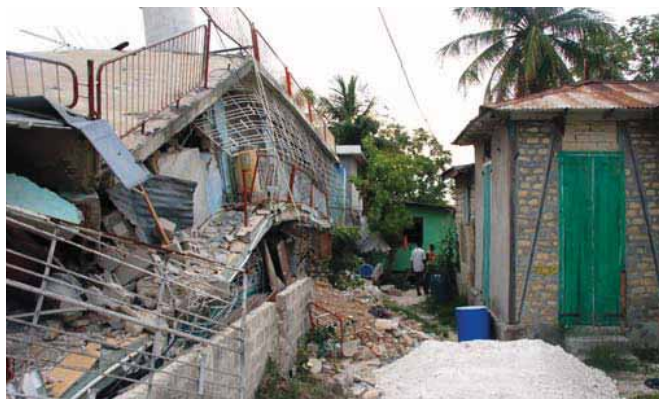
FIGURE 75 A pancaked concrete-frame building on the left and a *colombage* house on the right showing the comparative performance of these building types in a seismic event.

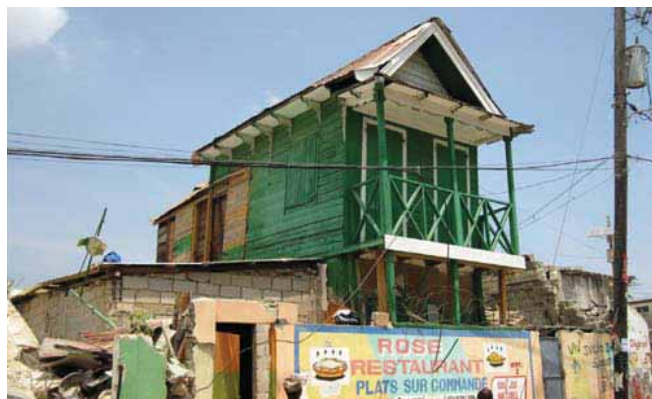
FIGURE 76 This two-story Gingerbread house survived amid the collapse of numerous concrete buildings. The owners do not want to tear it down. However, it needs temporary stabilization and long-term repairs.

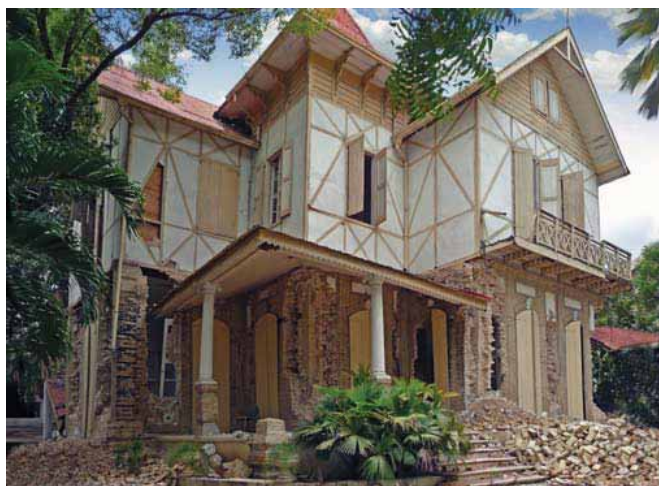
FIGURE 77 The Dufort House, a hybrid structure, exhibited substantial damage to the masonry first-story walls, including its limestone panels and brick piers, but significantly less damage to its *colombage* and wood frame second-story walls. Notwithstanding the increased seismic loads on the first-floor walls, the difference in performance of the systems is indicative of a tendency seen throughout the surveyed buildings.

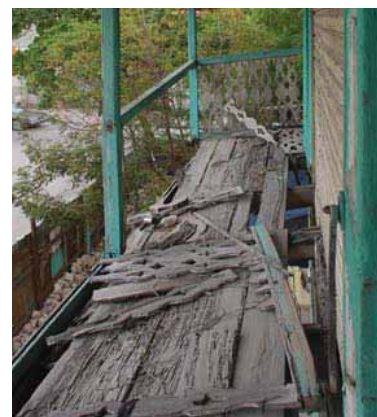
FIGURE 78 Second-floor porch structure made unsafe by termite damage.

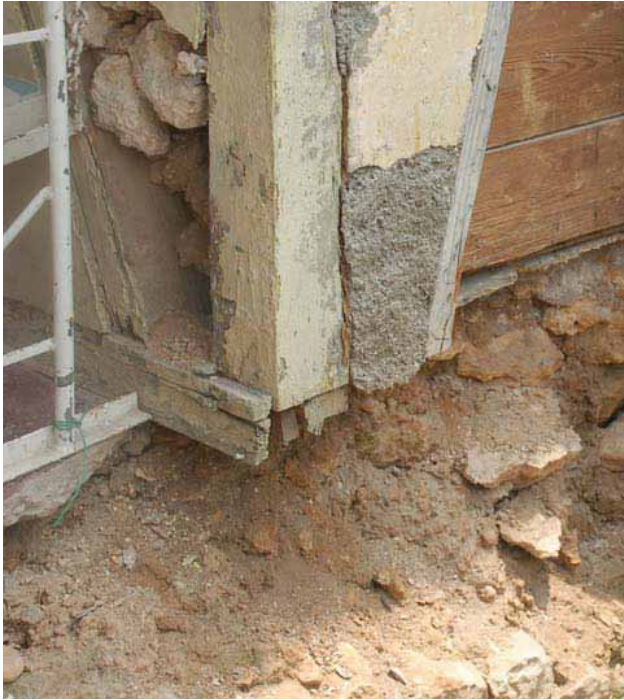
FIGURE 79 The wood sill that was previously termite damaged was crushed during the earthquake. This caused the entire structure to settle on its foundation. The result is that many of the doors to the exterior cannot be opened or closed.

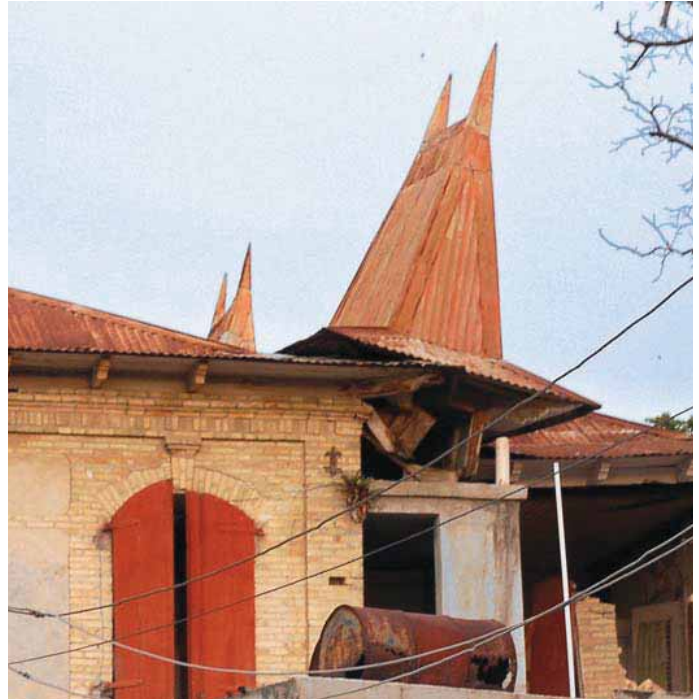
FIGURE 80 Both of the steeples of this Gingerbread house were shaken out of plumb during the earthquake.

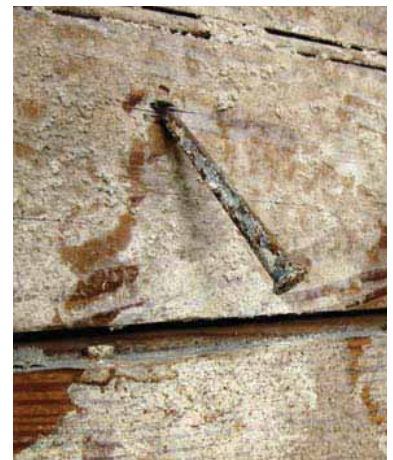
FIGURE 81 Cut nails of iron or steel are common in the Gingerbread houses. Many of the original cut nails show surprisingly little corrosion.

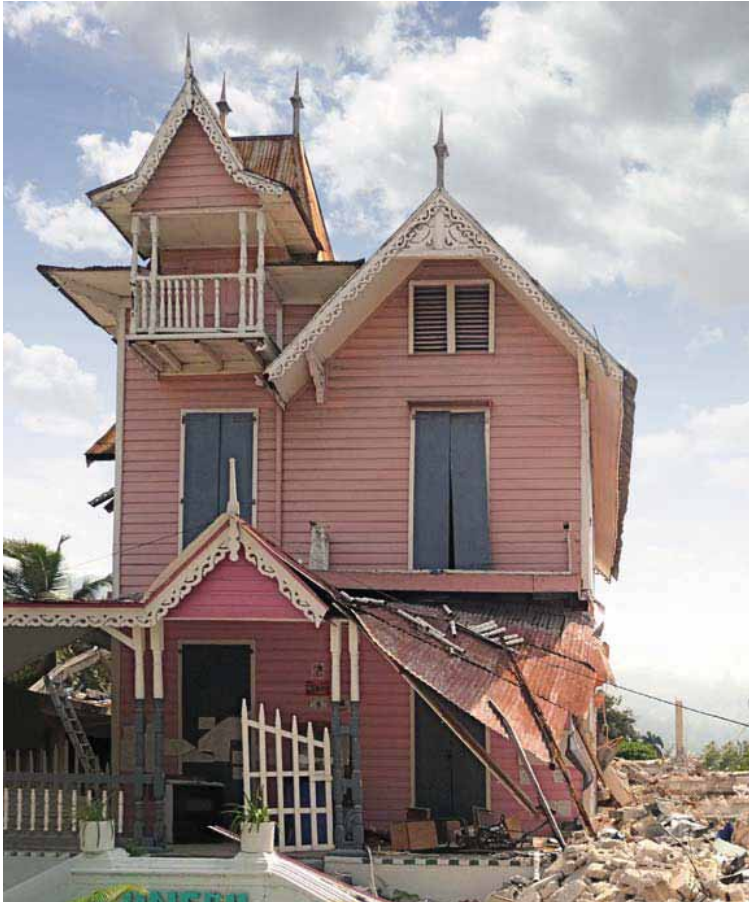
FIGURE 82 Wood frame Gingerbread at the Episcopal University at 14 Rue Légitime next to the site of a collapsed concrete building.

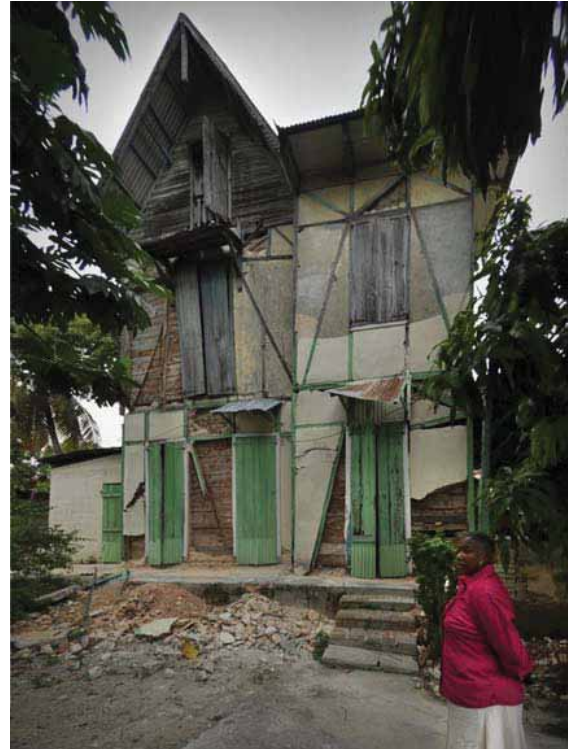
FIGURE 83 Marie Céleste Florence Jacob, seen here, continues to live in this century-old wood frame house at 14 Rue Marcelin. This house was extensively consumed by termites prior to the earthquake which damaged it further. Even in this badly compromised state, this structure remained standing after the earthquake only a few short blocks away from the National Palace and many other concrete frame structures which collapsed.

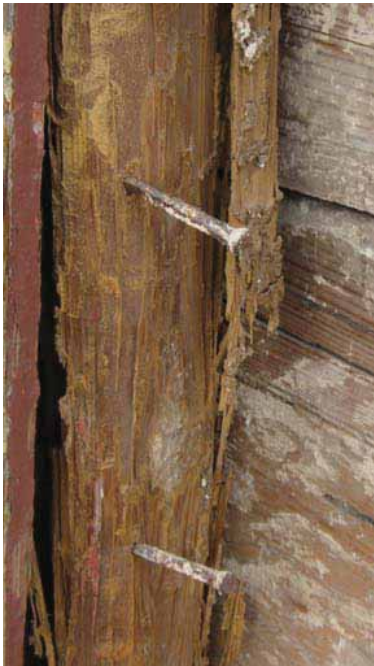
FIGURE 84 Despite extensive termite damage, the remainder of this post is hard and dense, still holding the nail firmly.

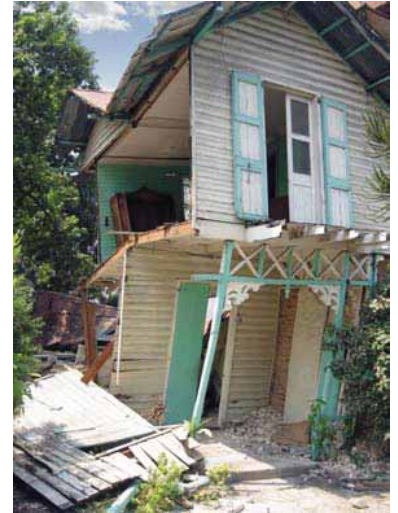
FIGURE 85 Despite severe damage, this timber frame building did not fully collapse. Note that the wall that fell away is the one on the side parallel to the joists, thus not having substantial tie to the floor.

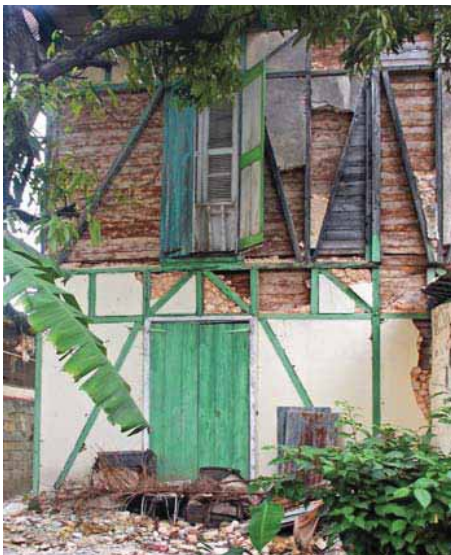
FIGURE 86 Much of the *colombage* stonework fell out of the walls of the second story during the earthquake.

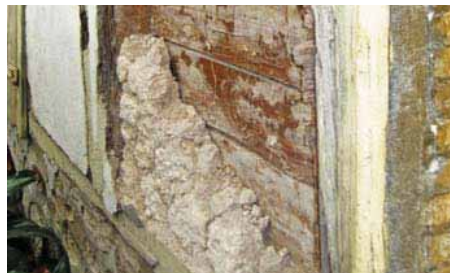
FIGURE 87 Close-up view of the failed *colombage* stonework. This infill, if laid up in clay, crumbles away and does not compromise the integrity of the wood braced frame.

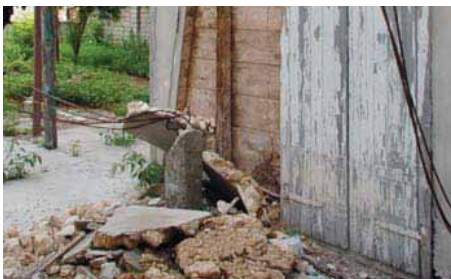
FIGURE 88 Stone infill that had been relaid with cement mortars would fall out of the wood frame in huge pieces during the earthquake causing damage also causing a safety hazard.

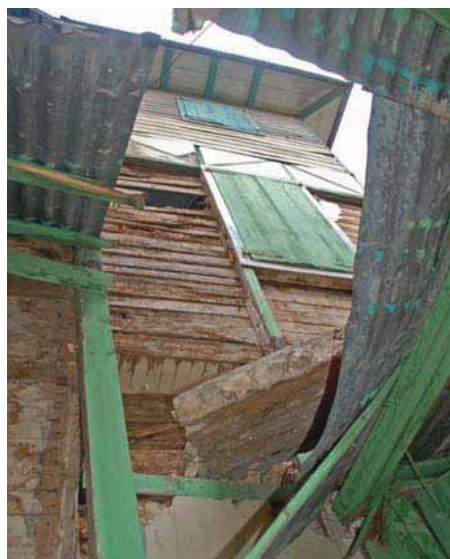
FIGURE 89 Brick infill that had been relaid with cement mortar fell out in huge pieces during the earthquake, causing damage to construction below.

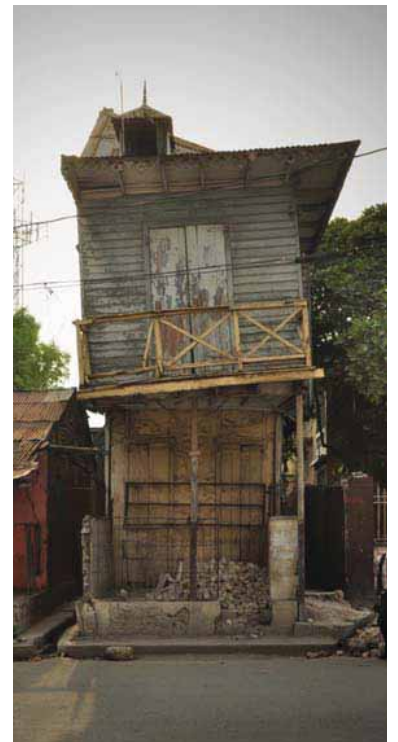
FIGURE 90 A wood clad and *colombage* structure of the most basic type on Rue Geffard near the National Palace. This structure appears to have been designed to be expanded to double its width, but never was. As a result, it was subject to the earthquake with a width at the base of less than 12 feet (3.6 meters). Also, at the time of the earthquake, it was in extremely poor repair. In spite of all of this, the earthquake did not cause it to collapse.

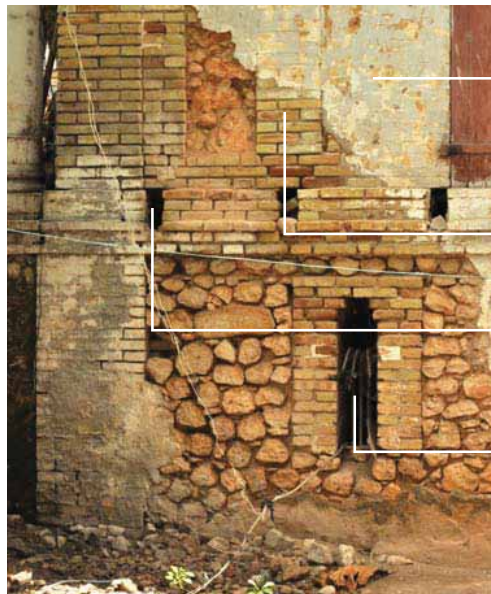
FIGURE 91 Examining masonry structures

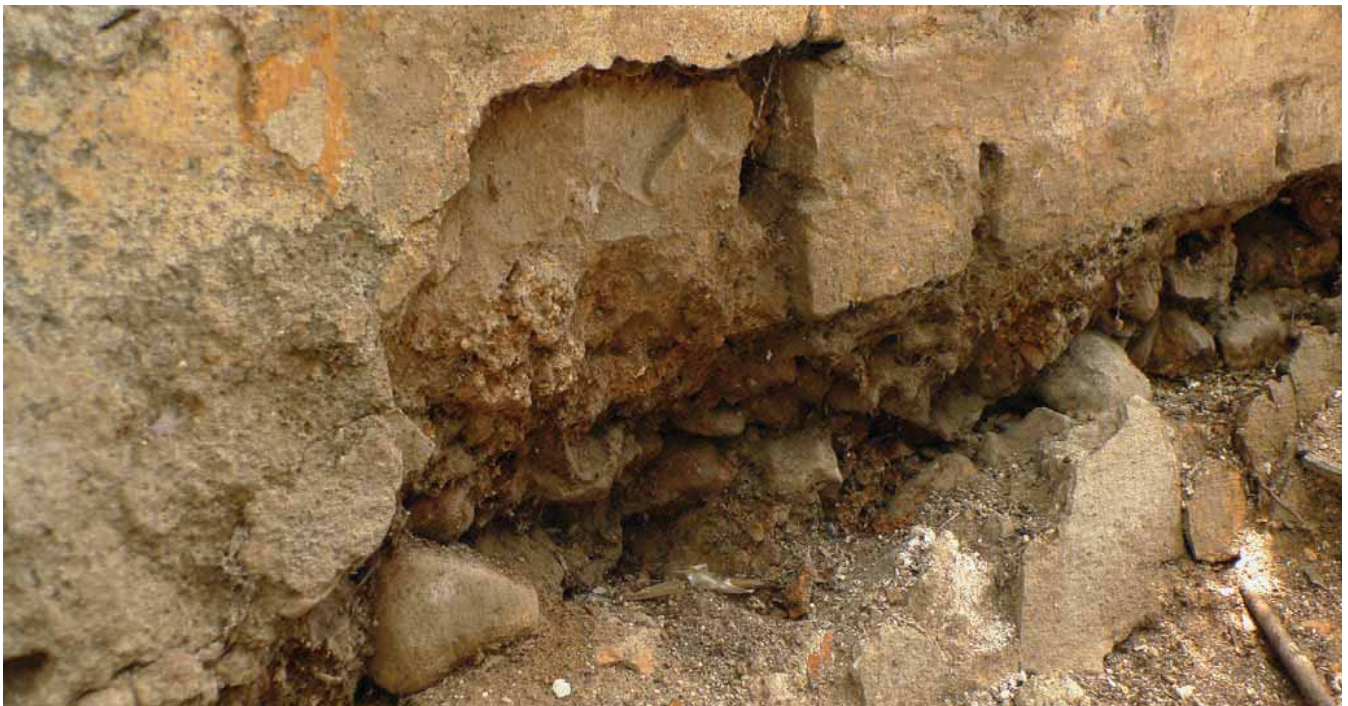
FIGURE 92 Basal erosion of the wall surface and foundation.

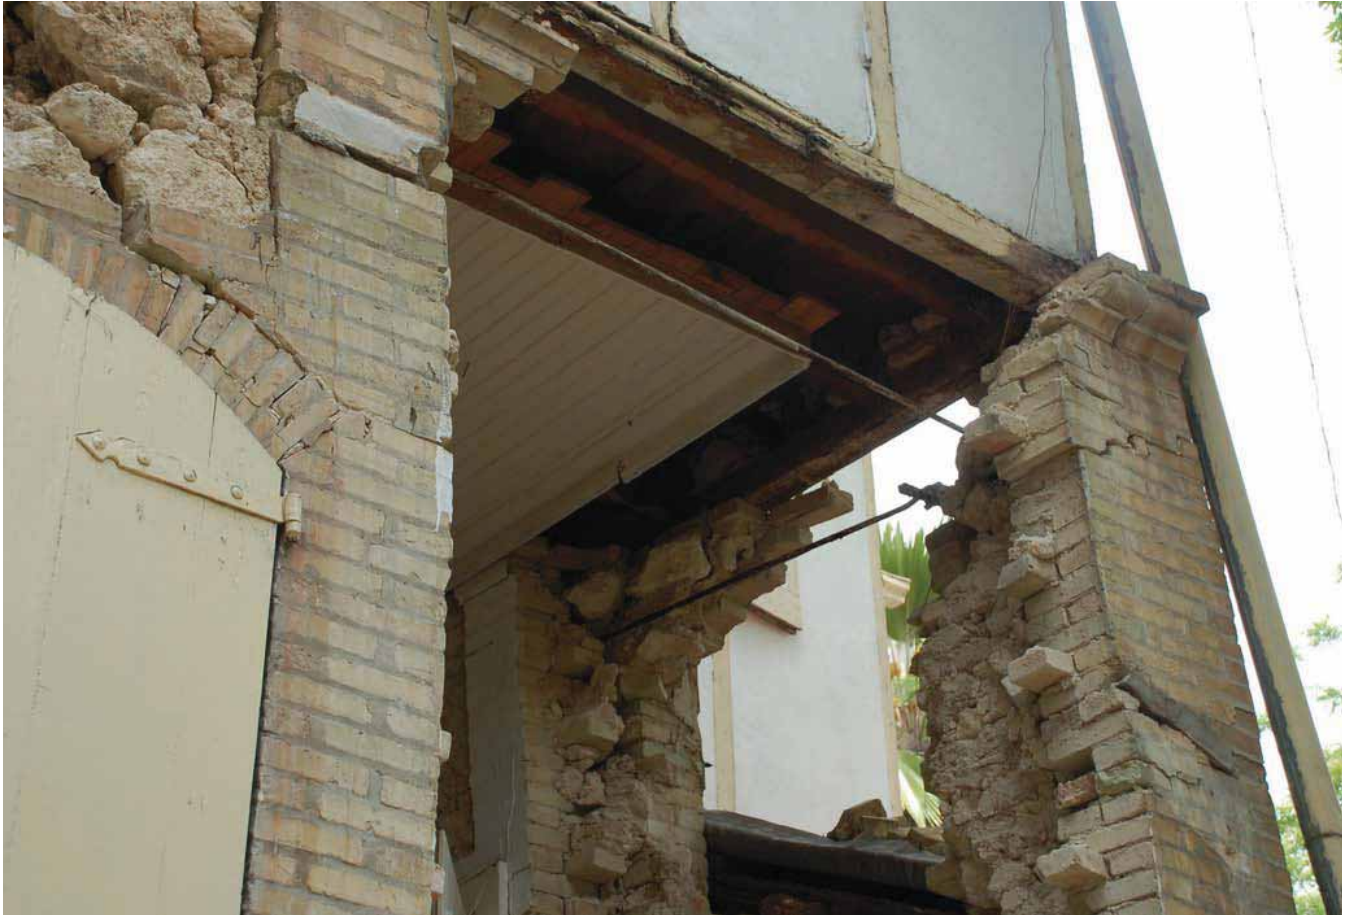
after the disaster indicates that the numbers of collapses for these construction types was very small—perhaps less than 3 percent.

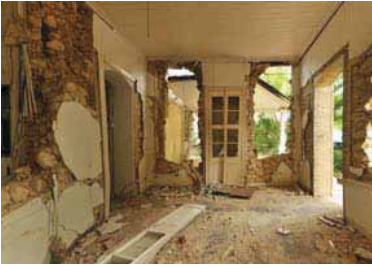
FIGURE 94 Ground floor interior of the Albert Dufort House on Rue du Travail Deuxième showing complete disruption of the rubble panels in its construction. The interior wall on the left, which did not have brick piers walls because of the lack of window and door openings, collapsed completely.

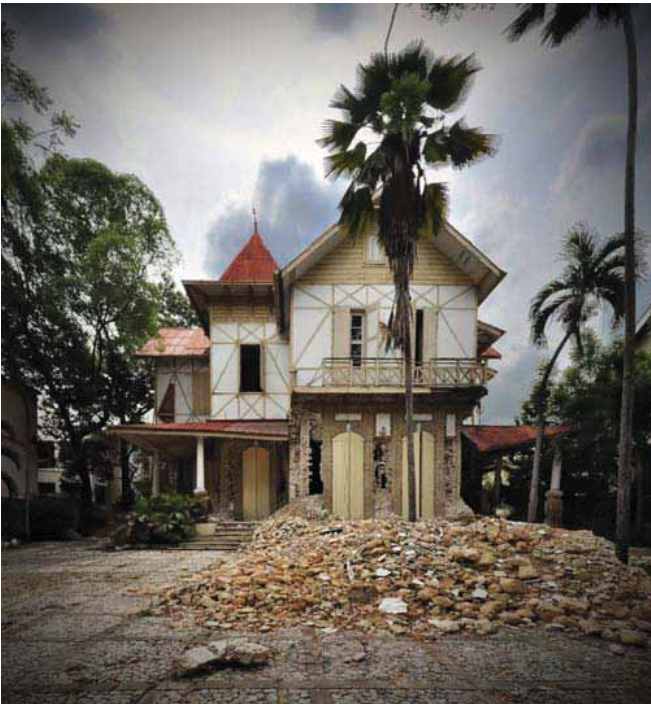
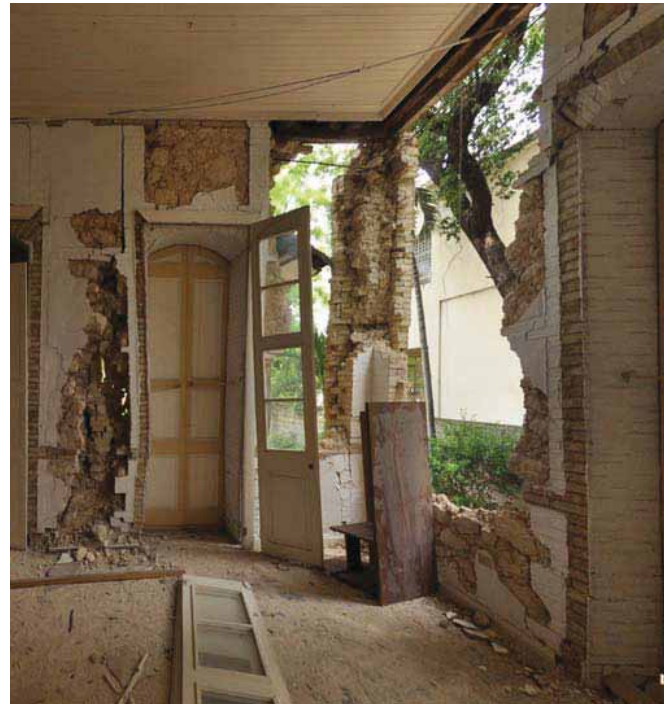
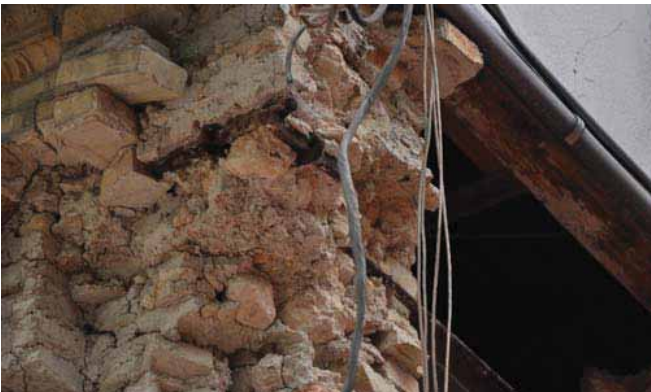
In a number of instances where the rubble stone panels were fully degraded or collapsed, the buildings (such as the Dufort House and Le Manoir) were saved from total collapse by the brick piers that surrounded and confined the rubble stone (see Figures 95 and 96). Unfortunately, this brickwork was not bonded one wythe to the

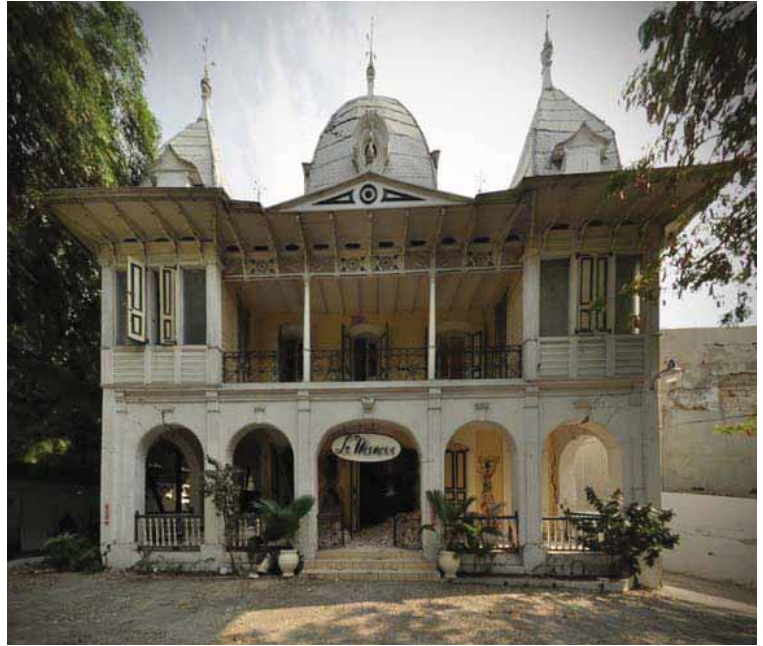
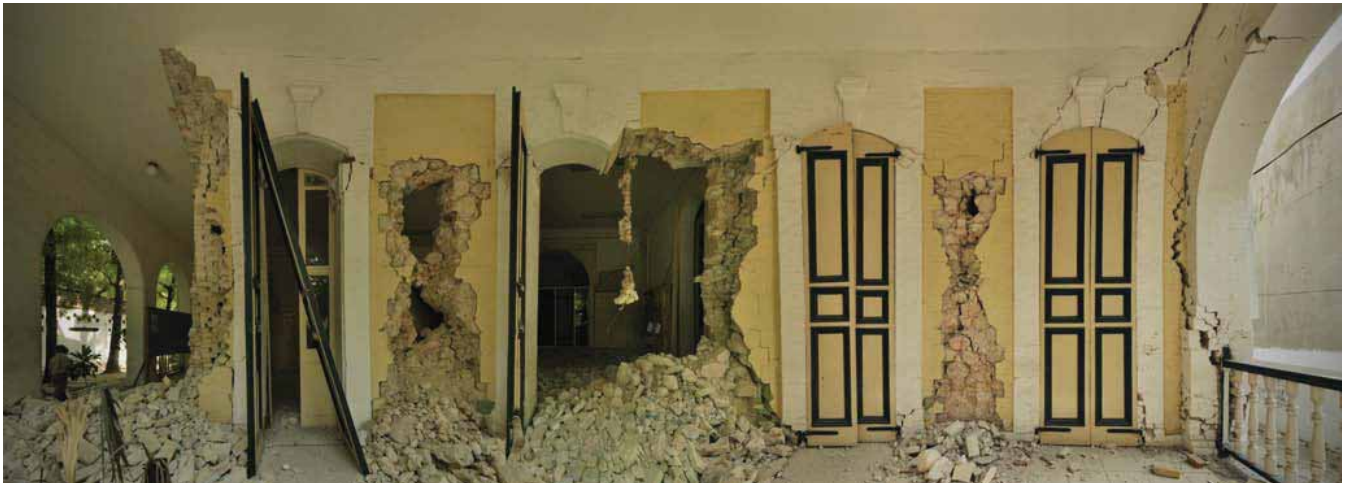
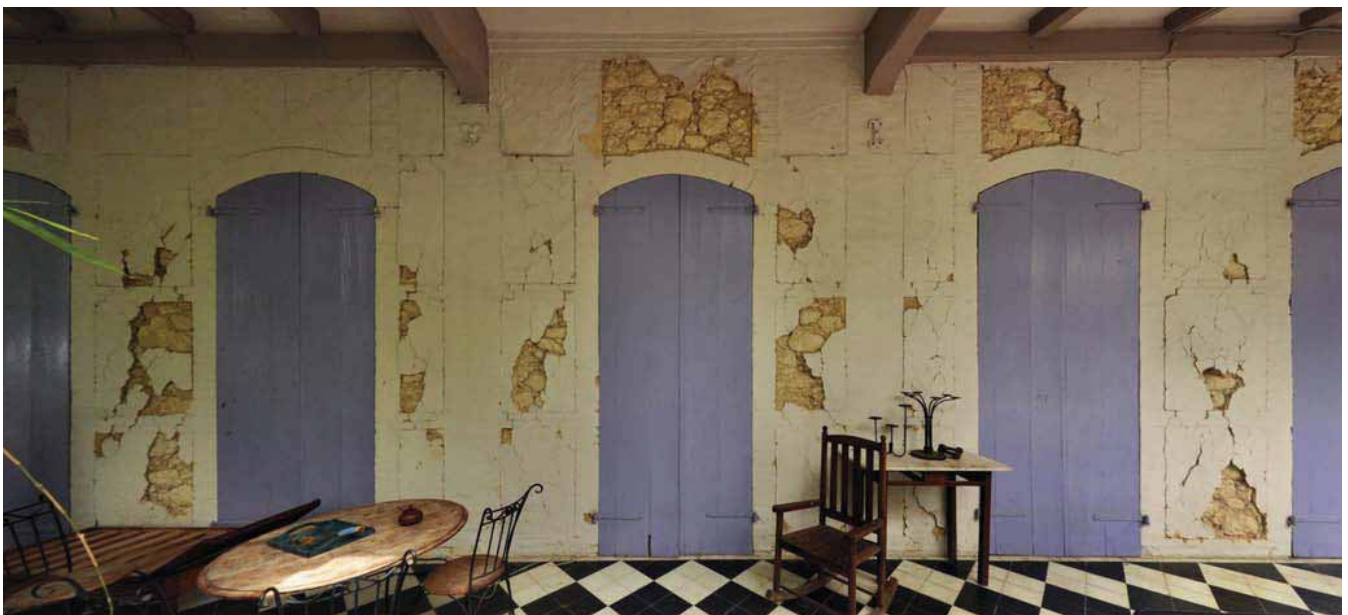
FIGURE 96 *top* Exterior view of Le Manoir on Avenue John Brown. *middle* interior view of Le Manoir showing a fully disrupted ground-floor wall where the rubble panels have collapsed, but the buildings remained standing on the brick piers. (view is a mosaic of several photos connected together). *bottom* House at 65 Avenue N showing infill panels manifesting the onset of damage, but little displacement during the earthquake.

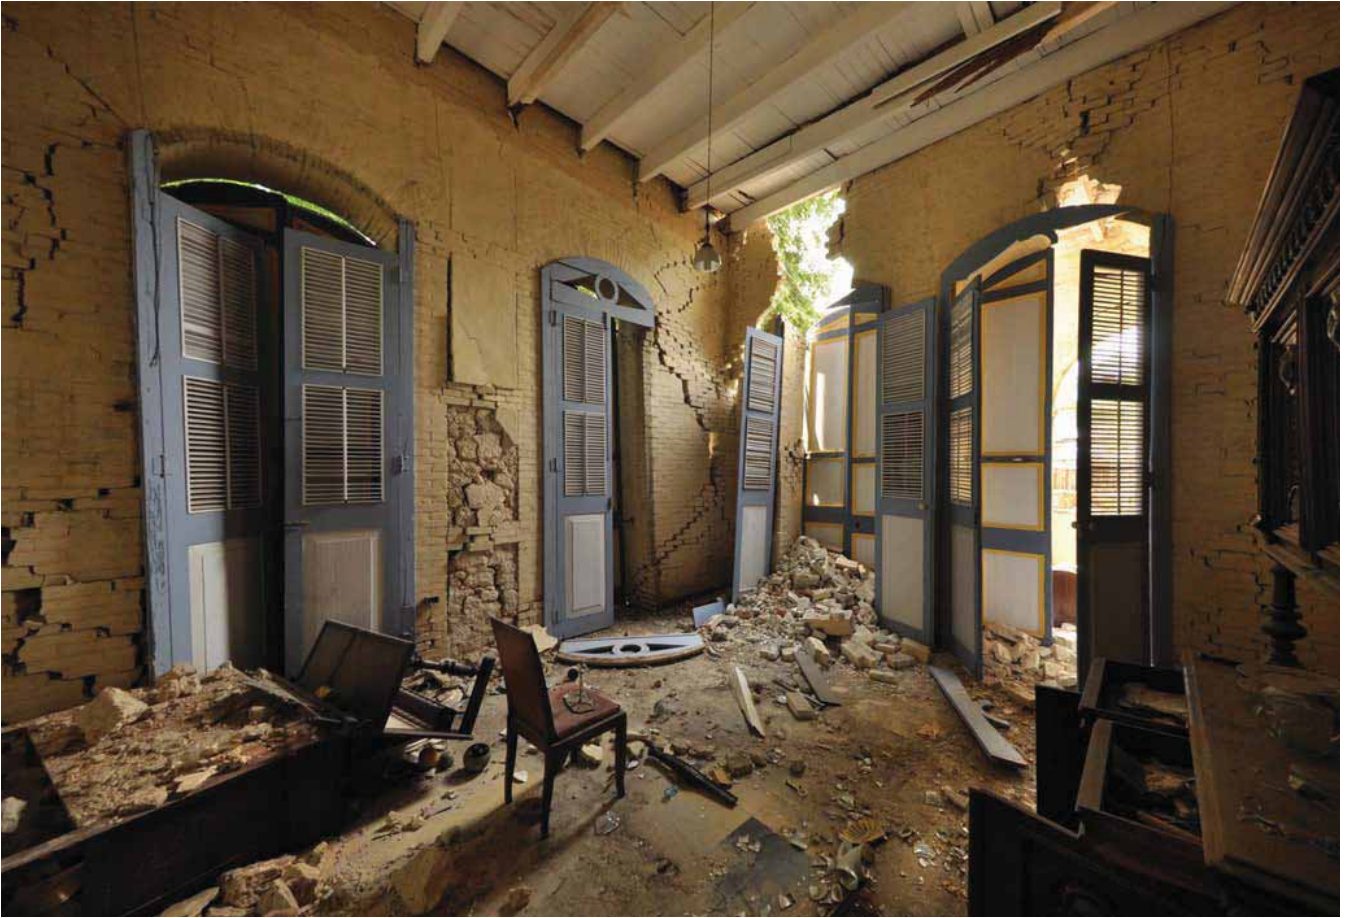
FIGURE 97 Two-story masonry house at 46 Avenue Christophe. During the earthquake, part of the second floor collapsed, followed by the subsequent collapse of the rest of the second floor. These photos show the ground floor, which remained standing, but with major rupture to the masonry walls, particularly at the corners. *right* The iron rod that had held the building together at the floor level is visible where it had failed because of corrosion. This image also reveals how the inner wythe of brickwork was not bonded to the outer layers of rubble stone. To form the inner corner of the room there is a layer of brick, whereas in the middle of the room, the rubble stone panel goes through the entire thickness of the wall.

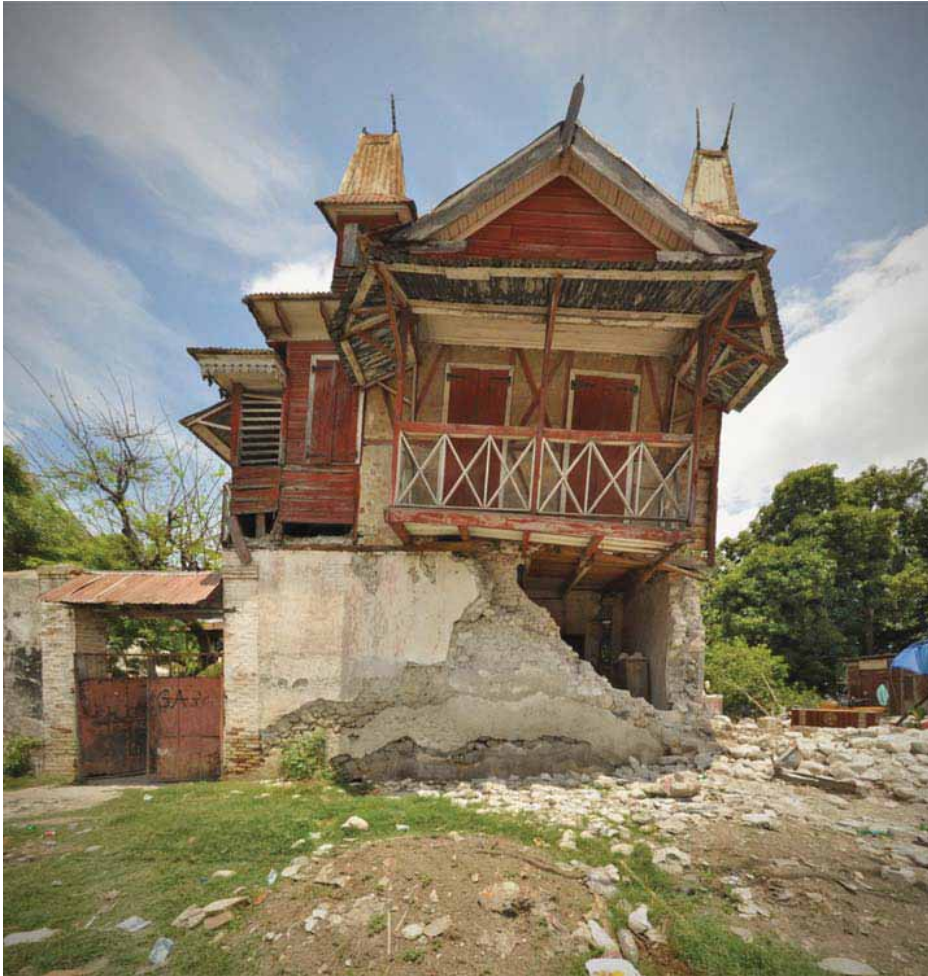
FIGURE 98 House in Léogâne where the solid rubble stone wall on one side partially collapsed, while the side with the two door openings with brick piers and rubble panels seen through the collapse remained standing with much less damage.

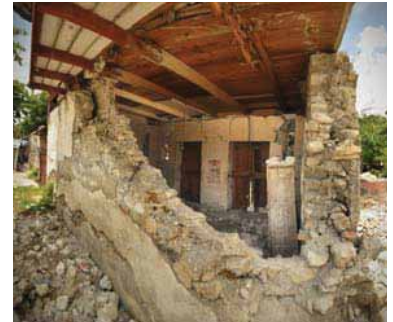
next, so the piers have been shifted in those locations where rubble has been heavily disrupted or collapsed (see Figure 97). However, because of the horizontal bedding of the masonry, they remained stable. Walls that were disrupted to this extent will need to be rebuilt, and when rebuilt, a more stable masonry can be substituted for the rubble masonry. Since the rubble was always in recessed panels covered with plaster, substitution with better material should not result in a visual change.

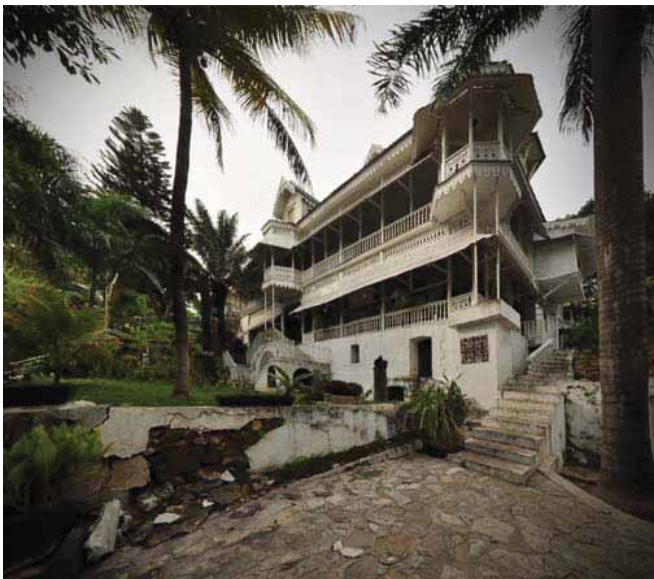
FIGURE 99 The Hotel Oloffson. This building is constructed of brick masonry without the rubble stone panels. The masonry walls are hidden in the front by the wide wooden Gingerbread-clad porches, but are visible below.

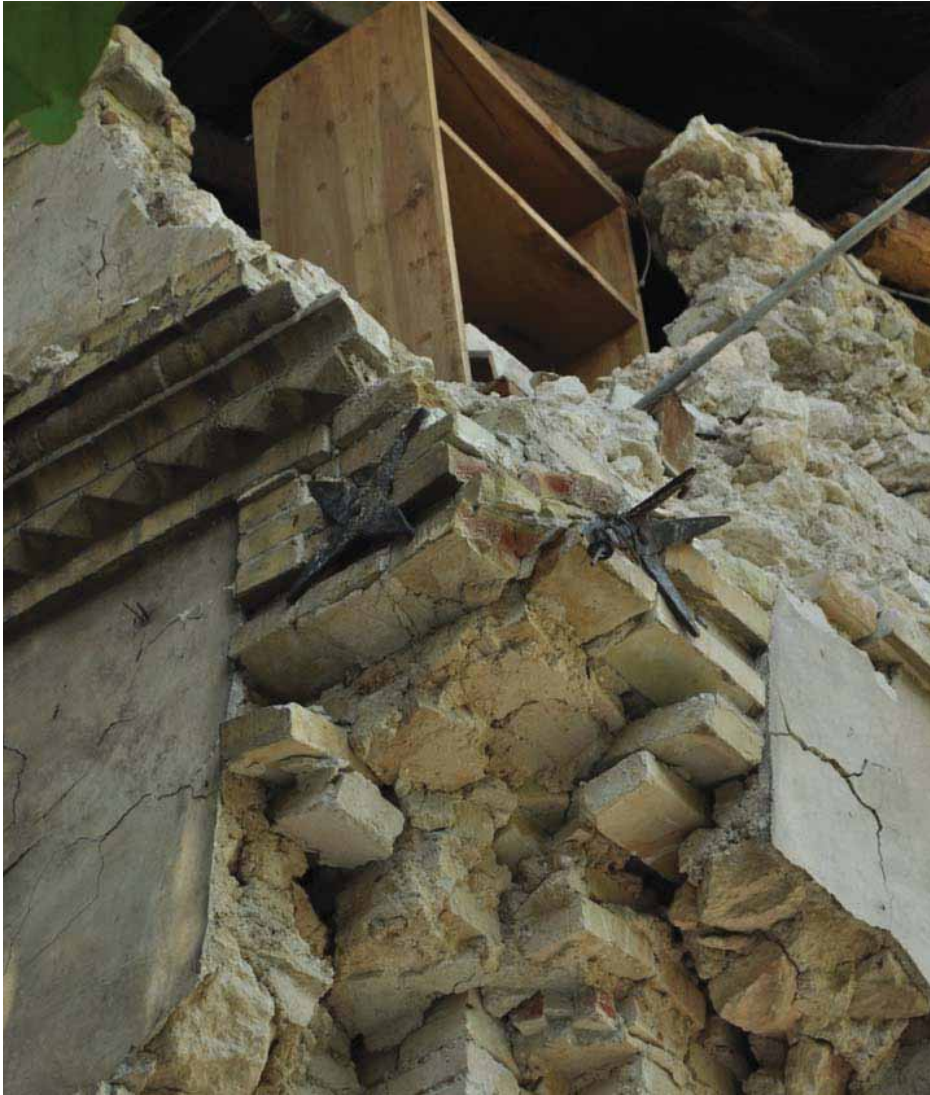
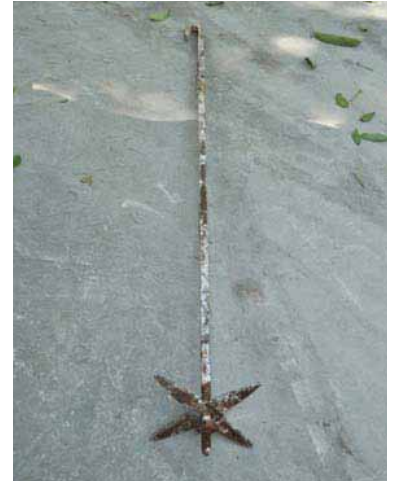
FIGURE 101 Iron chains are common in many of the masonry walls of the Port-au-Prince Gingerbread houses. Above is the first section of the chain with the star-shaped metal plate, and the view at left shows the metal plates where they remain holding the wall at the floor level in place, thus stopping the further separation of the walls at the corner. Had these floor level reinforcement rings not been installed, the lower floor walls would probably have collapsed as well.

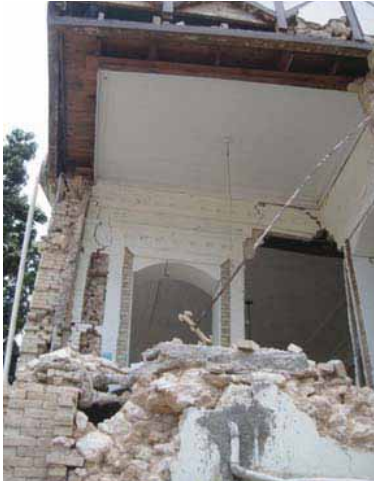
FIGURE 102 In this case the horizontal metal ties failed to prevent the collapse of these masonry walls, but may have helped prevent the collapse of the rest of the building

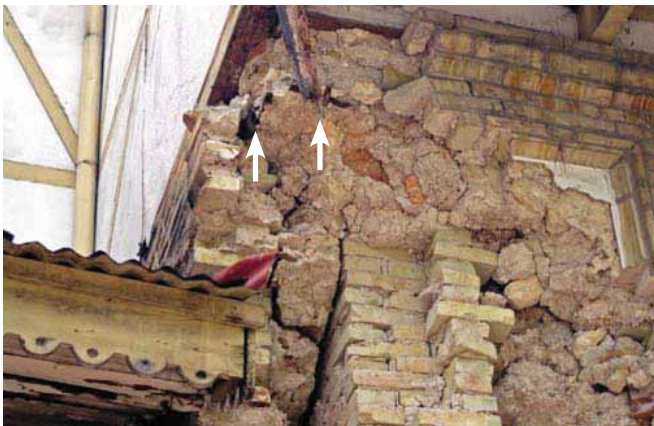
FIGURE 103 Embedded tie rods cross at the corner, anchored by iron bars. Also note rubble fill between inner and outer leaves of brick masonry.

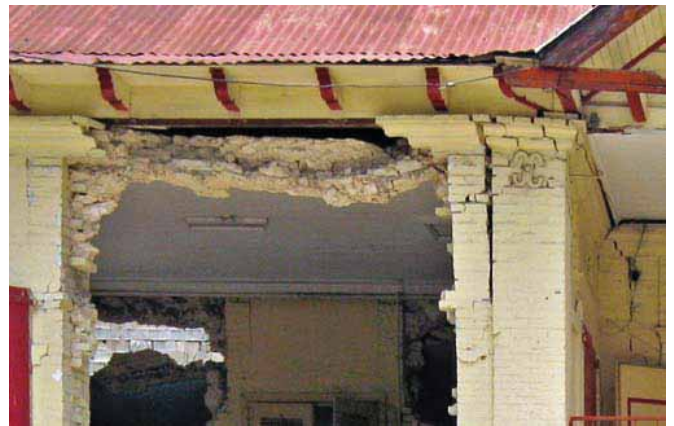
FIGURE 104 Total collapse was avoided in this heavily damaged masonry building due to embedded iron rods at the top of the walls, with exposed end plates.

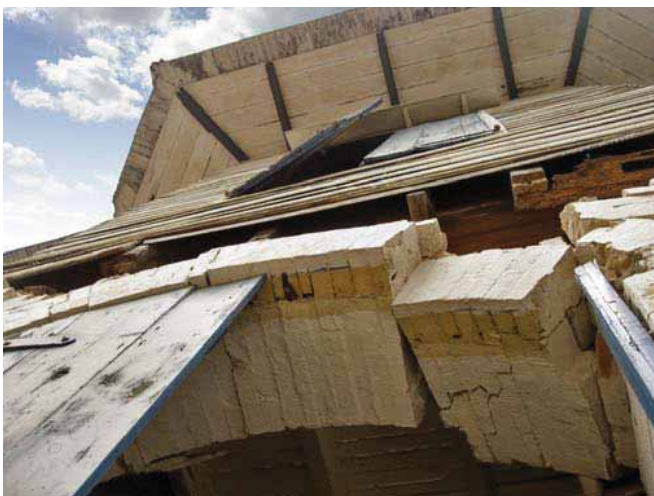
FIGURE 105 Severely damaged arch, and displaced wood framing above. Absence of tie rods, combined with decay of the timber sill plates made the building more vulnerable.

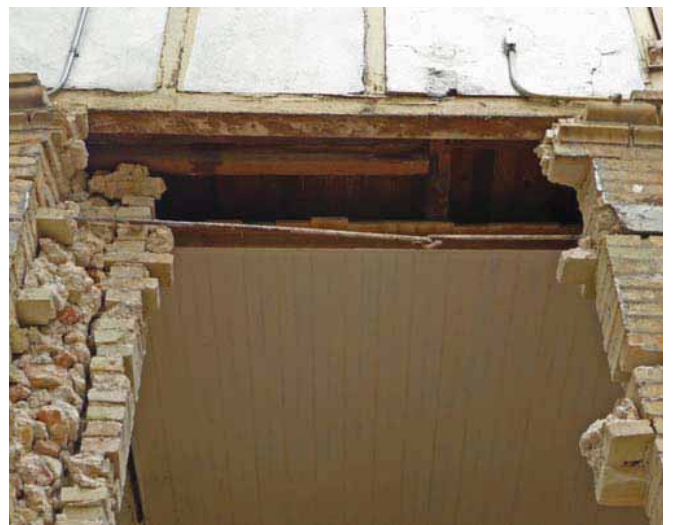
FIGURE 106 Linked iron tension rods exposed after the limestone infill panel was discharged. The rod may have prevented complete wall collapse.

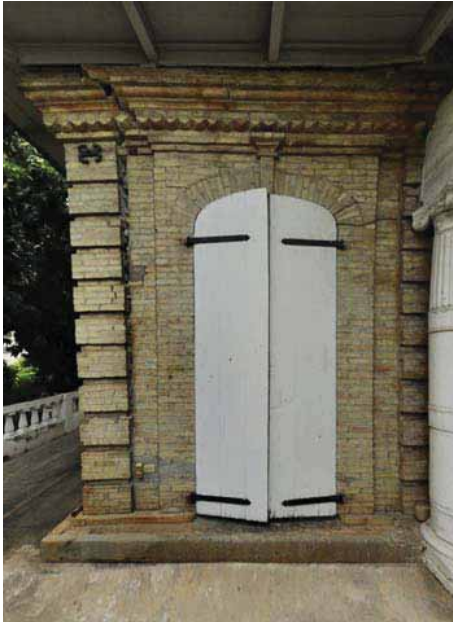
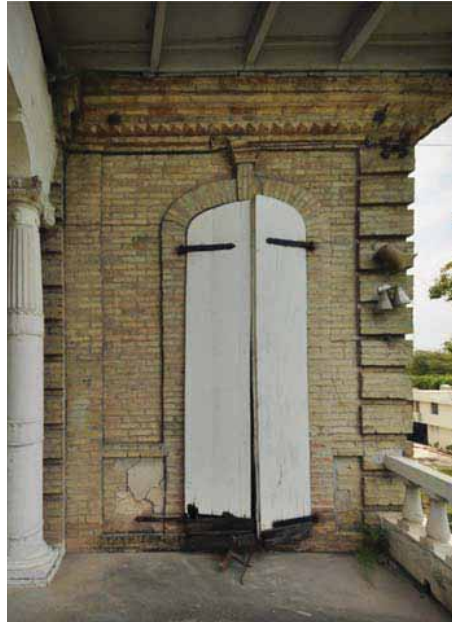
FIGURE 107 112 Rue La Fleur Ducheine, showing the metal plates at the end of the iron chains that are laid into the walls at the floor level. The end of the second floor wall on the left suffered damage because the plate around the corner to the left had fallen off probably because of rusting of the rod, whereas the plate on the right hand corner of the same wall shown on the right was intact, and thus the earthquake did not damage the wall at that end.

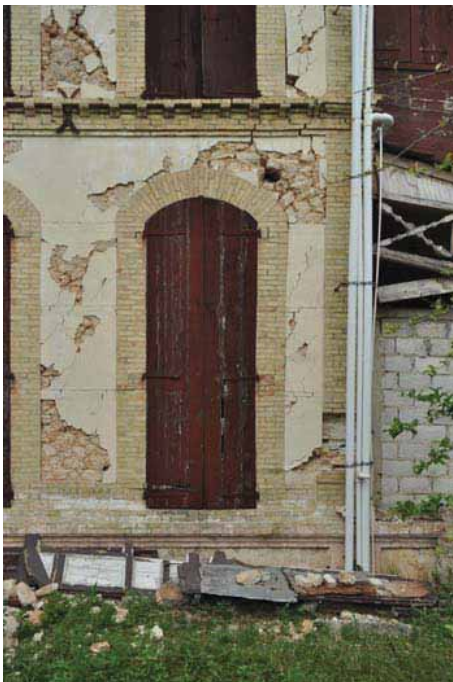
FIGURE 108 The Villa Castel Fleuri shows the effect of the absence of iron chains at the 2nd floor level corners. The pier on the right has been slightly displaced to the right at the second floor level. It is possible to repair it without rebuilding it, but the deflection will then remain visible. A better quality and more resilient restoration will require shoring and relaying of the masonry of the corners of the building with new masonry units to replace the rubble stone. The rebuilt masonry need only extend across to about the middle of the arch.

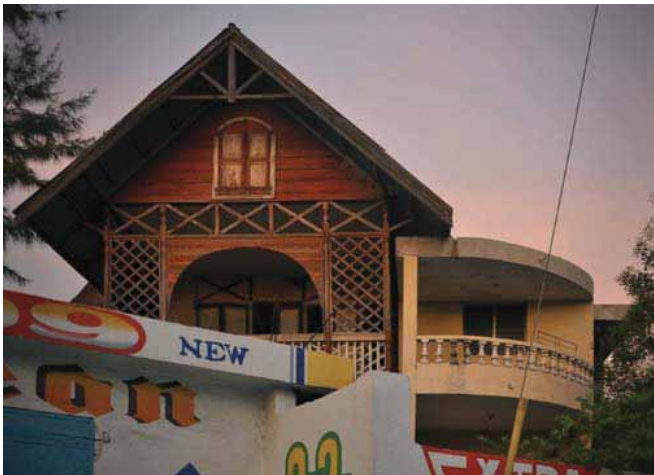
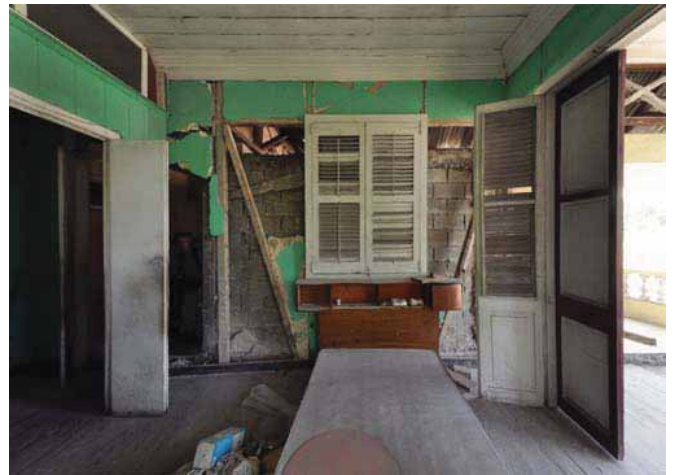
FIGURE 109 Interior and exterior of 51 Avenue Christophe showing reinforced concrete addition to the timber and *colombage* house. The two parts pulled away from each other during the earthquake.
