Preserving Haiti's Gingerbread Houses

2010 Earthquake Mission Report

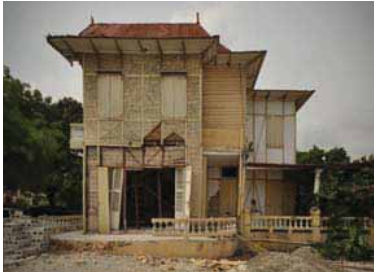
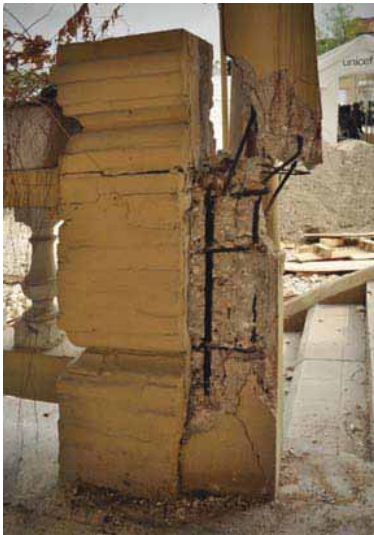
FIGURE 114 The Bazin House on Rue du Travail Deuxième. An upstairs bathroom of reinforced concrete and block construction clad with wood visible in the middle of the left photo almost caused the collapse of the entire house because it was standing on thin legs of heavily deteriorated concrete with rusted rebar. It was heavy, causing the whole house to sway, almost collapsing the bathroom wing, which may then have carried part of the house down with it.

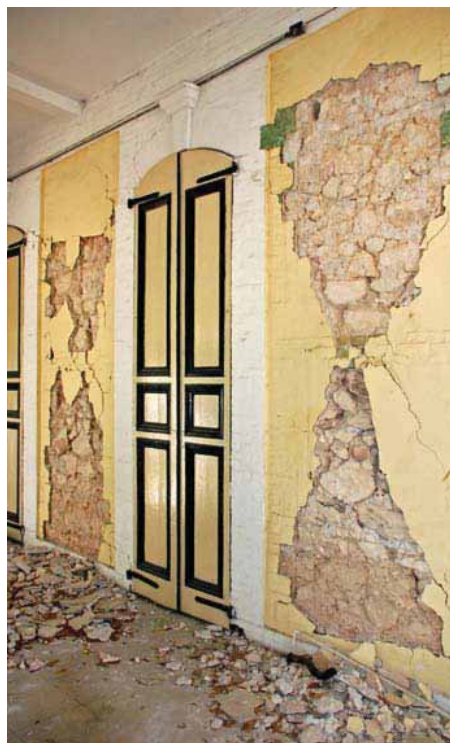
FIGURE 115 The characteristic X-cracks seen on masonry wall infills of concrete frames are also present at Le Manoir. These are due to the reinforced concrete second floor slab (above the damaged wall in this picture).

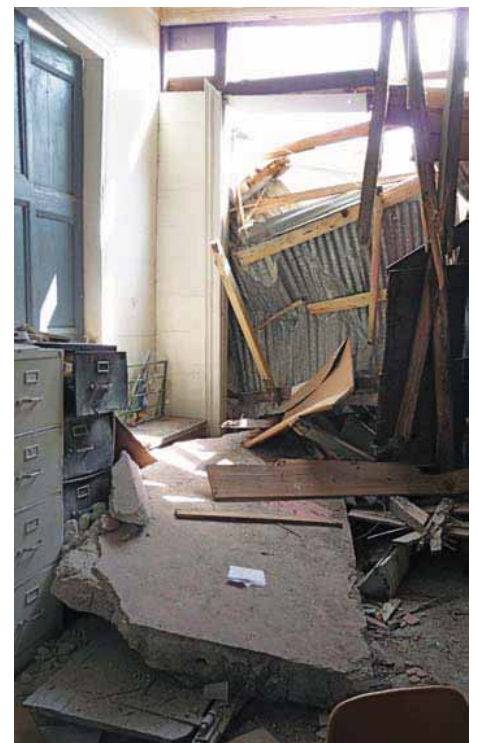
FIGURE 116 The most damage this Gingerbread suffered was from a concrete slab ejected through its back door from the collapsed concrete building behind. The building's front porch roof was also damaged, by a collapsed concrete building to its side (see Figure 82, page 40).

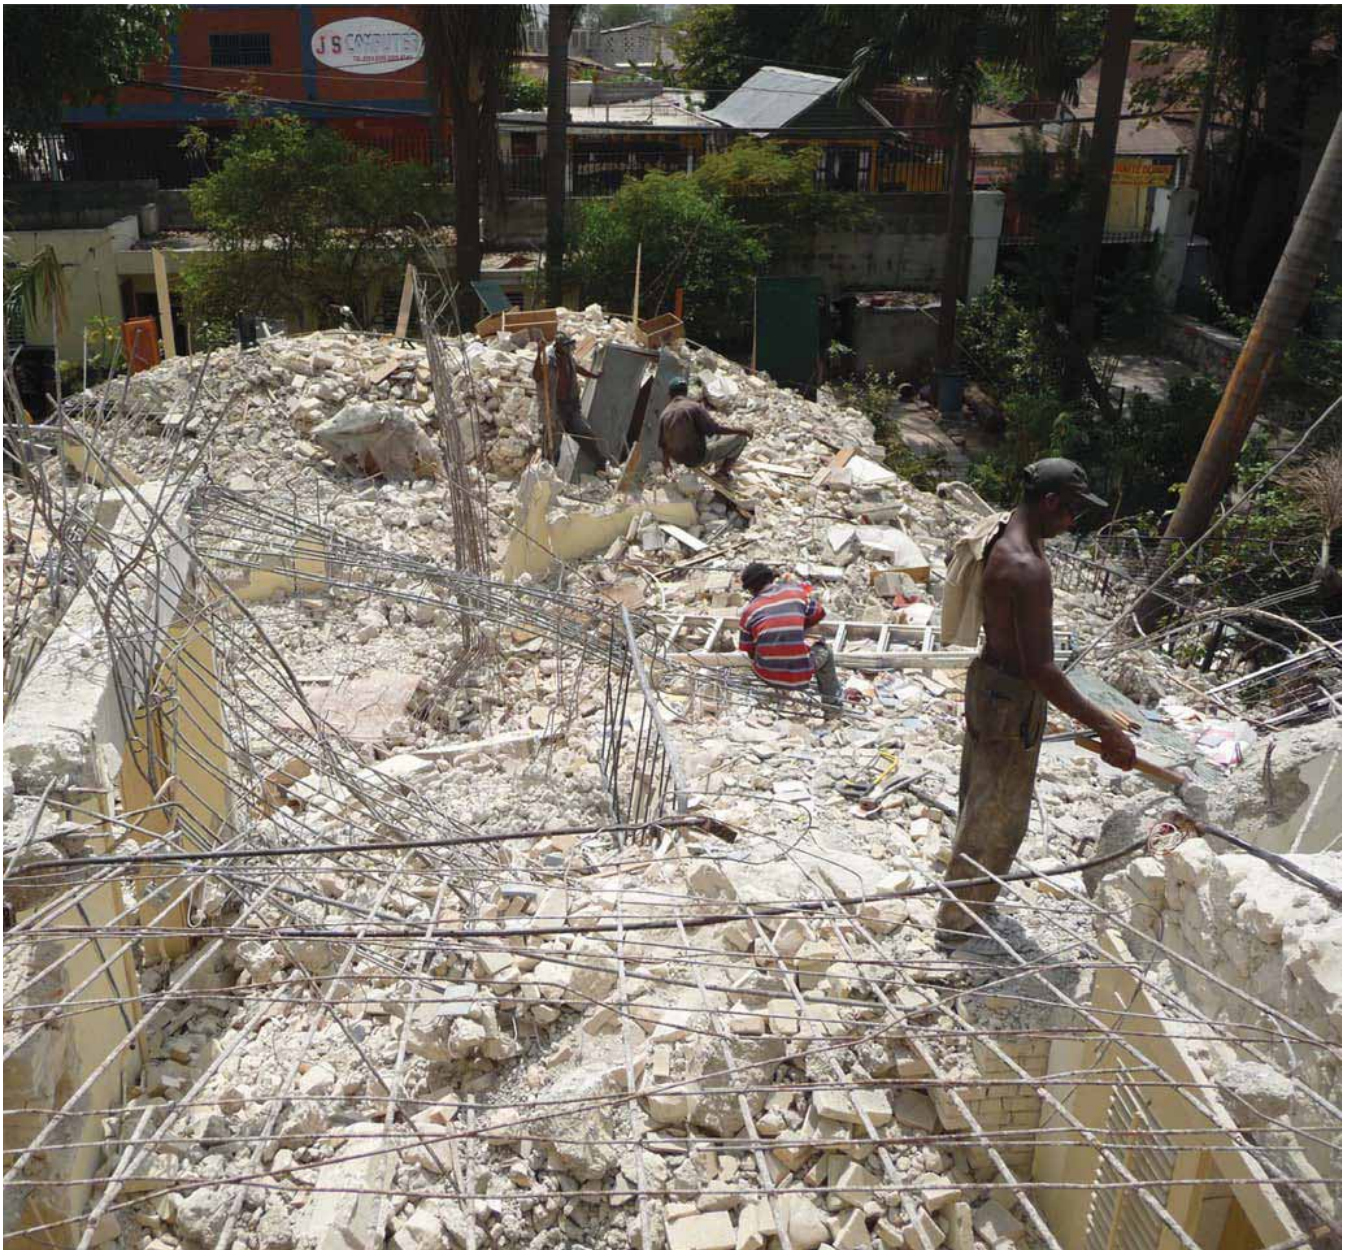
FIGURE 118 In a typical scene, a Gingerbread stands intact beyond the tragic collapse of a modern concrete building

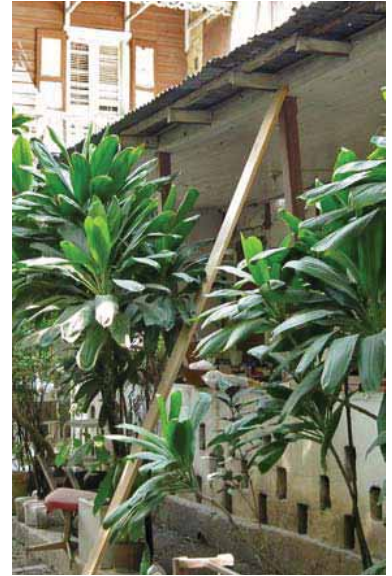
FIGURE 119 Temporary measures are important: this lateral brace is a good idea, but it is too slender and there is only one.

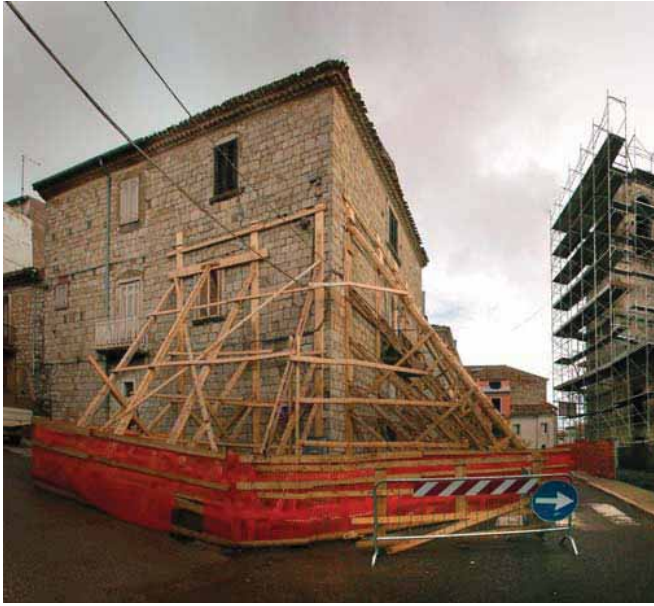
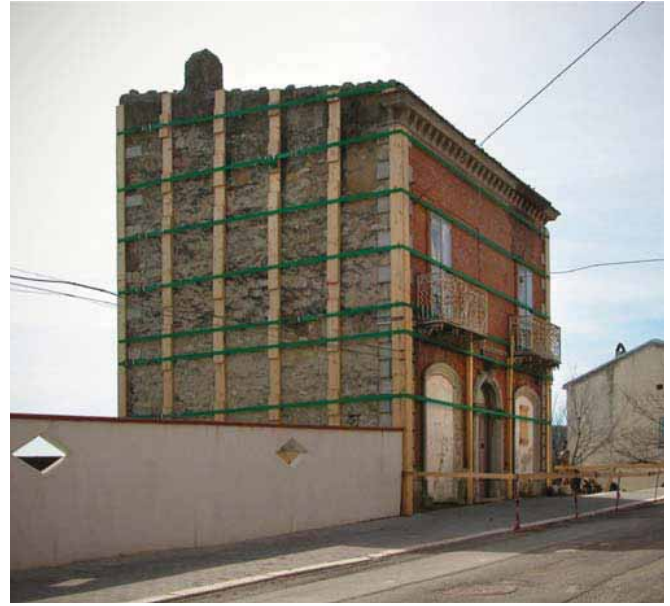
FIGURE 121 Examples of shoring in Italy after the Molise earthquake, showing the heavier timber diagonal braces in the example on the left, and polypropylene straps holding the building together on the right.

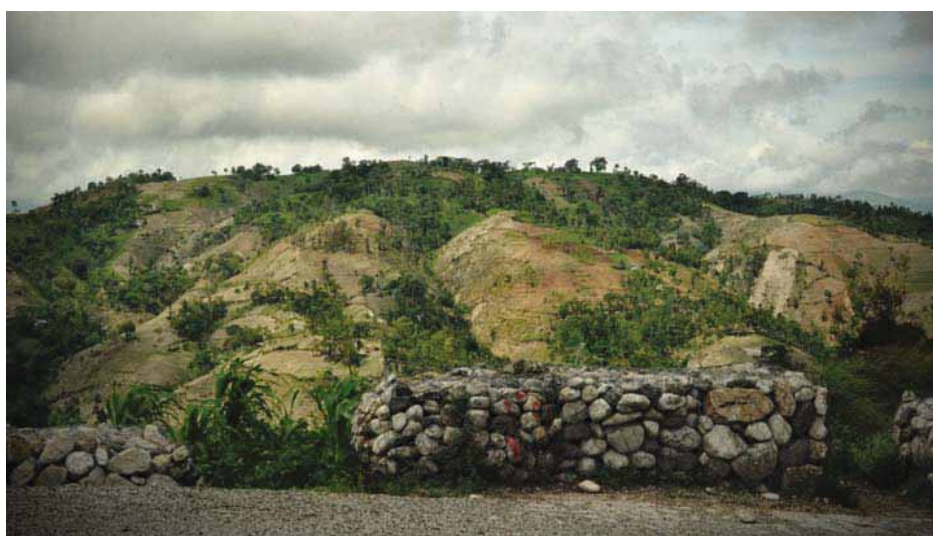
FIGURE 122 The mountain landscape between Léogane and Jacmel shows the terrible beauty of a landscape largely stripped of its historic tree cover.

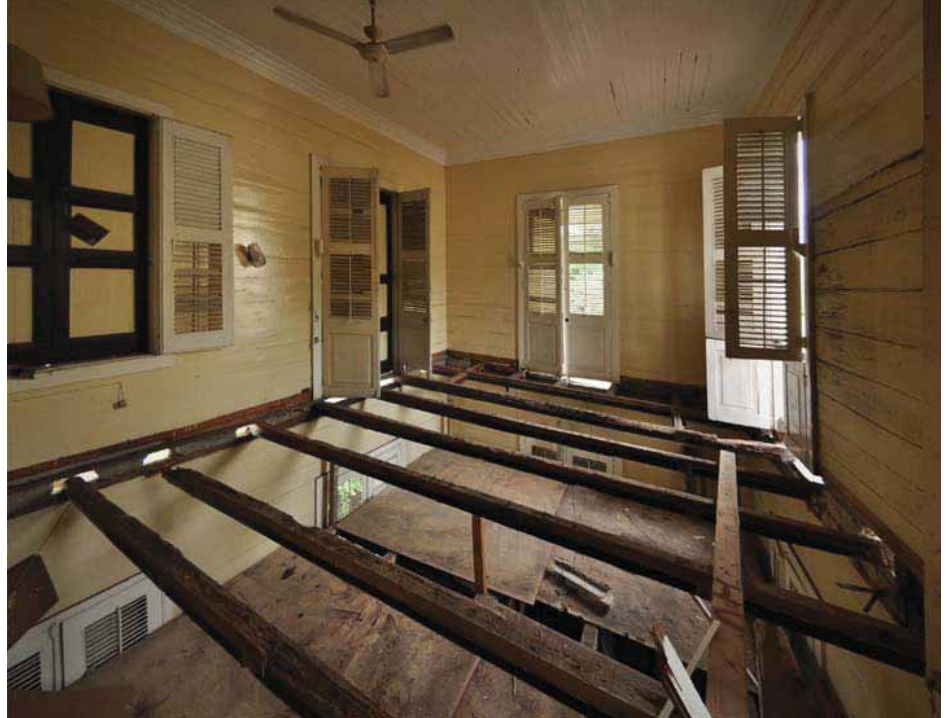
FIGURE 124 House at 32 Avenue Lamartiniere now under restoration, showing the decayed ends of the joists.

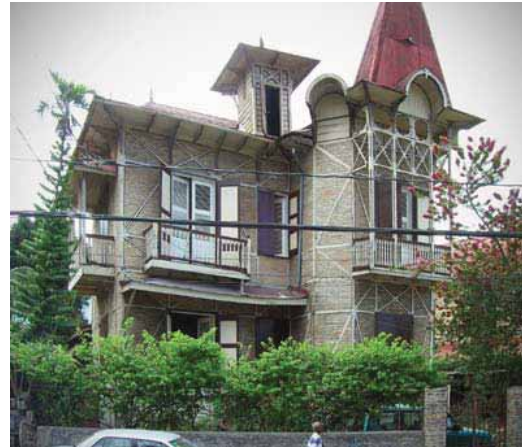
Typology-specific Interventions

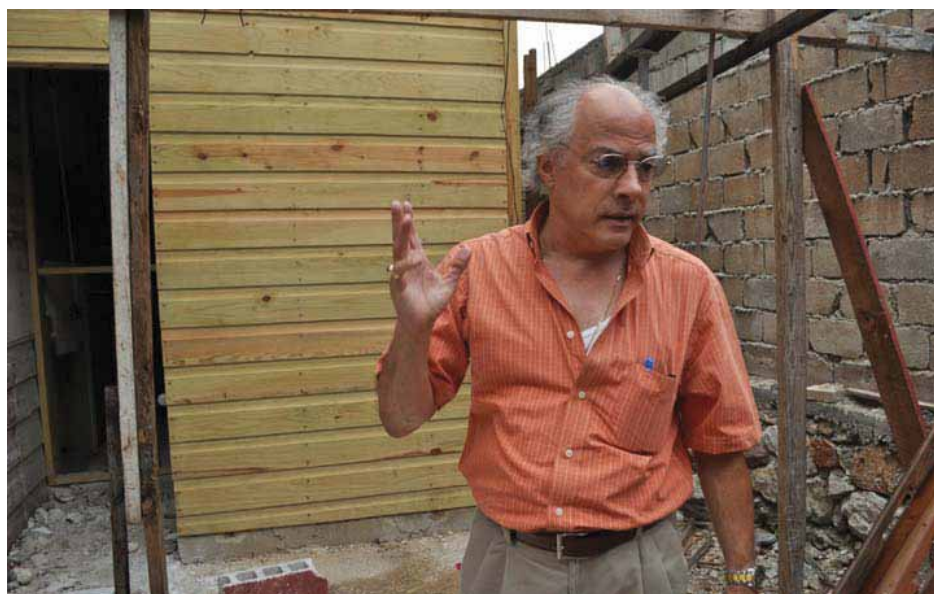
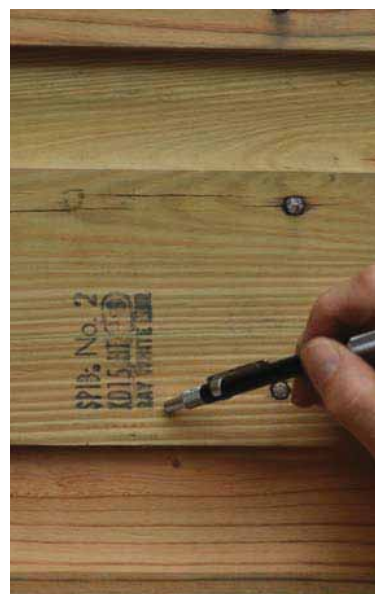
Masonry Bearing Wall:

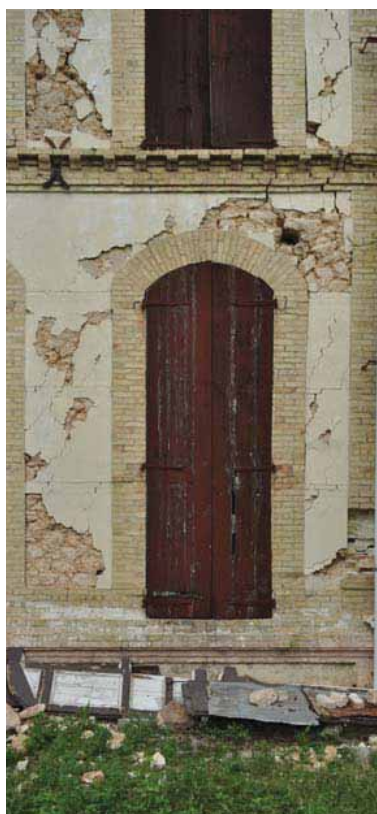
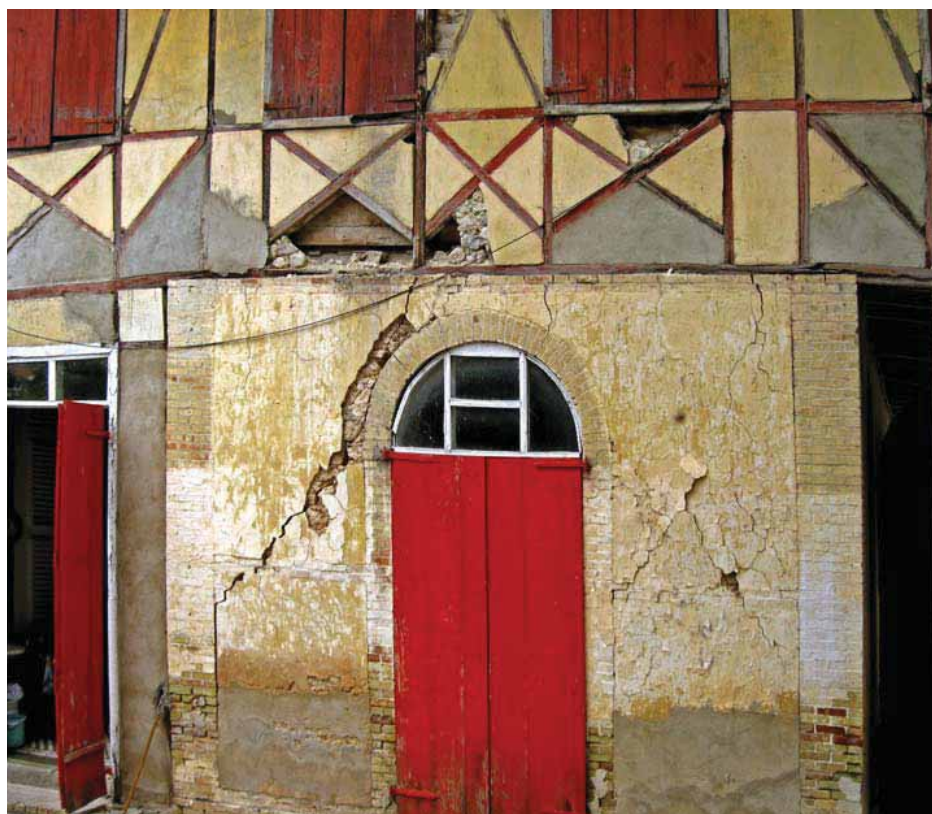
FIGURE 127 Typical 'brick frame' with rubble infill construction. Note crack pattern/energy absorption in rubble fill. The addition of ties to resist the spreading of the arches at the tops of the openings will improve earthquake resistance, especially when the arch is close to the corner of the building as in the figure on the left.

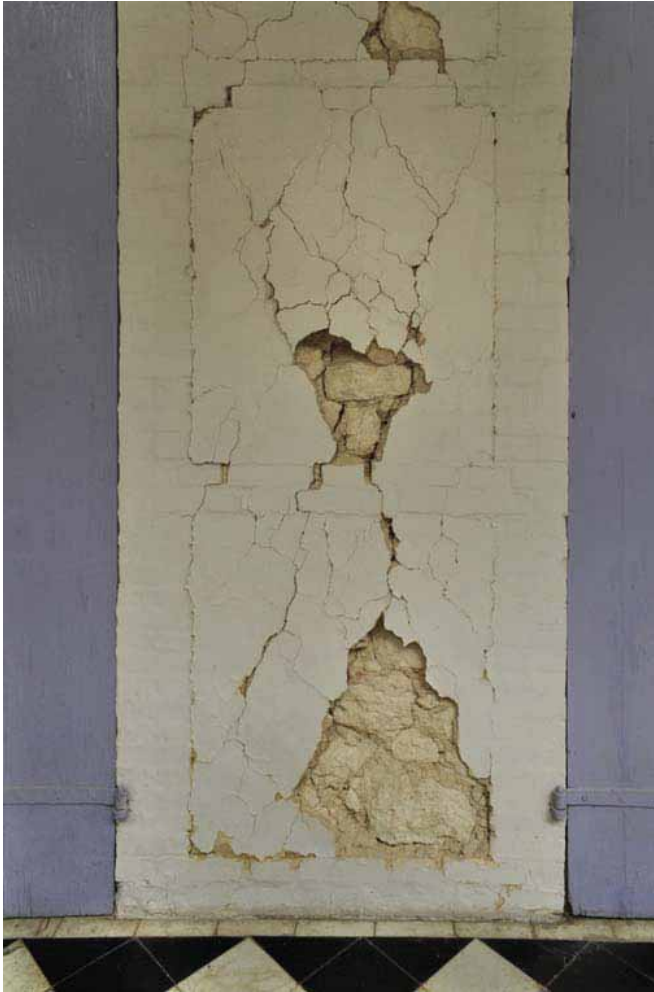
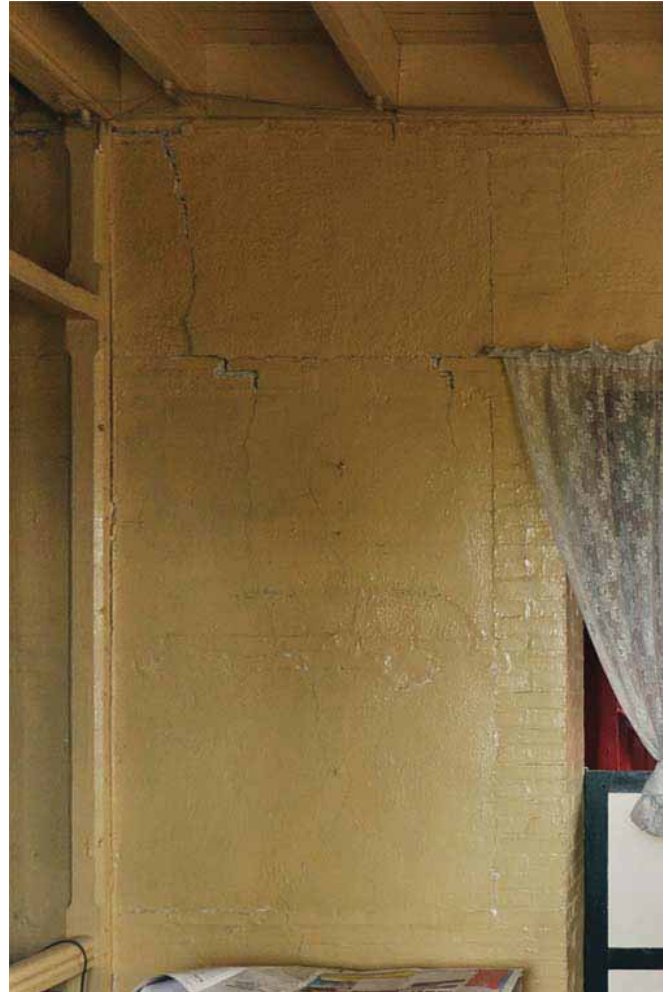
FIGURE 128 Interior and exterior examples of low levels of damage to rubble stone panels in masonry walls.

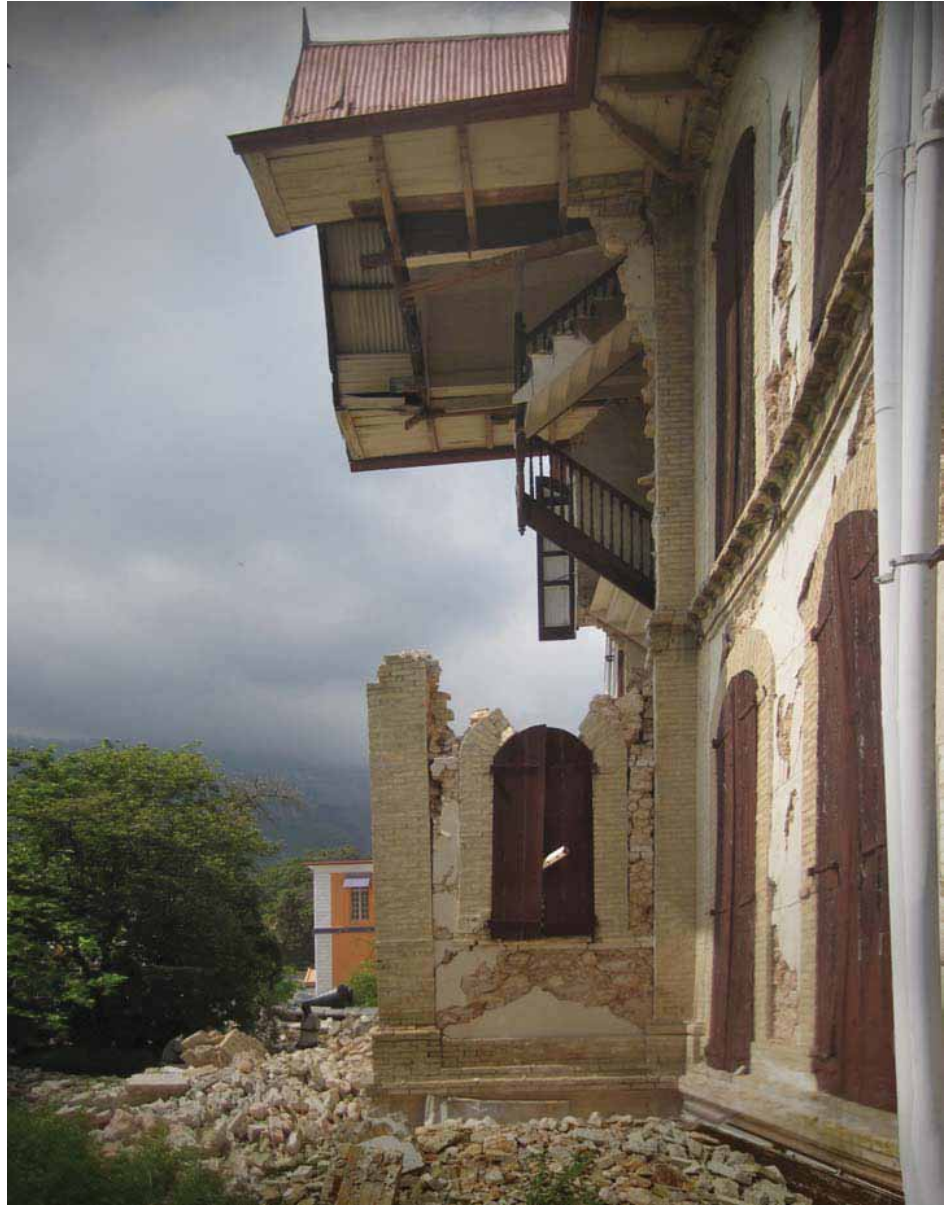
FIGURE 130 *below left* A rubble panel on the second floor of the Villa Castel Fleuri that collapsed showing the displacement of the bottom of the brick pier into the doorway which resulted from the expansion forces from the panel. *below right* Le Manoir on Avenue John Brown showing a heavy level of disruption of the masonry walls caused by the rapid degradation of the rubble stone panels during the earthquake.

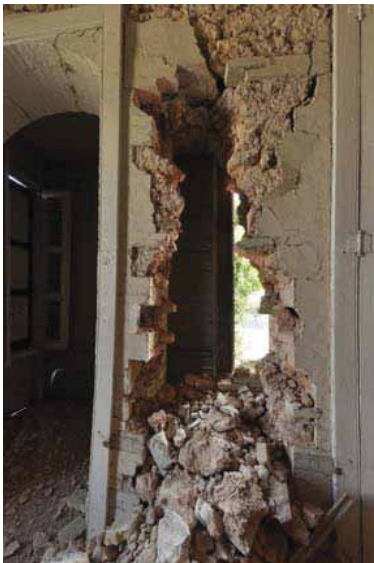
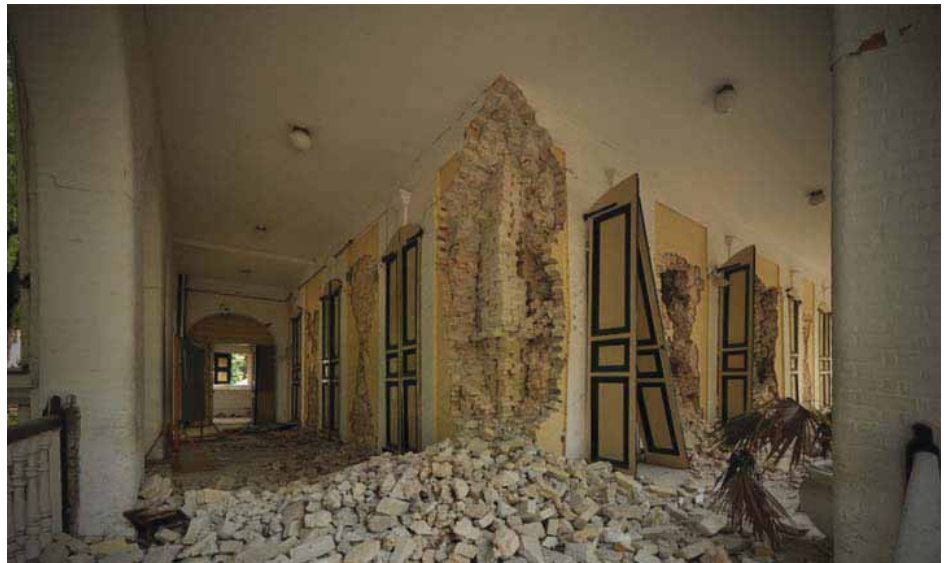
B. Repair of masonry walls with rubble stone panels and brick piers where the rubble stone is damaged and disrupted, but still largely in place, and the brick piers have suffered only minor dislocations. *The repair of this type of construction presents problems that may require further research to design the best strategies, but based upon the preliminary analysis the following can be stated:*

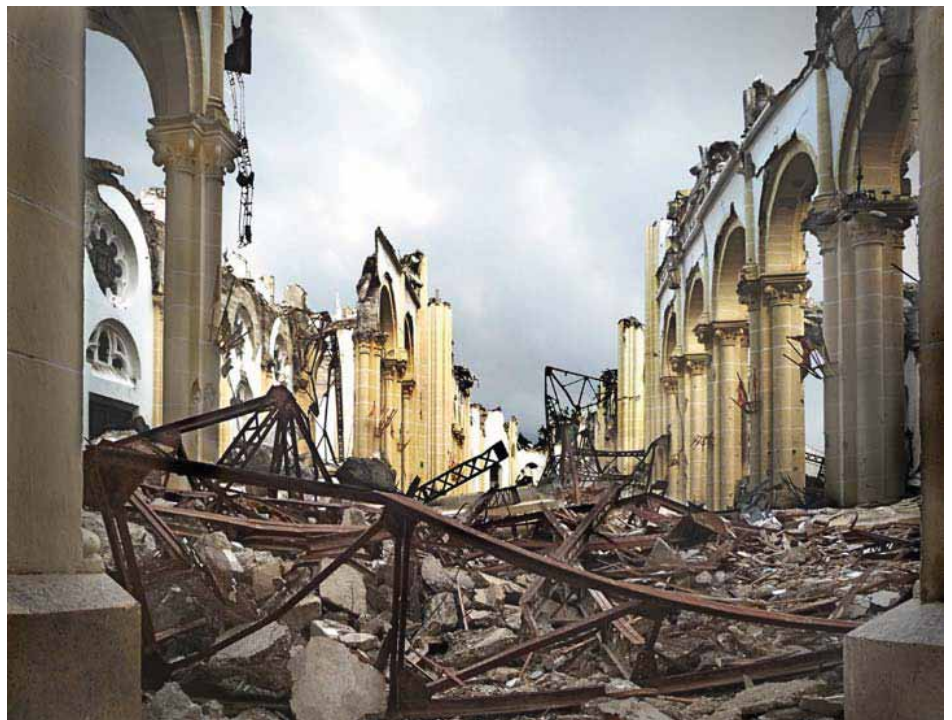
FIGURE 131: interior of the *Cathédrale Notre Dame de L'Assomption* after the 2010 earthquake suffered a complete roof collapse, collapse of sections of its interior arcades, and collapse of the tops of its two bell towers. Remarkably, all four of its two-story exterior facades remained largely intact. The building was constructed between 1884 and 1914, with walls of reinforced concrete with infill masonry construction. Much of the reinforcing had become heavily corroded by the time of the earthquake. Weak bonding due to the use of smooth rebar also made this and other reinforced concrete structures particularly vulnerable to seismic damage.

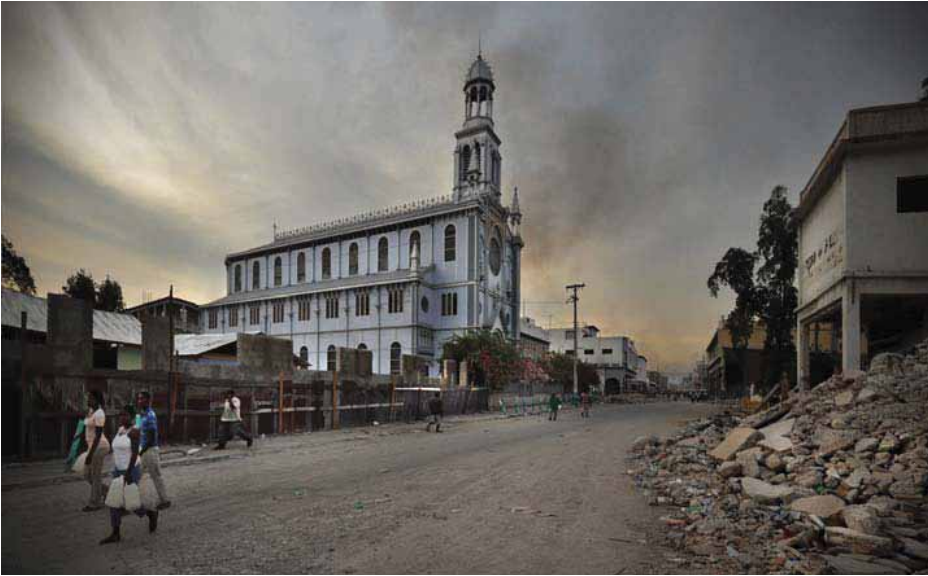
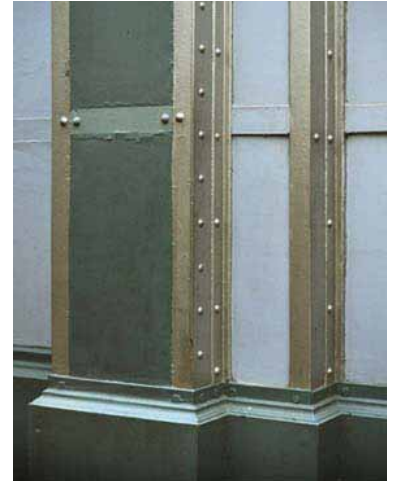
FIGURE 133 Saint Louis de Gonzague Chapel on Rue Du Centre after the earthquake. While the modern buildings of the Roman Catholic School collapsed, the Saint Louis de Gonzague Chapel survived without major damage. The Brothers of Christian Education founded the School in 1890, and the Chapel dates from after that date. This chapel is as large and tall as the nave of the Cathedral had been. Its iron frame, which serves to confine the masonry walls, was prefabricated in France. This structural system proved remarkably resilient compared to the early reinforced concrete construction found in the Cathedral as well as the National Palace.

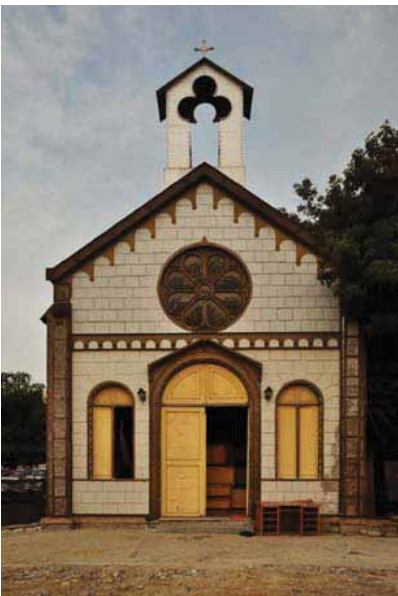
FIGURE 132 This small chapel next to the Cathedral has the same surface-applied steel reinforcement system as the Saint Louis de Gonzague Chapel and fared very well in the earthquake.”

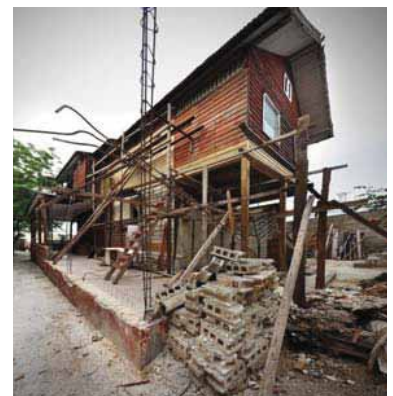
FIGURE 134 The modern reinforced-concrete frame with concrete-block back additions to the house at 24 Avenue Lamartiniere collapsed in the earthquake and have been removed. The owner, architect Gilbert Mangones, is now doing all of the repairs with timber framing and cladding, which will be much more compatible with the flexible timber frame of the original house, and less likely to collapse in a future earthquake.

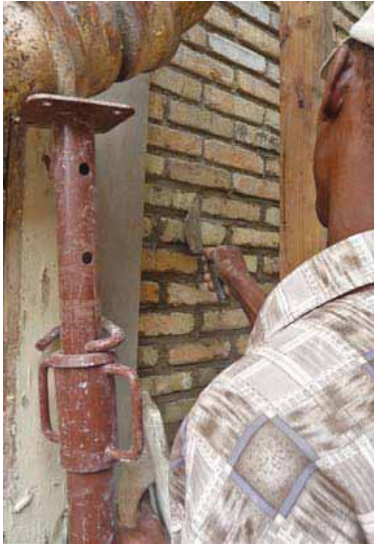
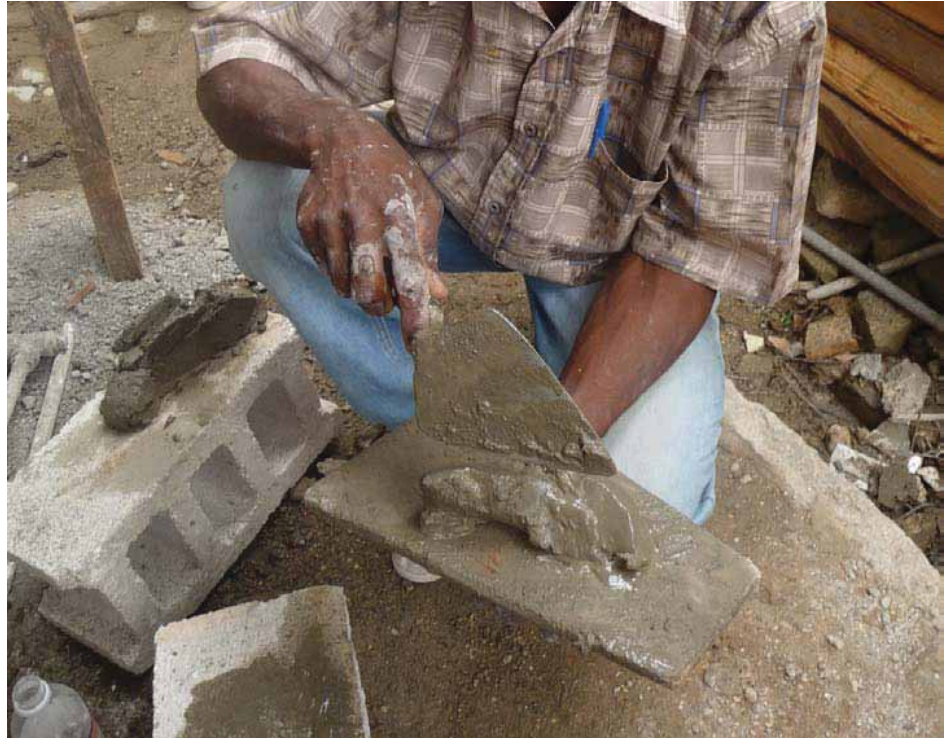
FIGURE 135 Well-intentioned but improper repairs with cement mortar in brick work (*above and right*), and cement plaster for colombage infill (*below*). Lime mortar and lime plaster should be used.

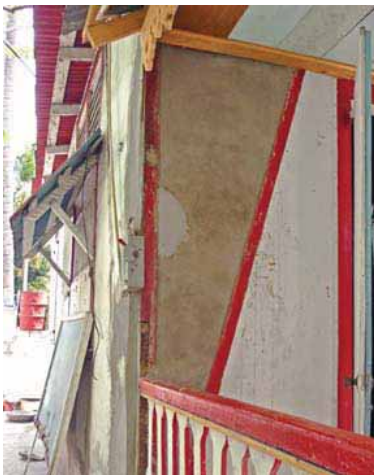
Education and Training

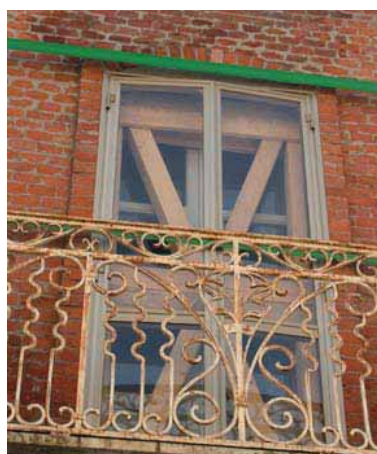
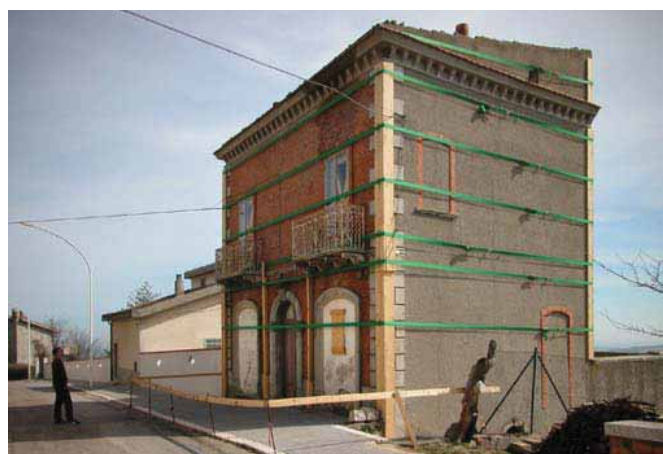
Protection of the building using tarpaulins. Tarpaulins and rope are typically used to protect building interiors from rainwater after hurricane damage. Such a mitigation strategy must be used only with the greatest caution as tarpaulins can act as a sail and cause further damage during high winds when used in conjunction with a structure that has already been structurally compromised.

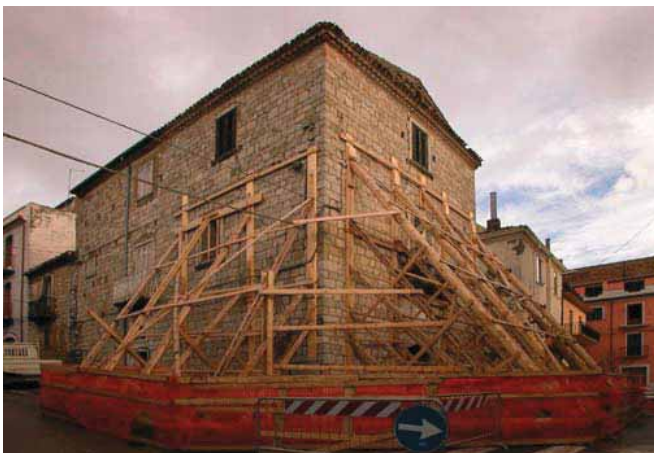
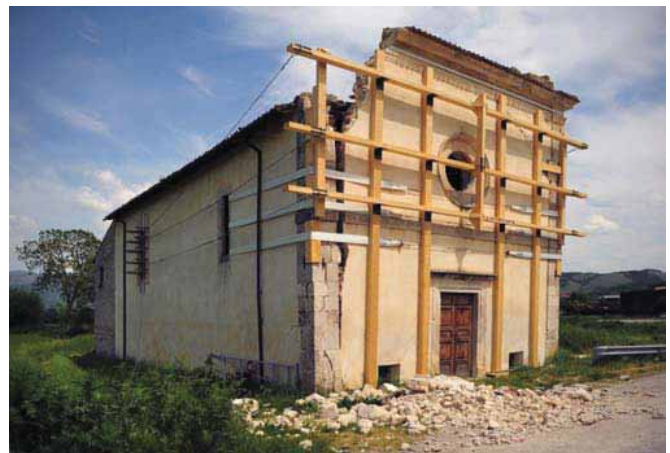
In all cases, the debris should be sorted as it is removed. Storage space should be set aside for the storage of each category: rubble, rough stone, whole bricks, dressed stone, reusable roofing materials, beams, joists and structural timbers, joinery, valuable small items e.g. bits of plaster with mural painting which it may be thought possible to reassemble later on, hardware, art objects and collectors' items.

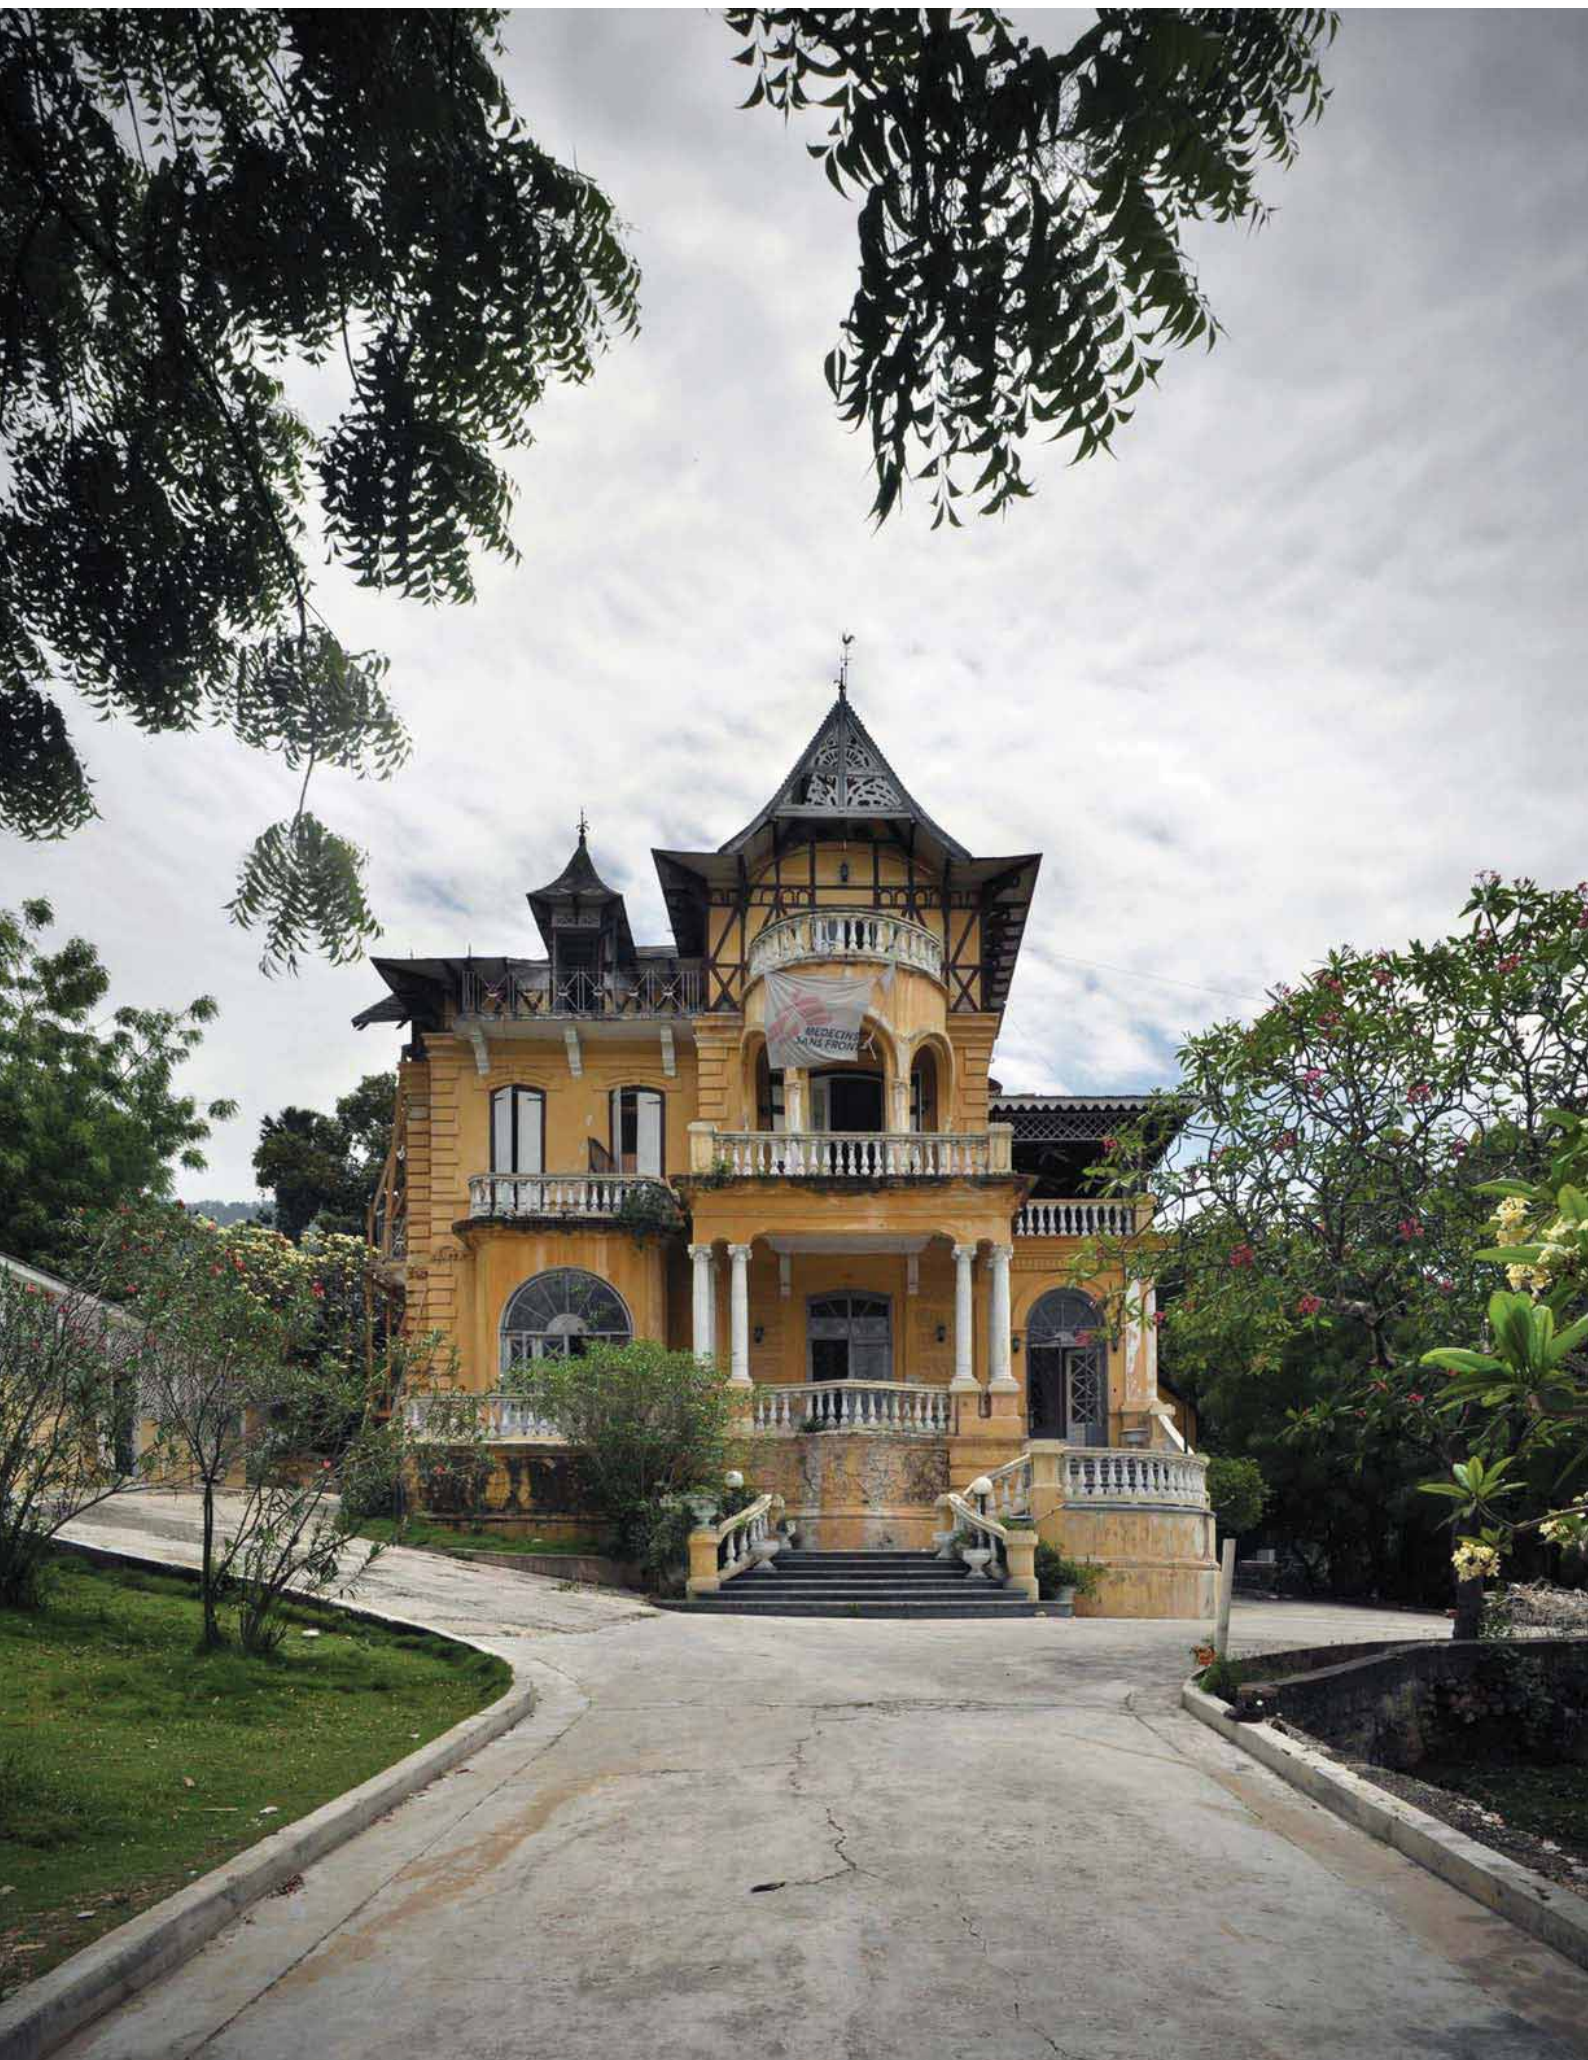
FIGURE 141 back cover A splendid mansion of masonry construction on Rue 4 Pacot occupied at the time of the earthquake by Doctors without Borders. The house generally suffered only a moderate amount of damage, but the back masonry wall separated from the frame at the third-floor level. This may have been caused by the later construction of a bathroom with a raised concrete floor.
