Preliminary survey and assessment of schools buildings

March 2008

Reducing Vulnerability of School Children to Earthquakes in Asia-Pacific Region-Shimla, India

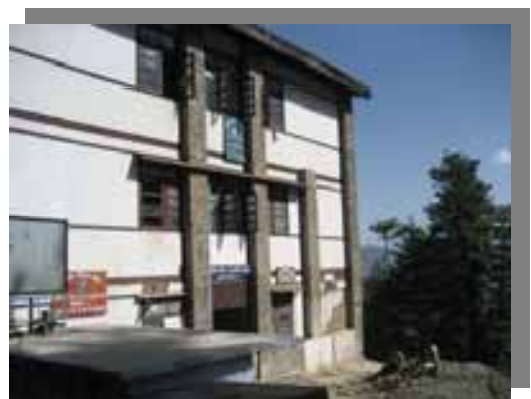
School building is having G+2 stories and made up with the traditional materials like stones, wood and burnt bricks. Building is having a plinth area of more than 500 sqm. Shape of the building is nearly rectangle as at one end of the building there is offset because of the staircase block. Position of the site for the building is fairly safe from different hazards like landslide, rock fall. Sub soil condition of the building is rocky and it's been built in a right manner.

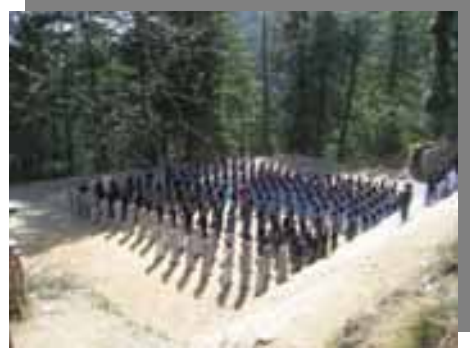
Design of the building is good when we consider earthquake resisting aspects of the buildings as there are continuous wooden bands provided at different levels in the buildings. Entire building is been divided into different infill panels of burnt brick, wood and stone as shown in the picture. As such school authorities don't have any information about the school building like plan and structural drawings. School building looks very old and there are some damages due to weather deterioration in cladding as shown in the picture.

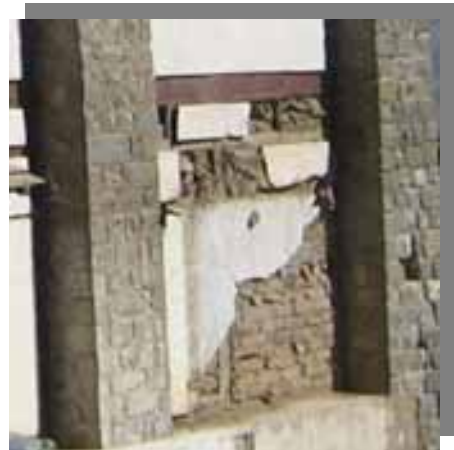
There are lots of defects in the building due to deterioration and ageing effects. In lots of places vertical wooden members damaged and they are not strong enough to transfer the load safely to the foundation of the building. All the floors are made of the wooden planks and in lots of places wood is damaged. In many locations in the panels of infill masonry wall there are diagonal as well as vertical cracks in the building which shows that there were some subsiding at the site of building might happened in the past.

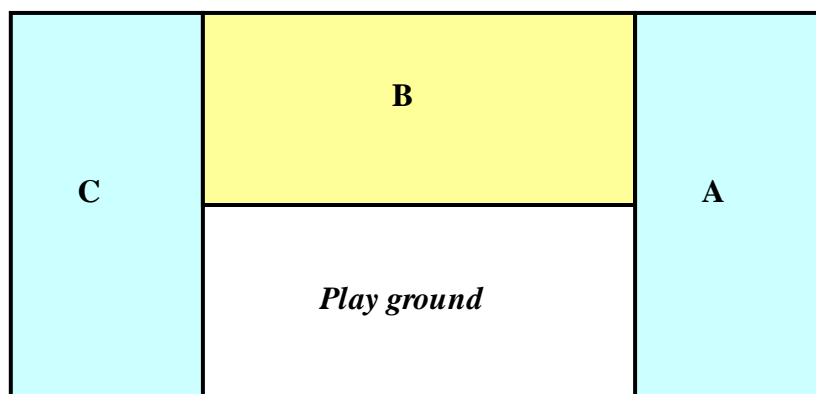
Entire school buildings can be divided into three blocks as shown in the picture below.

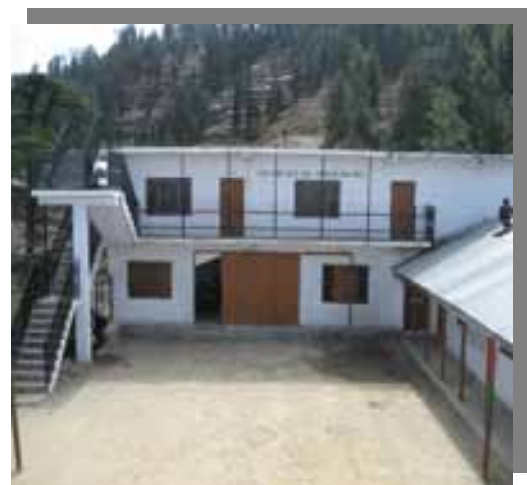
There are main three blocks in the school campus namely block A, B and C. Block A and C are similar in size and shape while there is a height difference in block B in comparison with the other blocks. All the blocks are G+1 type. Block A and C are having storey above it while block C is having storey below it. Block C was constructed initially while other two blocks were added to the building afterwards. Based on the information given by the school staff this school building was designed by the government engineers and it's been maintained by Education department's technical staff. There is a small play ground within the campus of the school as shown in the figure above.

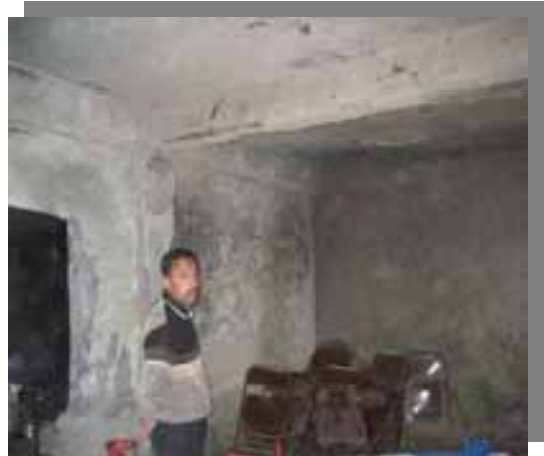
We have done a rapid visual survey of the block B as shown in the figure. There were lots of flaws in the design of the building and it seems that they have used very poor quality of materials for the construction of the building. At many places we can see the spill out of the concrete covers from the slab of the building and you can see the corroded reinforcement from the bottom as shown in the picture. There are lots of shear cracks in wall of the building which shows that load is not being transfer in a proper way. There are also some columns which are not properly oriented in the building which can attract lots of stresses during the time of an earthquake. This school building can be one of the good examples for the community and administration for spreading earthquake safety in Himachal Pradesh.

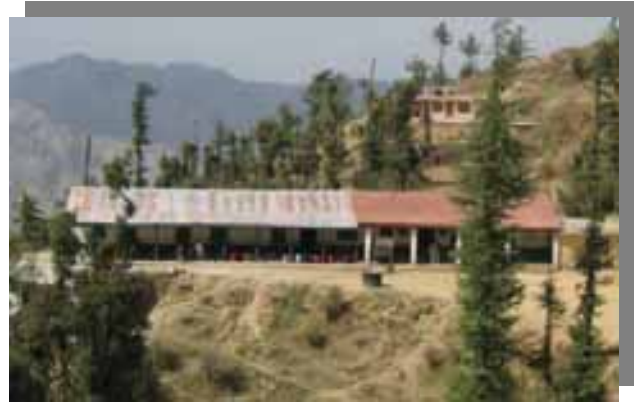
School is having only one building and huge play ground in front of the building. This school building was constructed during 1953 and some rooms were added during 1990. This school building is having five rooms and construction materials used for the building are different based on the year of construction. Old portion was constructed with the wooden bands and flat stones. There is no sign of mortar used as binding materials between two stones. Thickness of the walls is 18". Plan of the building is simple rectangle as shown in the picture.

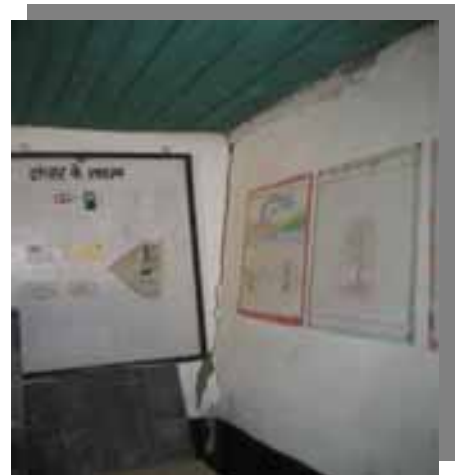
As this school building was constructed during 1953 due to aging of the building and technology used for the construction of building there are lots of defects in the building. As there is no proper use of the mortar we can see lots of separation in the building. At every cross wall of the class room there is no proper bonding and huge vertical cracks have been developed at every corner of the building as shown in the picture. There are lots of cracks developed at the corner of each opening which shows that building might have experienced a lateral thrust in the past.

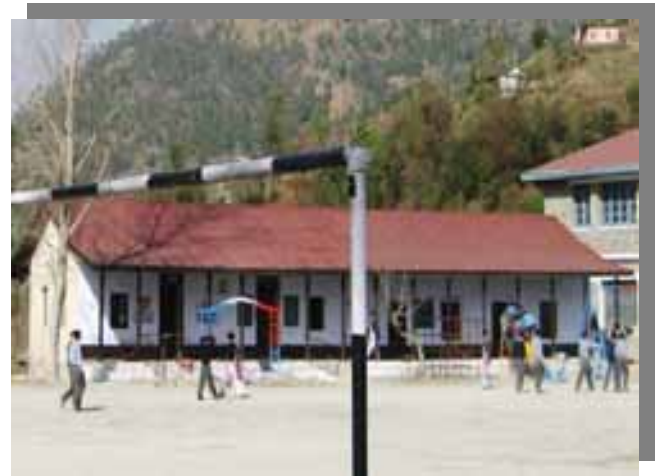
This school building is situated in very large campus. There are five other buildings situated in this place with the huge play ground in front of it. The block for Primary school was constructed in 1931 A.D. main construction materials used for the construction of the school building is stone and wood with mud mortar. Thickness of the wall is 18" and partitions are made out of the plywood. This school building is having G+1 type structure. There is one storey below the building shown in the figure. Plan of the building is simple rectangle. There is a veranda in front of cladding as shown in the figure. Roofing is made out of CGI sheets. There is also a falls ceiling at the roof level for better thermal comfort. There is a huge play ground in front of the school building with the dimensions about (100MX200M). This school campus is also having other facilities like library for students.

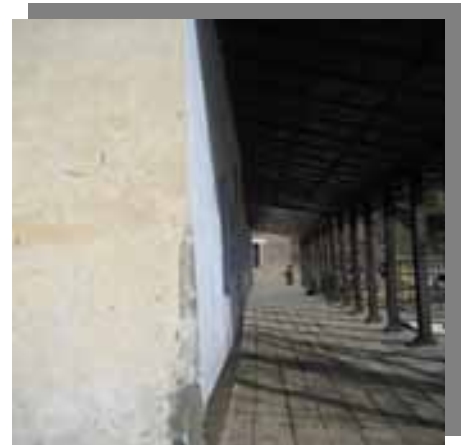
This school building is having lots of defects into building because of the aging of the structure and poor quality of materials used for the construction of the building. There are lots of cracks in the walls and around the openings of the building. Plaster is being chipped of in many places. There is no continuous band provided in the building for resisting any lateral loads. Condition of roof structure and roof covering is

better in comparison with the other elements of the building. Veranda is being built with the wooden planks and condition of the same is not good as there are some places where these wooden pieces are missing which reduces the diaphragm effect of the floor. One of the major problems with this building is that there is a bulging of the wall in front face of the building as shown in the picture. This gives a sign that there is no integrity in the structure and in future even a minor earthquake can lead to major disaster in this school building.

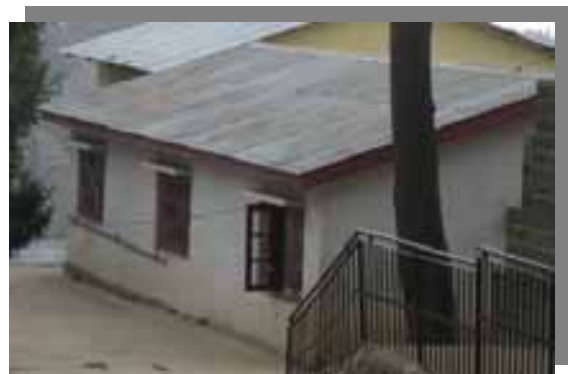
This school campus is having four building blocks which are situated at different levels because of the hilly terrain. They are running separate classes for deaf and blind children in different buildings. Two blocks are used as the hostel for the students.

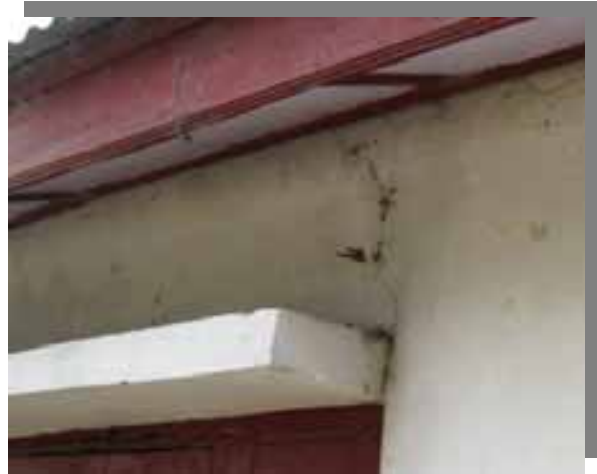
This school building is built during 1980s and because of weather and aging it have developed lots of defects. There are diagonal cracks around openings. There are lots of vertical cracks also on exterior wall of the building. Condition of the flooring is really deteriorated and students are facing lots of problems due to the same.

This building not only lacking the proper earthquake resisting features but it also lacking the universal design for differently abled children. This will be good school building to choose for this project.

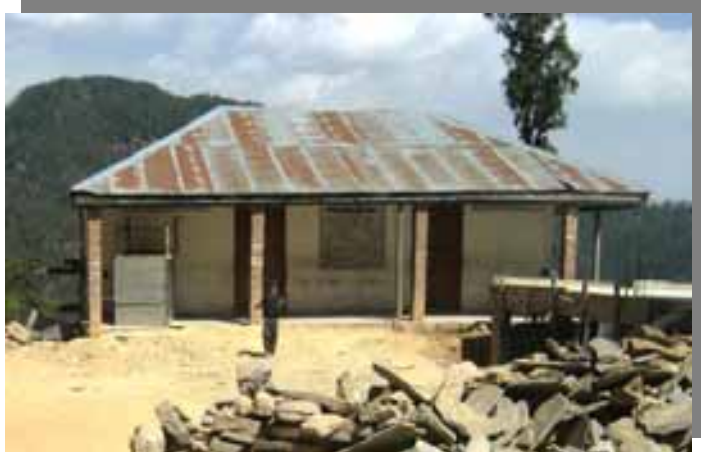
As you can see in the picture there are slender brick columns which cannot transfer the load of the roof it was done by government department as part of maintenance. There are five rooms in school building out of which only three rooms are used by school authority. They don't have any open ground also at the ground level which can be very dangerous during the time of an earthquake.

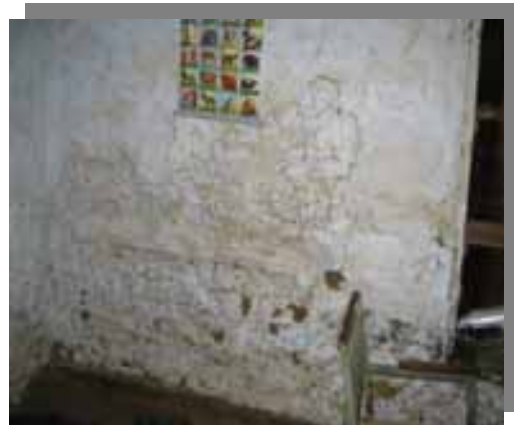
There are lots of defects in the school building. Walls are not in a good condition there are lots of cracks in every wall. There is no coherent load path available in the building. There is a broken veranda which can be very dangerous for the school children even during normal time. There is no cross walls available in the building which makes it more vulnerable. This building is in such a bad shape that retrofitting won't solve the problem. This building cannot be taken for retrofitting.
