Landslides and associated mass movements events in the eastern part of Madagascar: risk assessment, land use planning, mitigation measures and further strategies

V. J. RAMASIARINORO¹, L. ANDRIANAIVO², E. RASOLOMANANA²

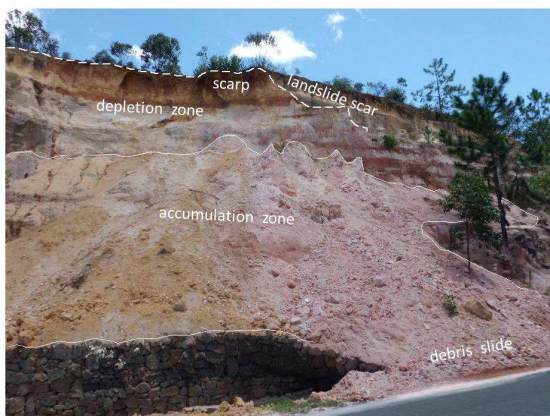
Figure 6: Landslide of complex-type with a predominance of rotational-type movement

A typical shallow rotational landslide on a concave slope segment is shown in Figure 6. Rotational landslides are more likely to occur on concave slopes where runoff and subsurface water can easily concentrate (Thomas, 1994).

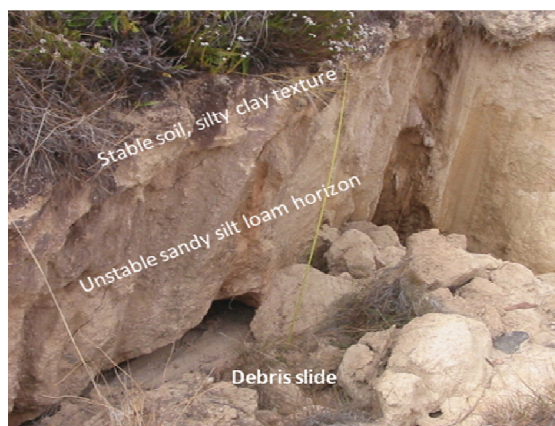
Figure 7: Alternation of stable pedogenesis phases and unstable phases of regressive erosion

All landslide scarps show a similar profile of at least two buried soils, created by an alternation of stable pedogenesis phases and unstable phases of regressive erosion (Figure 7). In this example of slump, the superposition of a soil horizon with a silty clay texture (52-57% clay, Ap category according to the Laboratoire des Ponts et Chaussées - LPC classification) on a coarser, sandy silt loam horizon (45-48% clay, SL or SA category) of an older soil (Ramasiarinoro, 2008) creates a pore discontinuity that hinders drainage.

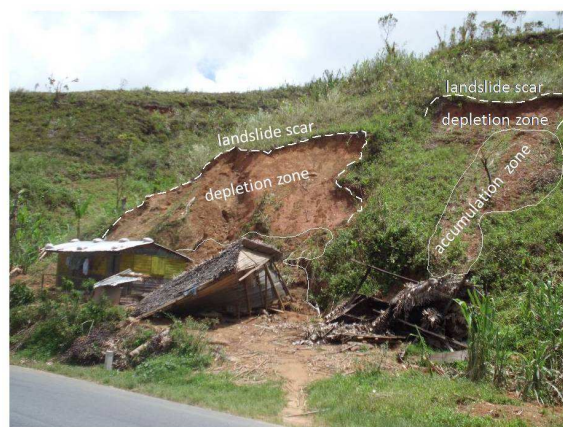
Figure 8: Destruction of house due to translational landslide (PK 189 of the RN2)

Heavy rainstorms during the recent passage of Giovanna cyclone (13-14 February 2012) and Irina cyclone (25 February – 02 mars 2012) combined with ZCIT passage are responsible for landslides occurrences and cause damage to roads, buildings (Figure 8) and farmlands.

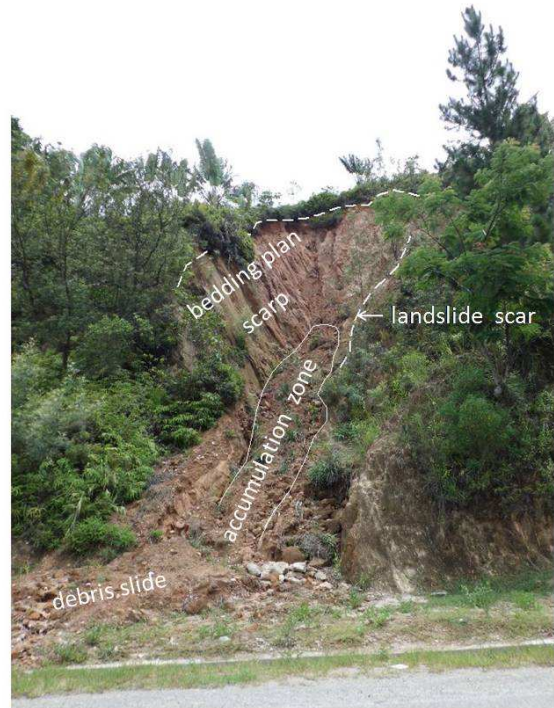
Figure 9: Dip of the bedding planes parallel to the slope enhances slope failure (PK94 of RN25)

Excavation is particularly destabilizing (Figure 9) when the bedding planes of the substrata are parallel to the slope. In addition, farmers often dig away parts of the slope in order to level their plots. The formation of step-like slopes by agricultural practices and intensified by natural processes removes the lateral support. Then, it causes water stagnation and increased infiltration, leading to an

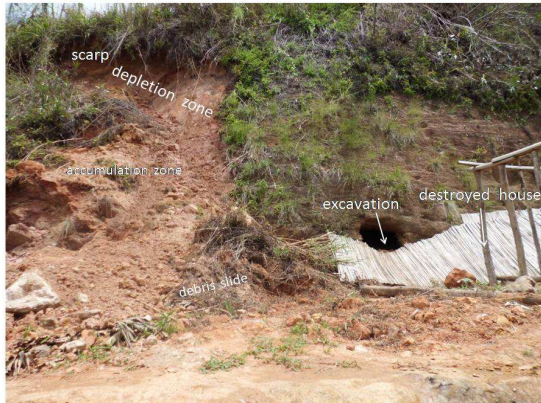
Figure 10: Slope excavated for house building and the consequent small slides above (left) the excavated zone (PK 189 of the RN2)

A few examples of a slope excavated for house building, footpaths or for agricultural purposes can be seen along these 2 national roads. The excavation for house building (Figure 10) was the direct triggering cause for slope failure and creep phenomena during the passage of recent cyclones (February 2012).

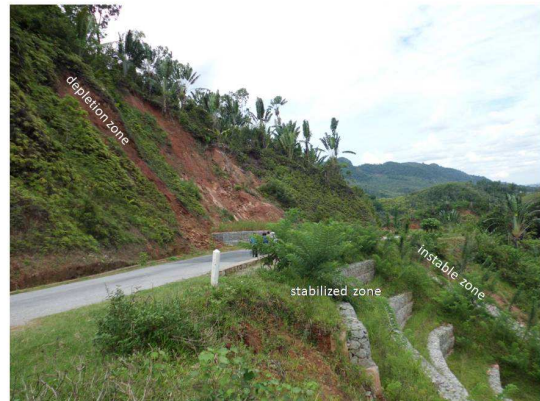
Figure 11: Technical measurements of stabilization (PK 95.200 of the RN25)

Tools for vegetation management could include reforestation, farm forestry, space-planted trees (Figure 11), riparian planting or retirement, gully wall planting, or channel planting. These soil conservation techniques in risk zones could locally enhance stability.
