The Future of the Oxfam Emergency Shelter

An Architecture essay submitted in partial fulfilment of the requirements for the  
First Examination for the Diploma in Architecture June 2001

### Five Section Shelter Experiment#1

## Five Section Shelter Experiment#2

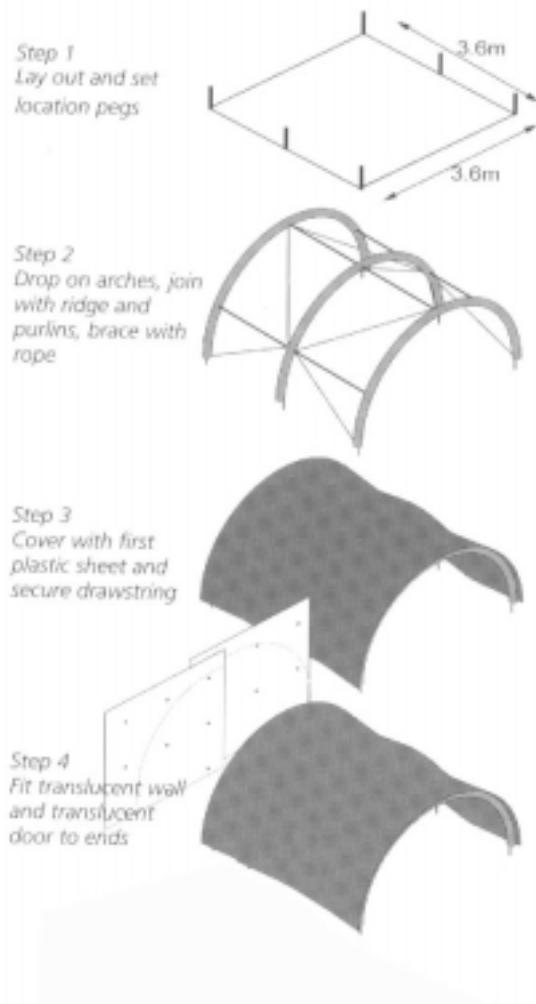
Fig. 1

The SES2 is a solution to a specific emergency refugee situation. It has been designed to be deployed after all other avenues of shelter have been exhausted. These included rebuilding existing homes, finding lodgings with relatives, staying with host families or in existing communal buildings. In the past shelter based refugee camps have sometimes stood empty because by the time the shelters have arrived, people have used these other solutions. The SES2 is designed to be a simple structure that can be supplied on demand in order to prevent a waste of resources. The materials used have been selected for their international availability as common building materials. This cuts down the lead time involved in getting the shelters to much less than that of conventional systems currently used by the UNHCR (United Nations High Commission for Refugees). These materials include MDPE piping that is used to carry water, scaffolding pole, tent poles, rope, reinforcement bar and Monarflex plastic sheeting. These can be obtained from a builder's merchant and reused or sold after the need for a shelter has passed. Materials can either be gathered in the country of need or packed up abroad and flown in. The sizes of parts in the kit-form version of the shelter are chosen to fit a 1.5m square air-freight palette. Fig.1 shows the method of construction for the on-site version of SES2 (Instructions for Kit-Form: Appendix B).

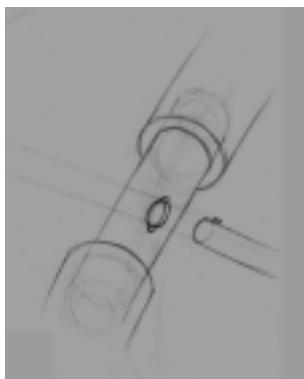
Fig.11

This study uses the kit version which employs 1.5m sections of pipe rather than one 7.5m piece. For a larger shelter another section of pipe was added to each purlin frame. The sketches below show the method used to erect the five-section kit-form shelter. First 0.25m lengths of reinforcement bar are driven halfway into the ground to form the footprint (Fig. 2). A tent pole can be used to measure the distance from back to front but the side to side distance must be approximated. A 1.5m section of MDPE piping is slipped onto each of the rods (Fig. 3). Meanwhile three scaffolding pole connectors are slid into place on a tent pole. They have been drilled with special shaped holes to allow the pole through (Fig. 11).

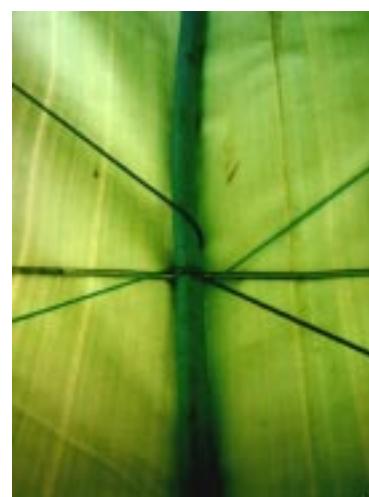
Fig. 17

The extra section of pipe made the purlins very flexible and vulnerable to wind loads (Fig. 6). Rope bracing was added to counteract racking. Guy ropes are avoided as they can take up space around the shelter and can be dangerous. Simple knots in the rope can stand high loads for a long time, which makes this part of the process quick and easy. Less bracing is better in terms of cost, but also in terms of the longevity of the shelter. At joints involving many ropes, these can chafe against the Monarflex and weaken it over time

(Fig.17).

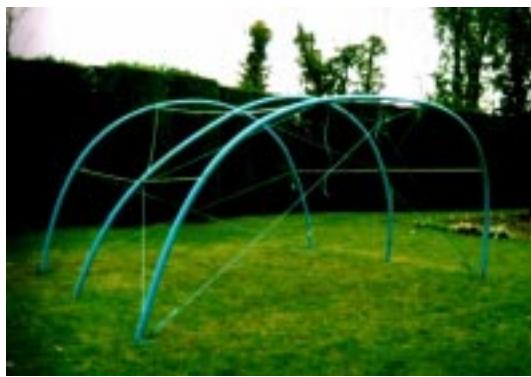
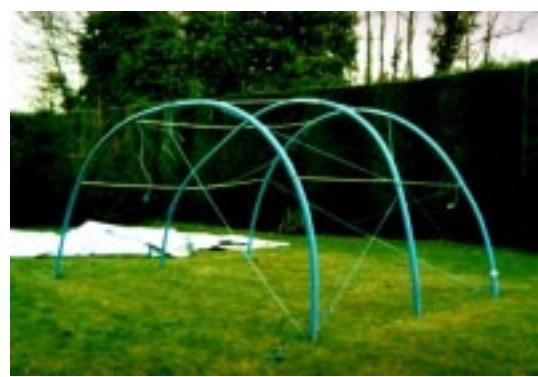
Every point of the structure that could rack was braced initially (Fig. 7,13 +14), and then

all but the essential ropes were removed (Fig. 8). The extra height and width created meant that bracing was needed across the front and back of the shelter, but this did not hamper access into the shelter. 9m of Monarflex was then threaded with rope along the edge and pulled over the structure. The ends of the rope are tied at the bottom of the outermost purlins and pulled tight, bunching the plastic over the pipe.

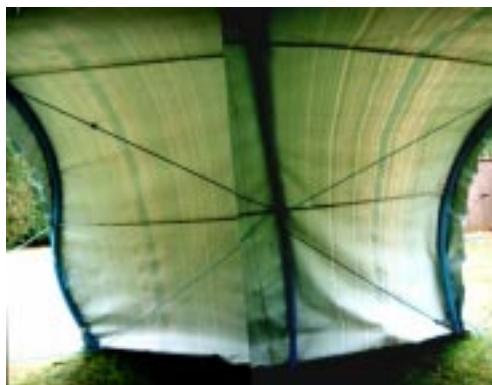
Fig. 18

The pipe tends to be stored rolled up. This causes it to develop a curve. This small deformity can take its toll on the overall shape of the structure if repeated in many of the pipes (Fig. 18 +13). Starting from one side to put the parts together seemed to cause the structure to become asymmetrical as the pipes own weight was being carried along an irregular shape.

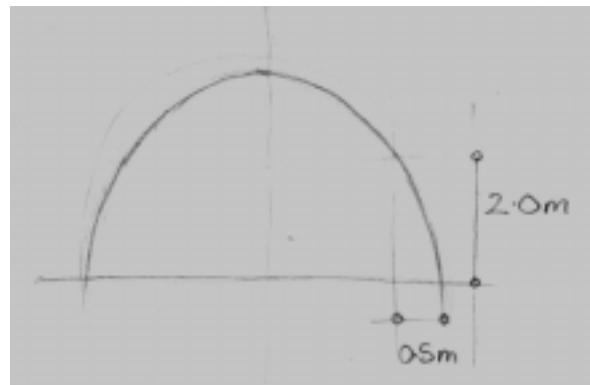
Fig. 19

The overall size of the structure made it difficult for somebody under 6ft to put it up alone but it proved to have useable proportions with plenty of head height and storage space (Fig. 19).

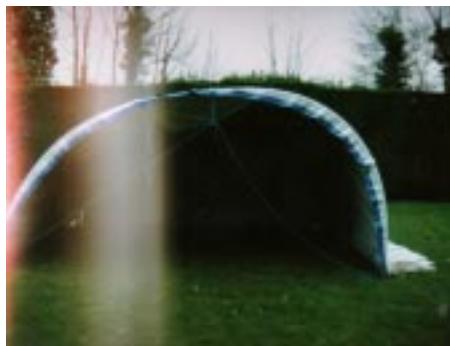
Fig. 20

After some days of rain, water had pooled on the skin between the top tent poles. The weight of the water was pushing the structure down and the pipes were deforming (Fig. 20). Some of the rope had become slack due to this deformation. The skin had not left the structure and all the re-bar was still fixed into the ground. At this point no attempt was made to adjust the structure in any way.

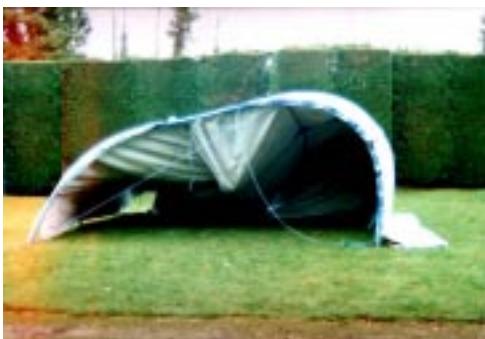
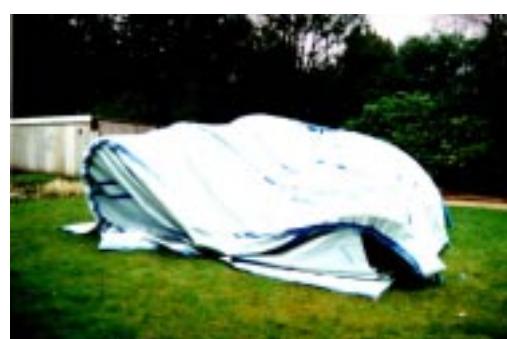
The weight of the water had caused a total collapse. The MDPE pipes had become permanently curved and could not be used to rebuild the shelter (Fig. 21+22). The shelter had had to support a volume of water at least equivalent to an average bath (Fig.23).

The collapse seems to have occurred for two reasons. First, the water pooling was caused by the lack of a ridge pole and the skin not being held down at the sides. The water was heavier than any force this type of shelter was designed to withstand. The structure failed because the MDPE pipes, in a semicircular configuration of this size, were not strong enough.

The purlins bent from the bottom causing the whole structure to deform. If the lower pipes could be made stronger, this would lessen the chance of collapse. If they could be made to stay straight, a parabola would be created, allowing the forces to travel in a more efficient way (Fig. 24).

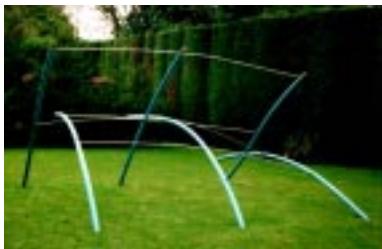
Fig. 29

This time a different technique was used to build the structure to try to avoid an asymmetrical result. Both sides were built up at the same time. Each side becomes very tall quickly as the first pipe is as tall as eye level and the next pipe brings the level up to that of an average ceiling. The re-bar begins to pull the turf up as the structure leans under its own weight (Fig. 28). At this point one side has to be leant against the other to prevent it falling over (Fig. 29). Putting the last section of pipe in proved impossible, as both junctions were too high to reach. This method was abandoned and the structure was built again from one side as before.

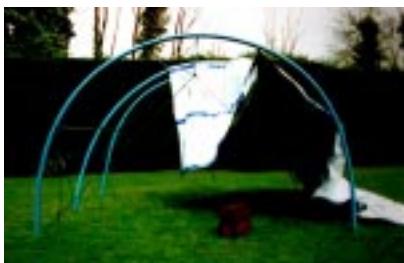
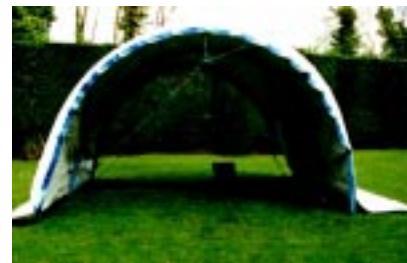
Once the re-bar, poles and pipes are in place, the top of the shelter is too tall to reach so a box was used to stand on. This makes tying on the bracing and pulling on the skin much easier (Fig.33+34).

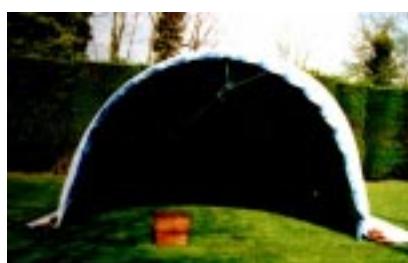
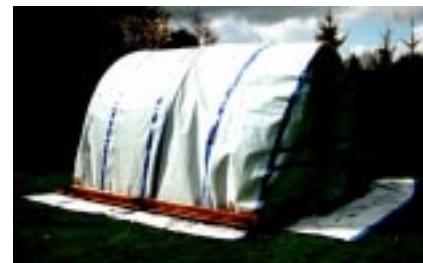
The skirt of Monarflex is held down on all sides by heavy timber planks to keep it as taught as possible (Fig.35+36).

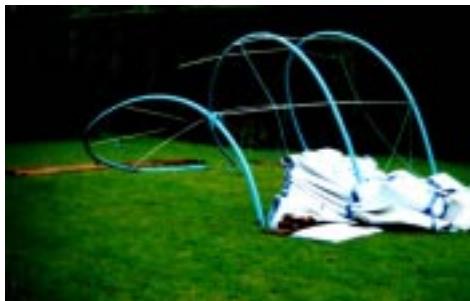
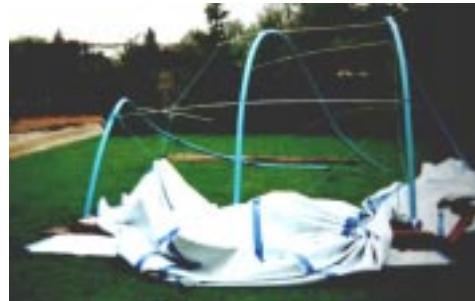
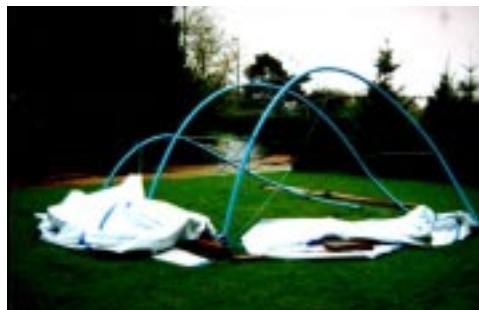
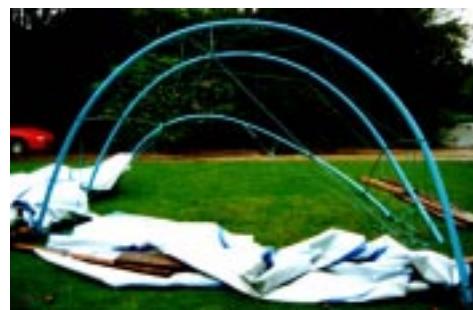
Unfortunately the second prototype also collapsed. At first glance, it appears that the tent poles have come apart and caused the structure to fail. (These tent poles lacked the spring-ties that would be present in the kit poles, so they came apart more easily). The skin had come off completely and had thrown off the timber planks on the left hand side (Fig.37, 38, 39, 40).

The cause of the collapse could have been aggravated by wind lifting the skin and pushing against the timber from the inside. A more likely cause is more water pooling. The water weighing down on the Monarflex could not crush the pipes this time because of the extra strength provided by the re-bar. The longer re-bar was very successful creating a good strong and even shape. Instead the skin was gradually pulled down, causing it to slide off the structure. The timber was not strong enough to keep the skin taught in order to prevent the build up of water, or to keep it in place with the weight of the water on the skin. The asymmetrical force of the water on the structure caused it to rotate, pulling the left hand side out of the ground. In an area with hard ground where no trenching can be carried out, there is no guarantee that material heavy enough could be found to weigh down the skirts. The materials used in their present configuration do not provide an adequate solution to the problem of a larger shelter. However, if the problem of water pooling could be solved, a larger shelter would be possible. This size of shelter has the disadvantage of being made with an odd number of pipe sections so that no ridge-pole is present. This appears to be critical to preventing water pooling. It would be a worthwhile exercise to try a six-sectioned version of the shelter to test this. Other methods of directing the water could be attempted such as using the bracing to form drainage channels. It may be possible to use the form of

The next step could possibly be a model making exercise to find a simple structural shape that avoids pooling and then another prototype test at full size to confirm that the shape can be made to work with a basic kit of parts. The 'Big Idea' behind this size of shelter needs to be carefully redesigned so that it works before a set of instructions can be produced for it.

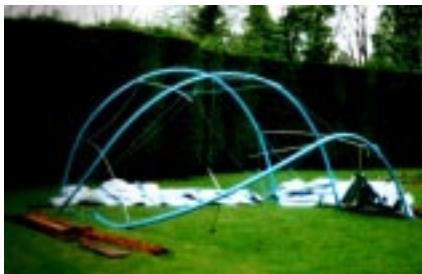
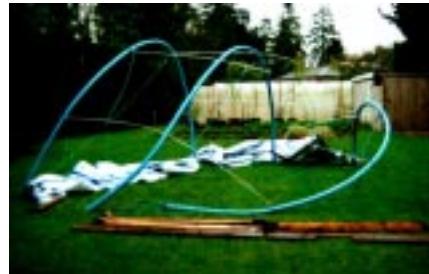
The front purlin had come away totally from the rest of the structure causing it to pitch forwards. (Fig. 41+42)

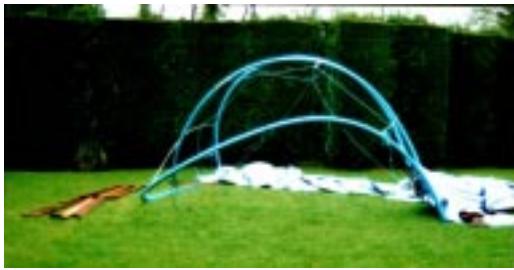
Fig. 43

The shape of the structure is still reasonably symmetrical despite the collapse.

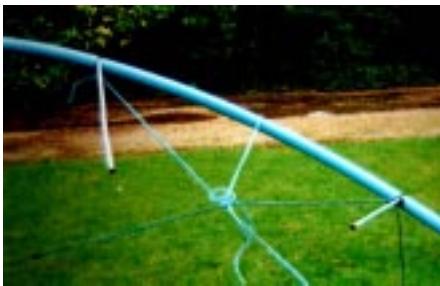
Fig. 44

(Fig. 43) Every knot of the bracing was also still intact (Fig. 44)

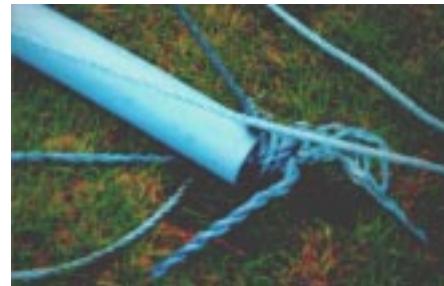
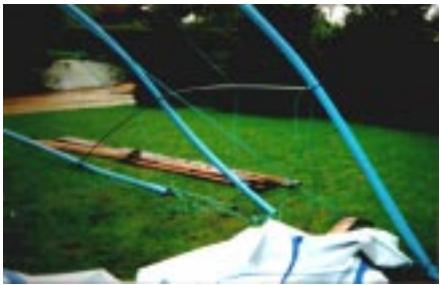
On closer inspection it became clear that the rebar on the left hand side had all come completely out of the ground (Fig. 45+46). The right side was still standing, still secured in the ground and still holding together. (Fig. 47)

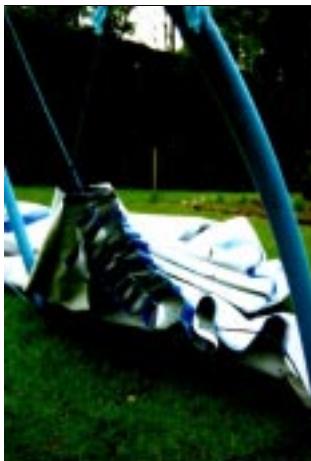
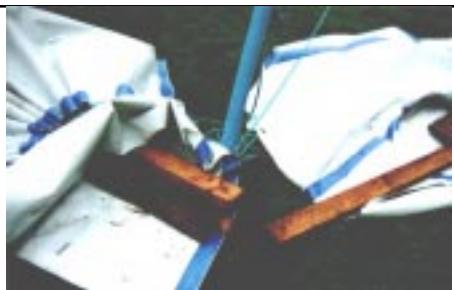
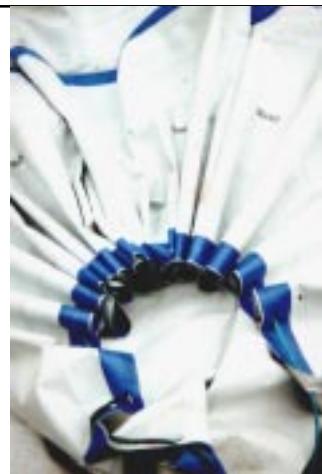
The skin had remained threaded onto the rope which was still tied in place. The timber planks had moved half a metre along the back of the shelter but had remained in place on the right hand side (Fig. 48, 49, 50).
