REBUILDING IN THE AFTERMATH OF AN EARTHQUAKE USING LOCAL SKILLS AND KNOWLEDGE

Rebuilding after an earthquake

Practical Action

technical brief

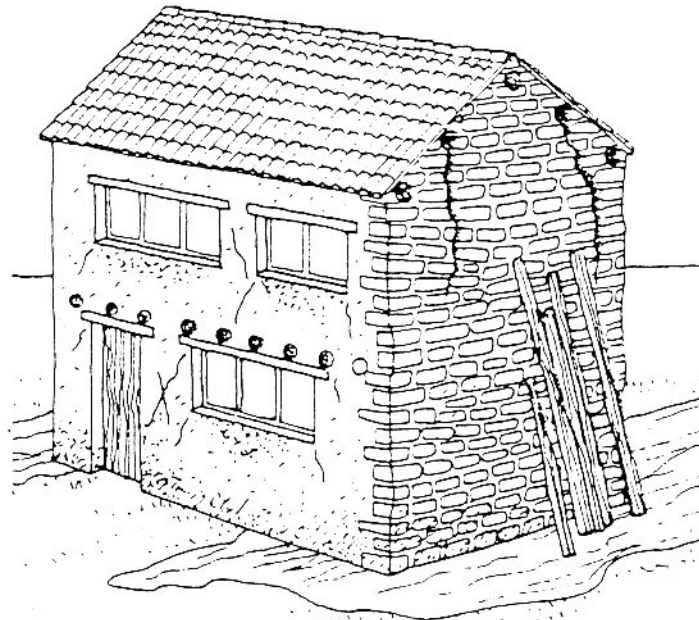
Many traditional stone and earth buildings are not built to withstand seismic activity, and are prone to crack and even collapse.

The most common failures in damaged buildings were the shattering and buckling of the outer face of stone masonry walls because of the lack of through stones, and corner failure in stone and brick masonry. Many walls had collapse, including load-bearing walls, and there were also many partial and total roof collapses. In RCC (reinforced cement concrete) structures the shear failure of brick masonry was apparent where there was a vertical opening between brick joints. Surprisingly, foundation settlement was uncommon in most of these houses.

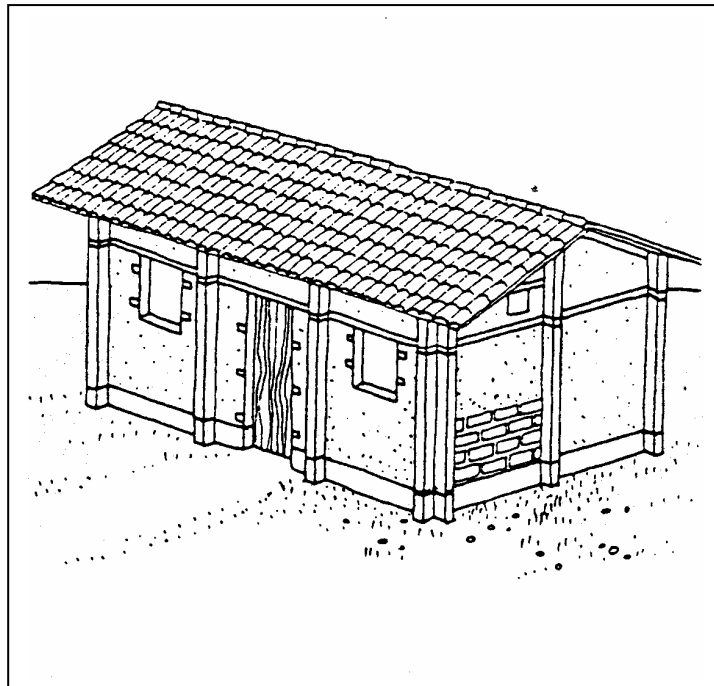
Once an appropriate site is chosen, the house should be built using good quality materials. A low one-storey building in a square (with reinforced corners) or circular shape is best. (Illustrations from *Earth Construction: A comprehensive guide* by Hugo Houben and Hubert Guillaud. IT Publications, London, 1994.)

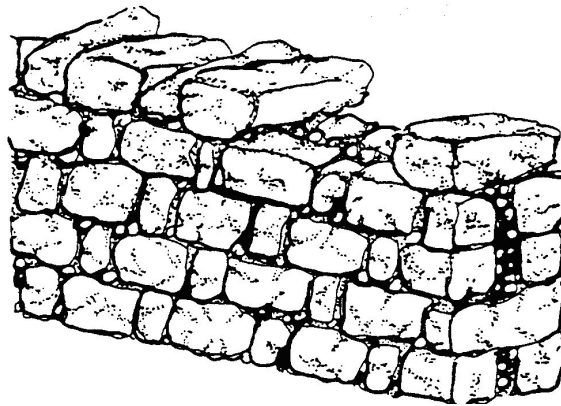
The use of long through-stones in a stone wall will make the wall more stable. (Illustration from *Technical Principles of Building for Safety* by Andrew Coburn, Richard Hughes, Robin Spence, and Antonis Pomonis. IT Publications, London, 1995.)
