EVOLVING STRATEGIES FOR LONG-TERM REHABILITATION ON SHELTER & HABITAT DEVELOPMENT IN THE TSUNAMI AFFECTED AREAS OF TAMIL NADU

Prepared by:
Anindya Kumar Sarkar
Ramachandra Panda
Manoranjan Sahoo
under guidance of Dr. Reuben Samuel
United Nations Development Programme

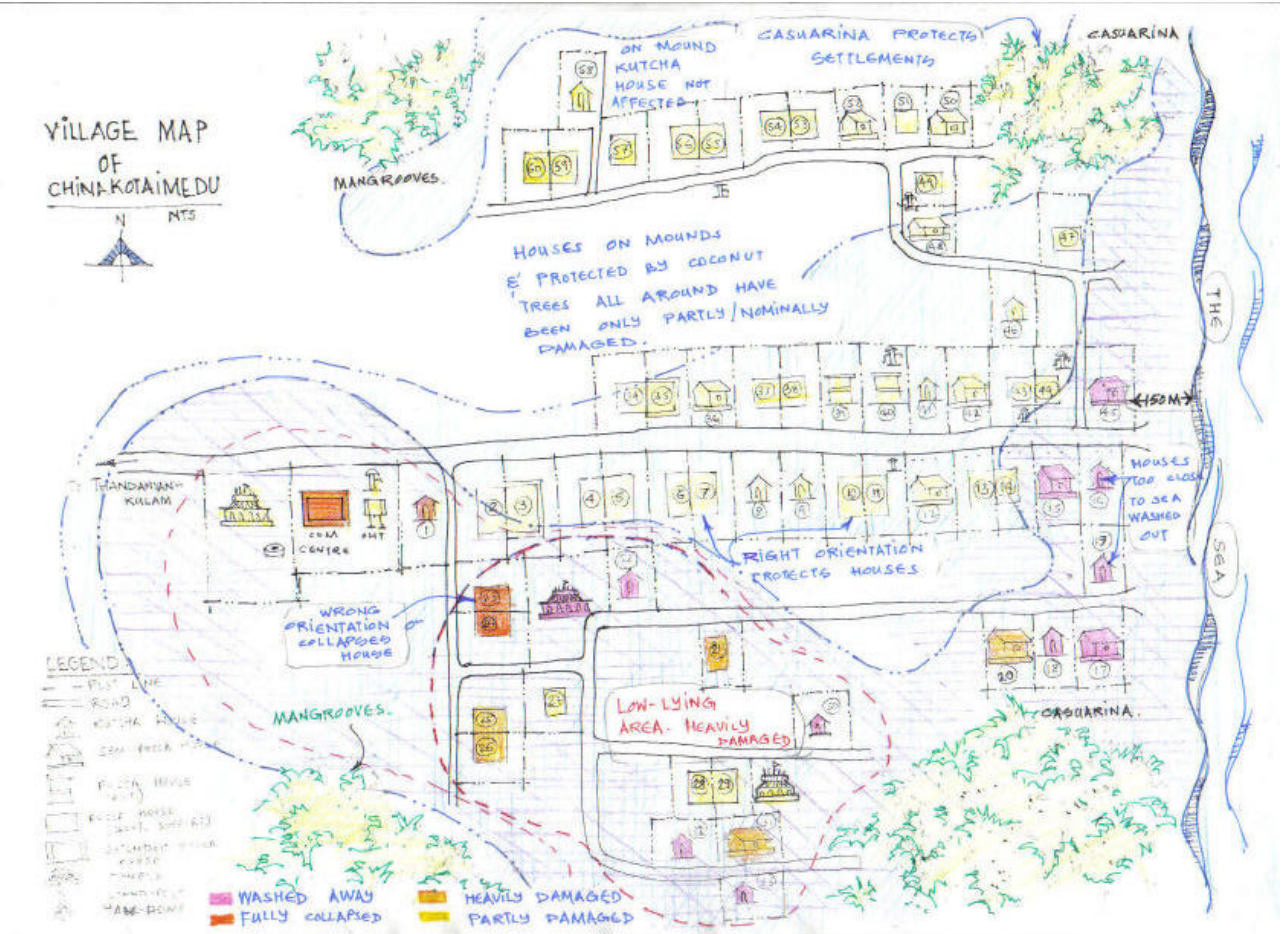
The map below describes the situation in this village at the time of and after the tsunami.

The casuarina plantations on either side of Chinakotaimedu have protected the settlements to an extent. However, damages also have been intense because of the removal of these plantations at the mouth of the settlement to the sea.

The houses too close to the sea have been washed away and there have been heavy casualties in the first line of houses. Close to the shore, the waters were of enormous height of about 20'. However with distance away from the sea within the settlement, the height of these waters dropped appreciably. They were of height about 4'-5' within the settlement; mostly children could not protect themselves and got drowned.

As explained earlier, Chinakotaimedu had low-lying areas as well as some shelters located on high mounds. Hence though a small settlement of 60 households, it portrays different degrees of damage to the houses and public infrastructure within the settlement. In areas extremely low-lying (marked on map), the tsunami washed away all the houses as well as the only community centre and a temple. A house with the wrong orientation in the low-lying area stands today with its foundations scoured and the long side of the wall facing the sea totally collapsed, while the remaining portion is hanging on loose soil.

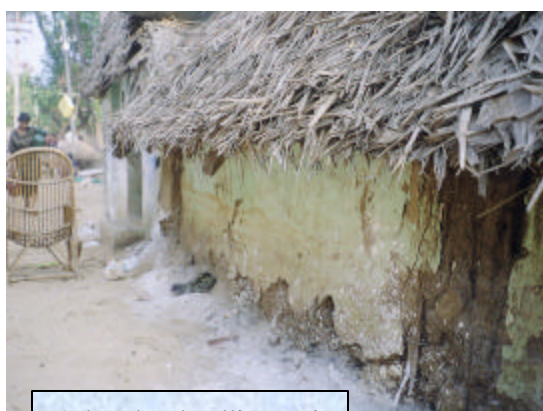
A kutcha dwelling unit

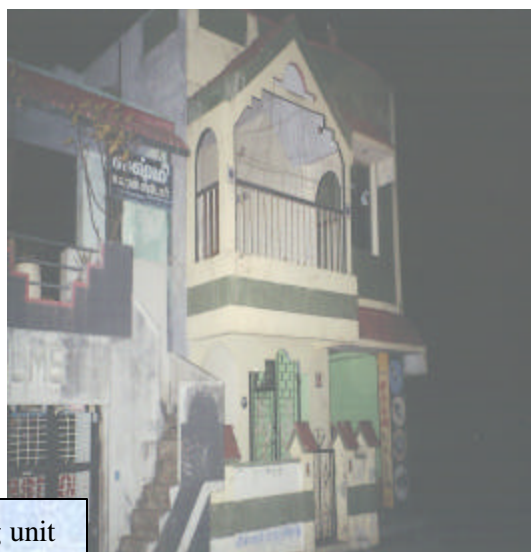
A pucca dwelling unit

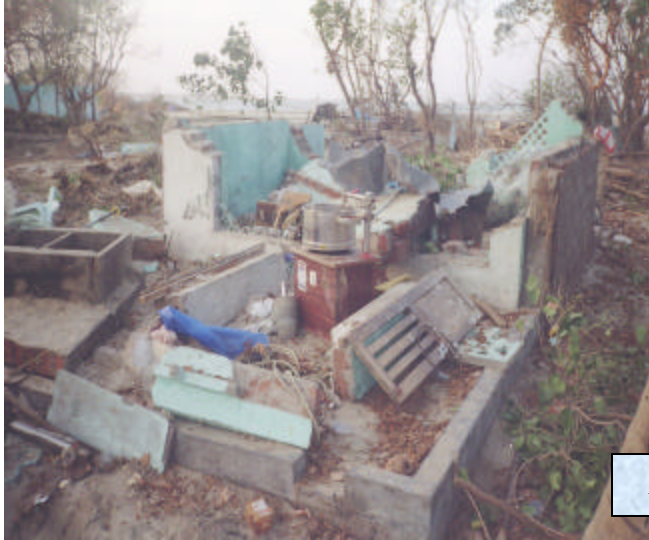
A fully collapsed pucca dwelling unit

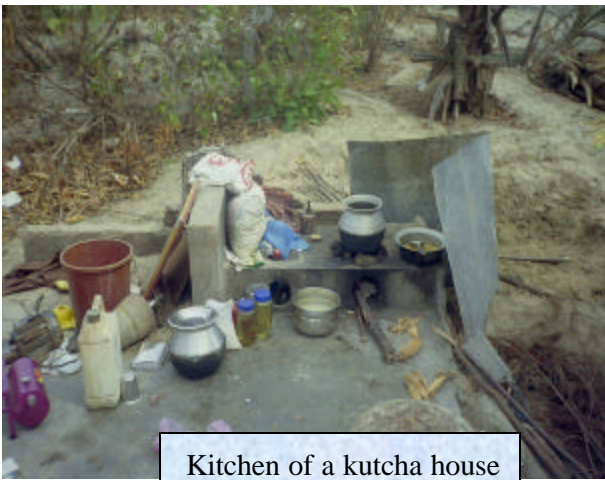
Kitchen of a kutchcha house

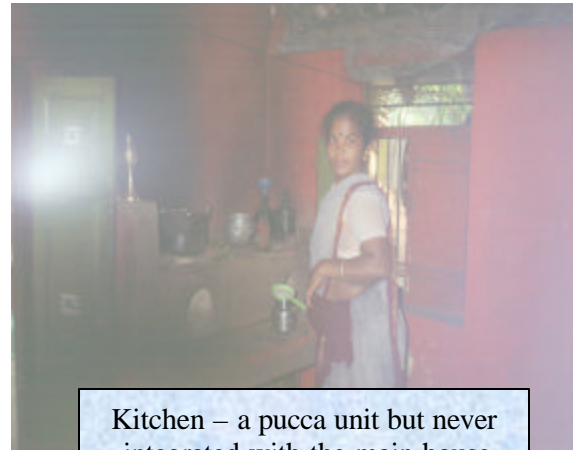
Kitchen – a pucca unit but never integrated with the main house

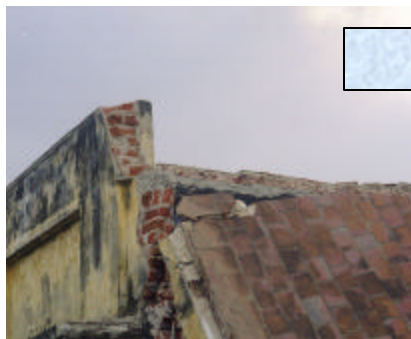
Damages to roof

- ? The thatch roofing has been severely damaged.
- ? The tile roofing are partly damaged, few of them are fully damaged which are nearer the sea & in low - lying area.
- ? Few of the pucca houses have collapsed.
- ? Cover concrete portion has already been removed causing rusting of reinforcement.

- ? The roof has been washed out because of the flow of water.
- ? Opening near sea face should be avoided.
- ? Because of improper covering & poor quality of RCC the bottom portion of concrete has fallen down.

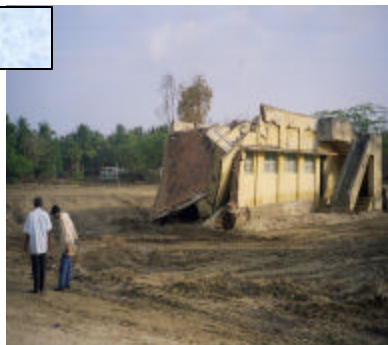
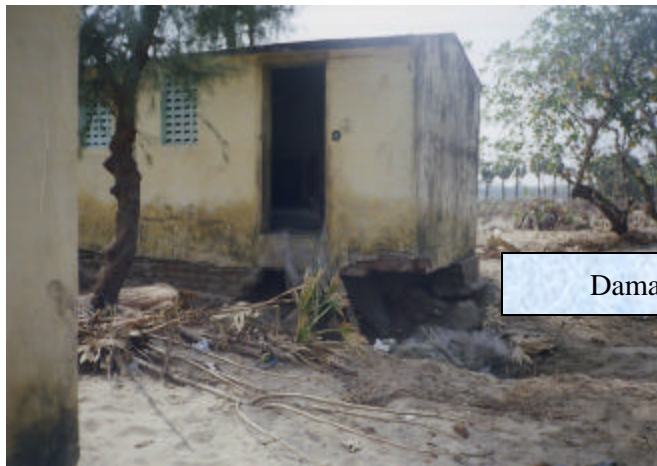
Damages to foundation

- ? The damages occurred to the buildings due to scouring of sand from foundation.
- ? Cracks have developed in most of the buildings due to foundation settlement.

- ? The depth of foundation is less so scouring has taken place.(<1m)
- ? No binding between PCC, foundation and plinth
- ? Sufficient corner lapping and cover to reinforcement were not properly placed
- ? The plinth height is less so sea water ingress below, so floor gets damaged.
