IMPROVED ADOBE MUDBRICK IN APPLICATION – CHILD-CARE CENTRE CONSTRUCTION IN EL SALVADOR

SUMMARY

EXPEDITION EL SALVADOR – CHILD-CARE CENTRE CONSTRUCTION

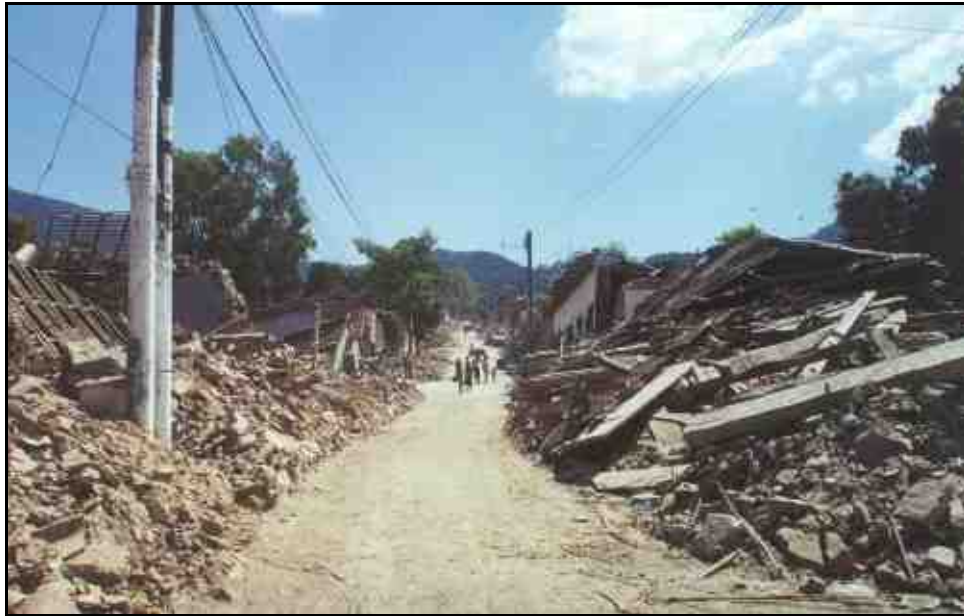
Figure 1. Destroyed adobe houses, El Salvador (López [5])

There are two main reasons why adobe houses performed so poorly in the earthquakes. Firstly, adobe is a low-strength, brittle material, which yields under much lower stresses than ‘modern’ materials, such as steel, concrete and conventional masonry. Secondly, traditional adobe houses are often poorly constructed and/or maintained due mainly to resource and skill limitations. These features mean that, in general, adobe structures are more vulnerable to damage during seismic events.

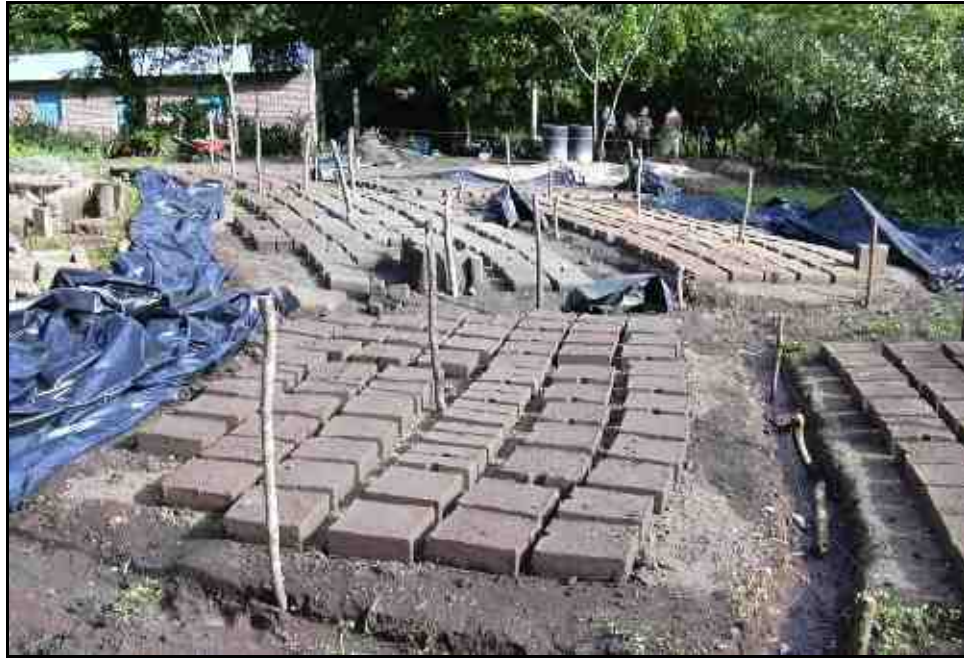
Figure 3. Drying bricks (Note: drainage ditches and plastic covers)

Timber and steel moulds were used to fabricate full size bricks (300 x 300 x 100mm), half size bricks (300 x 140 x 100mm) and channel bricks (for use in the ring beam, as described below). Voids for vertical reinforcement were included in the moulds. The bricks were made on a bare soil or sand ground surface (Figure 3) and covered immediately with opaque plastic sheeting to prevent cracking due to the differential drying of the brick in the hot sun. After two to three days the bricks were turned on edge and allowed to dry in direct sunlight. Bricks were rotated every couple of days to ensure thorough baking throughout. After a period of two to three weeks the bricks were stacked ready for transportation to the

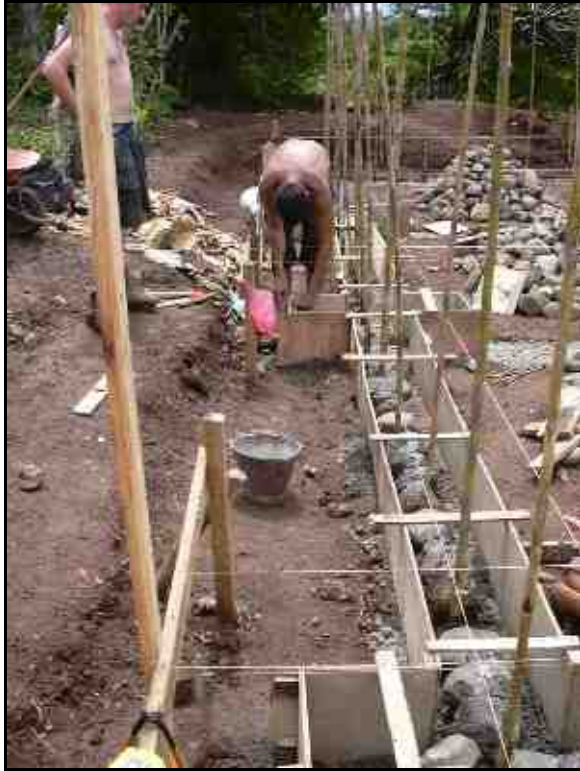
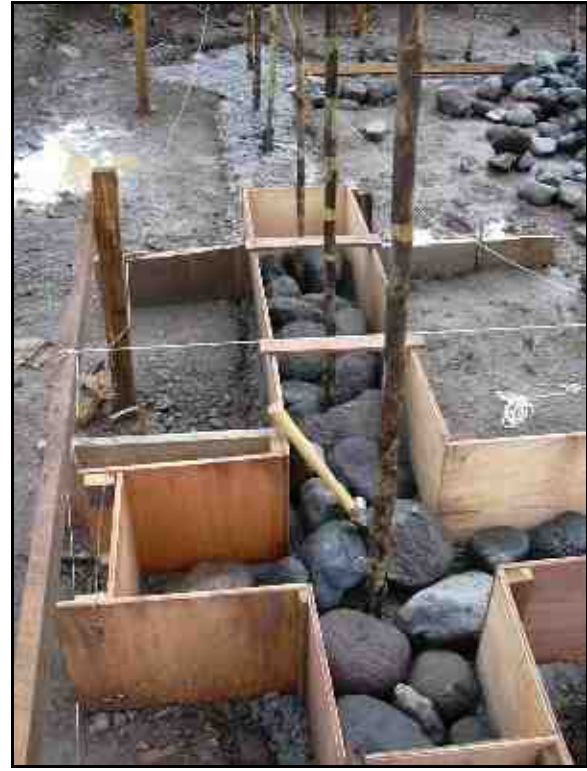
Figure 4. Location of vertical reinforcement and preparation of plinth formwork.

A local cane/bamboo, *vara de castilla* (*Gynerium sagittatum*, Hays [15]), was used as internal (within the wall) vertical reinforcement, placed every 640mm (Figure 4). It was attached to the foundation via L-shaped steel bars (tied with wire prior to pouring the plinth / ‘top foundation’) and connected to the ring beam at the top of the wall, thus creating a continuous matrix of reinforcement, tying the structure together. The placement of the vertical reinforcement presented significant problems. Firstly, during the pouring of the foundations a number of the steel L-shaped bars were knocked slightly out of alignment. This misalignment, combined with the natural and unavoidable curvature of the bamboo meant that the reinforcement was not in the precise location as per the design. As each course of the wall was laid, certain bricks needed to be trimmed and cut to fit. This created delays and frustrations during the construction of the wall, and highlights the need to ensure accurate alignment of the vertical reinforcement.

The inclusion of pilasters increased the complexity and resource requirements of the project. Firstly, the preparation of the formwork for the plinth layer became a complex task, requiring multiple right-angled corners and various adjustments (Figure 4). The configuration of the bricks around the pilasters was different to that commonly used by local builders and this created some initial confusion, although this was overcome as the wall construction progressed. The inclusion of the pilasters necessitated the expansion of the roof cover in order to maintain the desired minimum overhang of 600mm. This resulted in an increase of 13% in the plan area of the roof, with various elements of the roof structure designed to support cantilever actions of over one meter. These increases in costs and complexity should be considered in conjunction with the aseismic contribution offered by the pilasters and should be the subject of further research.

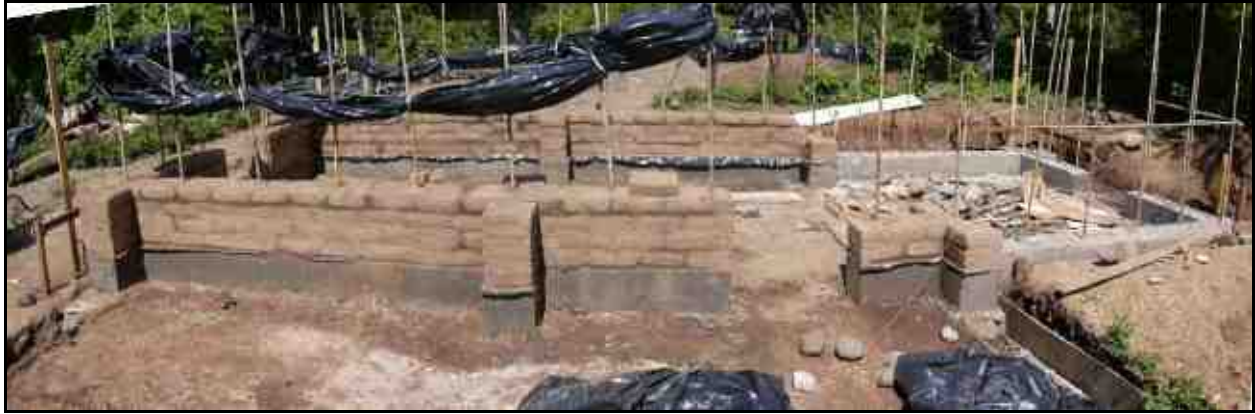
Figure 5. Adobe walls under construction, including plinth, pilasters, vertical reinforcement, plastic rain covers (Note: figure alignment offset due to photograph splicing).

The walls were 300mm wide, 2.24m high load-bearing walls, which consisted of the plinth layer, 15 courses of adobe bricks and a ring beam. The mortar joints were ~ 20-25mm wide and were made of the same material (mud) as the adobe bricks (Figure 5). String-lines were used to maintain alignment and plumb of the walls. There were some initial problems with the placement of blocks in the walls as the workers adjusted to the new technique. On several occasions blocks needed to be removed and the configuration changed. This was to be expected, but relied on fairly constant supervision to correct errors quickly.

Pilasters were constructed externally at each corner of the building and both internally and externally at third points along the long wall (Figure 5). The pilasters were 320mm deep (equal to one block plus one mortar joint) and extended to the top of the wall (2.24m).

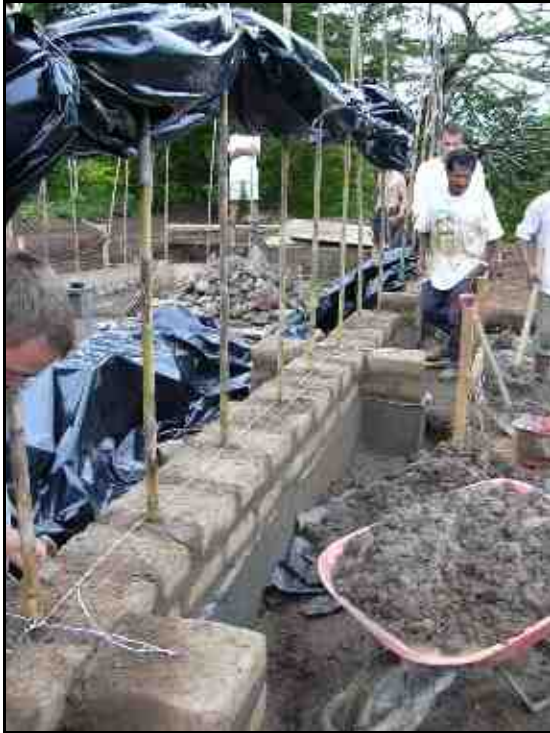
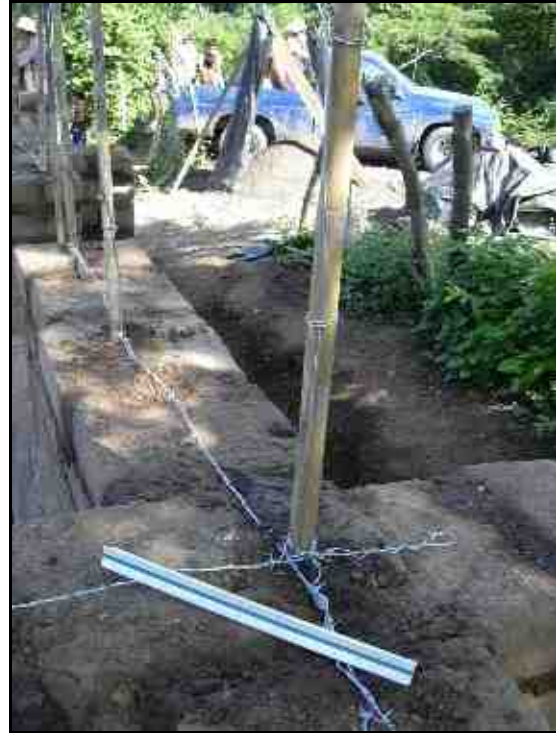
Figure 6. Adobe walls under construction, including plinth, pilasters, vertical and horizontal reinforcement, plastic rain covers.

Two strands of galvanized barbed wire were placed in the horizontal mortar joints every three courses (Figure 6). The barbed wire strands were weaved between and tied to the vertical bamboo reinforcement to promote continuity. The strands of barbed wire were extended into the pilasters, with U-shaped nails/staples used to connect the wire to the bricks. In some cases, this caused cracking of the bricks, and should be undertaken with caution. In the upper part of the wall (between courses 11-12 and 14-15) a strip of chicken wire mesh was placed horizontally in the mortar joints to augment the barbed wire in this critical section.

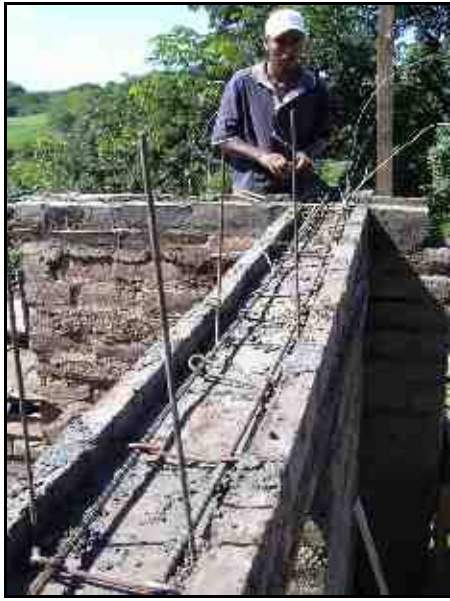
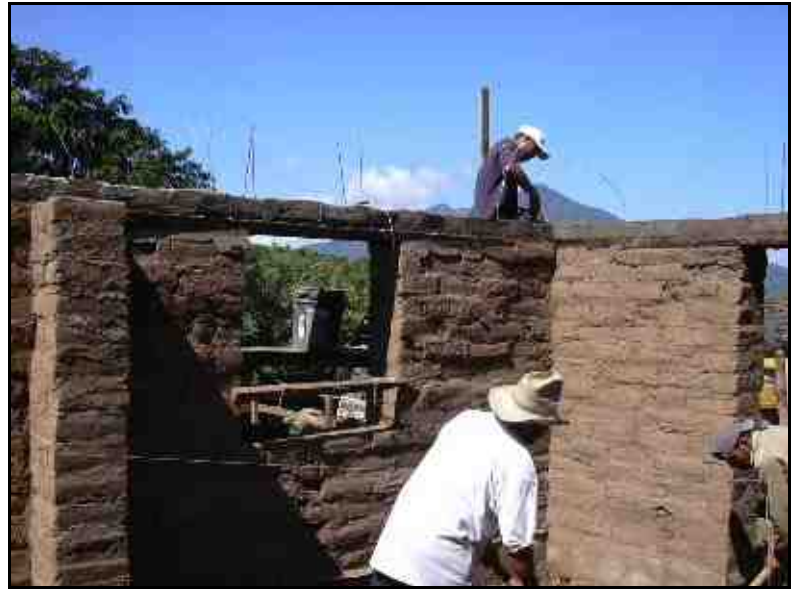
Figure 7. Ring beam channel blocks and reinforcement (Note: steel pins and wire straps for roof attachment).

'Channel' blocks were formed with special moulds, using a soil-cement mix of 7:1. The channel blocks were wet cured for a minimum of seven days. The ring beam channel blocks were placed on the top course of adobe bricks, using a soil-cement mortar (7:1). Where necessary, holes were bored in the channel blocks to accommodate the vertical bamboo reinforcement. A horizontal reinforcing mesh consisting of two 1/2" steel reinforcing bars with 1/4" stirrups every 250mm was placed in the channel (Figure 7). This reinforcement was tied to the vertical bamboo reinforcement and roof anchors. Finally, the channel was filled with a 5:1 sand-cement mix. At the places where the vertical strands of wire passed through the ring beam, it was difficult to level off the cement mix evenly. This created elevated points, which become points of concentrated load where the timber wall plate rests on the ring beam. One option to prevent this occurring would be to place the timber wall plates whilst the cement mix is still fresh enough to be manipulated to create an even contact surface with the wall plates.

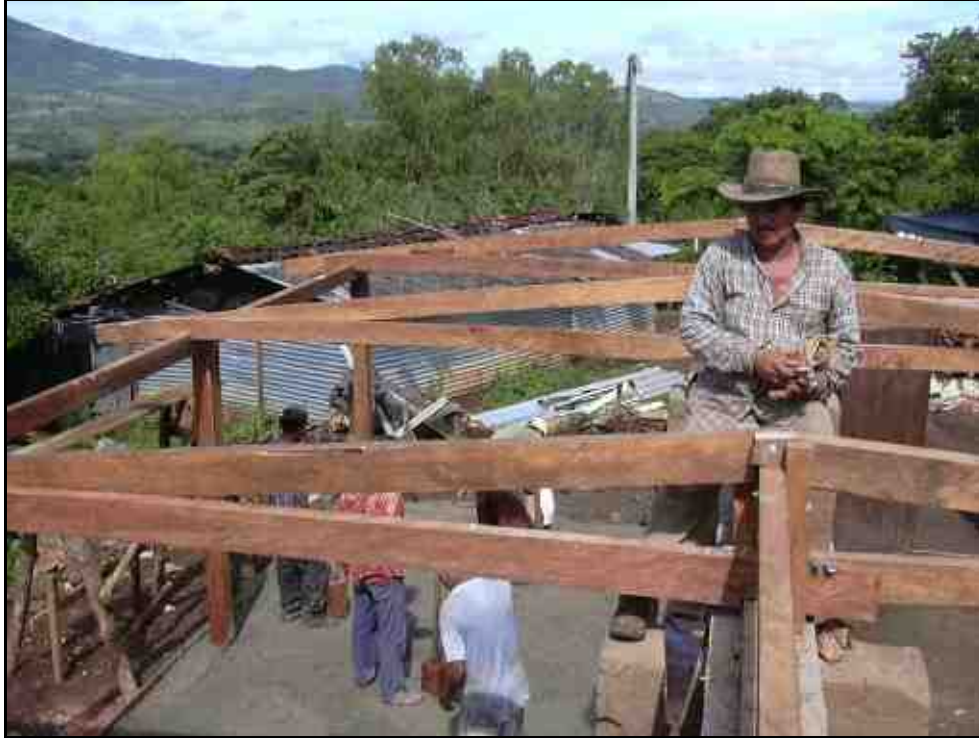
Figure 8. Roof under construction.

The roof consisted of a double-pitch timber roof structure with a Zinc-Alum sheeting cover. The structure comprised of timber wall plates supporting a timber lattice beam, trusses, purlins and diagonal bracing (Figure 8). Connections were bolted, nailed and / or strapped, as appropriate. The wall plate was tied to the ring beam and walls using heavy gauge wire and steel rods, as described above. A minimum overhang of 600mm was maintained around the building to protect from water damage due to rain. One pitch of the roof covered the verandah area, which was supported by timber columns in concrete footings. The gables were closed with welded mesh and screen mesh to allow free flow of air, whilst ensuring a secure and safe building.
